**Aircraft Type and Registration:** Rockwell Commander 112B, G-BENJ

**Date & Time (UTC):** 31 December 1994 at 1514 hrs

**Location:** Blackbushe Airport, Surrey

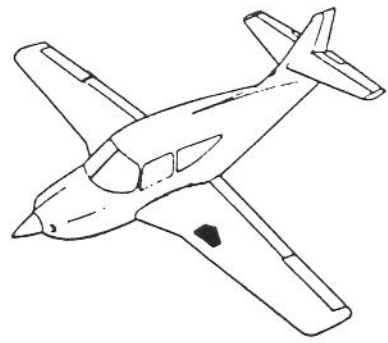
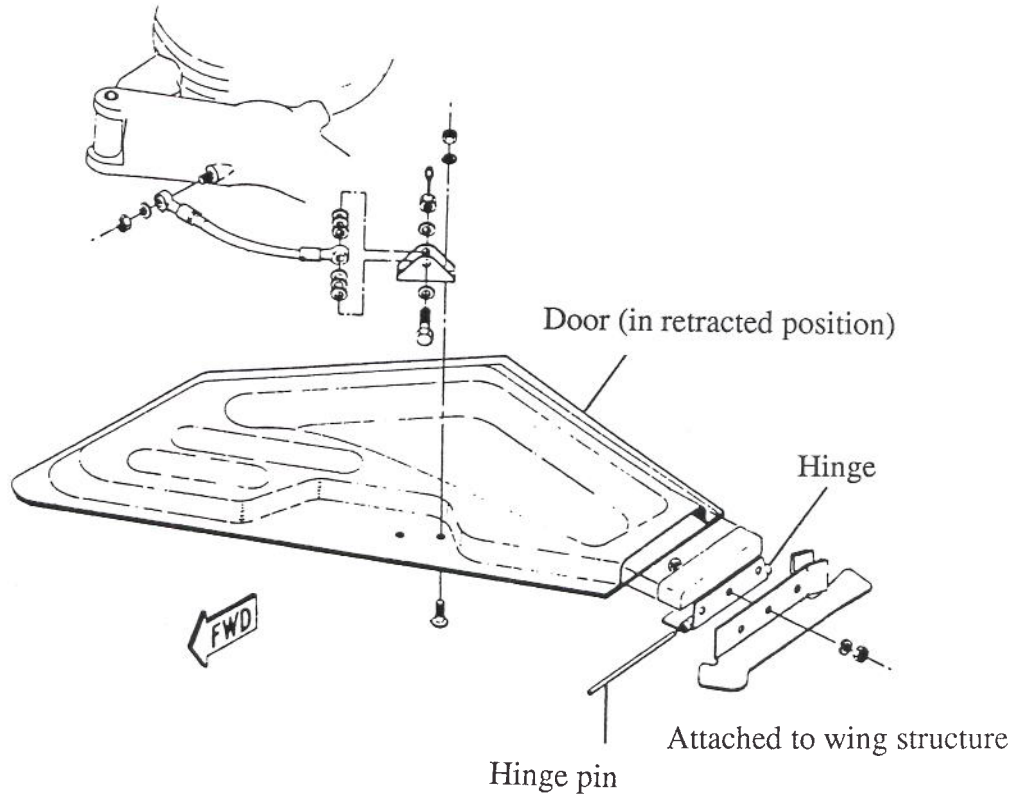
Main Landing Gear Door Details

Subsequent examination of the aircraft revealed that the left main landing gear door hinge had broken such that the top of the door was no longer attached to the aircraft structure. It was thus free to become lodged in the wheel well, although the various associated witness marks suggested that the top of the door had become jammed against the wing underside immediately outboard of the well. The door had been retained on the aircraft by a strut attaching it to the landing gear leg.

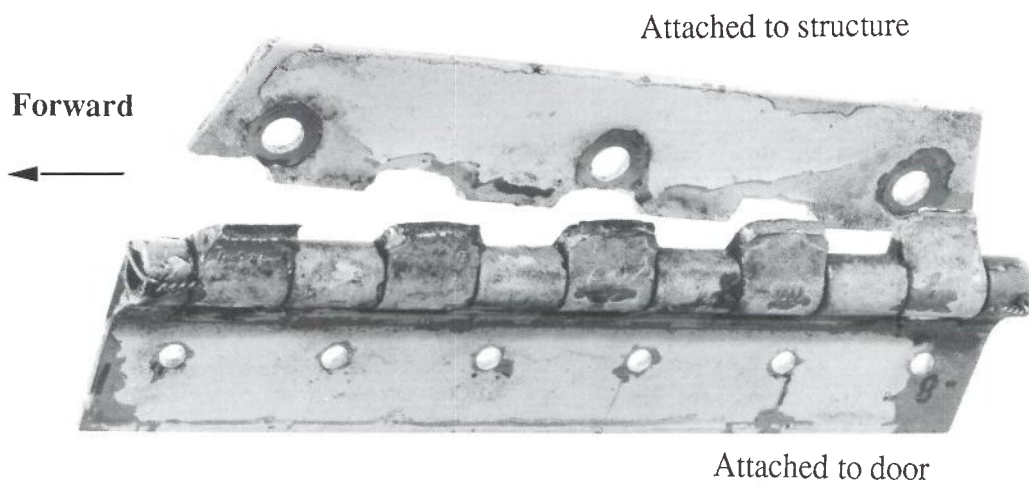
The two hinge halves, which were of light aluminium alloy, were removed from the aircraft and examined at the Structural Materials Centre, DRA Farnborough. It was apparent that all five hinge lugs had failed, each one being found at a different angle on the hinge pin relative to the others (see the accompanying diagrams and figure). All the lugs were found to be immovable on the steel pin due to the latter being in a corroded condition along most of its length, with only a very few remaining 'bright' areas. The bores of the lugs, which could be removed only after sectioning them longitudinally, were contaminated with corrosion product but were not themselves corroded. There was no evidence of any lubricant within the lug bores. However, oil residues were found in the recesses between the lugs.

The fracture surfaces of the lugs were all virtually identical in appearance and were indicative of fast, ductile fracture; there was no evidence of associated fatigue. A bright band along a longitudinal edge of each lug indicated a compression/shearing process, and was therefore the final part of the failure which had occurred by overstressing in bending in an inboard (ie gear retracting) direction. The as-found positions of each failed lug indicated that failure had progressed, during a single retraction cycle, in a rear-to-front direction.

It was concluded that the failure had occurred as a result of a lack of hinging action due to seizure of the two hinge halves on the hinge pin. The absence of fatigue on the fracture faces was perhaps surprising, as a partially seized hinge would be expected to result in reverse bending loading of the hinge lugs during the gear extension and retraction cycles. It was thus possible that the apparent seizure had occurred relatively suddenly, such that the lugs were overloaded during a single retraction sequence.

Photograph of G-BENJ main gear door hinge, showing failed lugs in their as-found positions.
