ACCIDENT

Aircraft Type and Registration:	PZL-104 Wilga 35A, G-BWDF	
No & Type of Engines:	1 PZL Kalisz AI-14RA piston engine	
Year of Manufacture:	1995	
Date & Time (UTC):	6 May 2010 at 0659 hrs	
Location:	Hinton-in-the-Hedges Airfield, Northamptonshire	
Type of Flight:	Aerial Work	
Persons on Board:	Crew - 1	Passengers - 1
Injuries:	Crew - 1 (Serious)	Passengers - 1 (Serious)
Nature of Damage:	Engine, undercarriage and fuselage damaged	
Commander's Licence:	Commercial Pilot's Licence	
Commander's Age:	45 years	
Commander's Flying Experience:	602 hours (of which 155 were on type) Last 90 days - 16 hours Last 28 days - 13 hours	
Information Source:	Aircraft Accident Report Form submitted by the pilot and further enquiries by the AAIB.

Synopsis

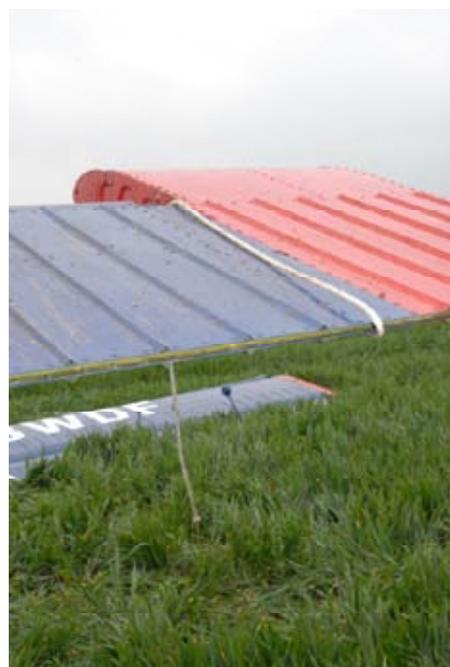
Figure 1.

Other photographs showed that the tow line was wrapped around the left elevator from the trailing edge to the hinge between the elevator horn balance and the tailplane (see Figure 1, which shows the tow line after cutting by personnel on the ground). Marks on the paint in the internal gap between the tailplane and horn balance were consistent with the tow line rubbing against the two surfaces.

After the aircraft had picked up the banner, the pilot believed that tension in the tow line combined with its downward angle created a nose down elevator input that he could barely overcome. He considered that on the final approach, the banner made contact with the ground when the aircraft was at approximately 35 ft agl, which increased the tension on the tow line momentarily and pulled the control column forward. Tension in the line was relieved as the aircraft descended, allowing him to raise the nose to a level attitude before impact.
