**AAIB Bulletin No: 11/93**

**Ref: EW/C93/8/4**

## **INCIDENT**

**Aircraft Type and Registration:** Shorts SC7 Skyvan 3A, G-OVAN  
**No & Type of Engines:** 2 Garrett Airesearch TPE 331-2-201A turboprop engines  
**Year of Manufacture:** 1971  
**Date & Time (UTC):** 26 August 1993 at 1740 hrs  
**Location:** Sibson Airfield, Peterborough  
**Type of Flight:** Parachute dropping  
**Persons on Board:** Crew - 1                      Passengers - 18  
**Injuries:** Crew - None                      Passengers - None  
**Nature of Damage:** Right-hand crew door separated, damage to propeller and puncture in fuselage skin  
**Commander's Licence:** Commercial Pilot's Licence with Instrument Rating  
**Commander's Age:** 32 years  
**Commander's Flying Experience:** 1,353 hours (of which 100 were on type)  
Last 90 days - 135 hours  
Last 28 days - 50 hours  
**Information Source:** AAIB Field Investigation

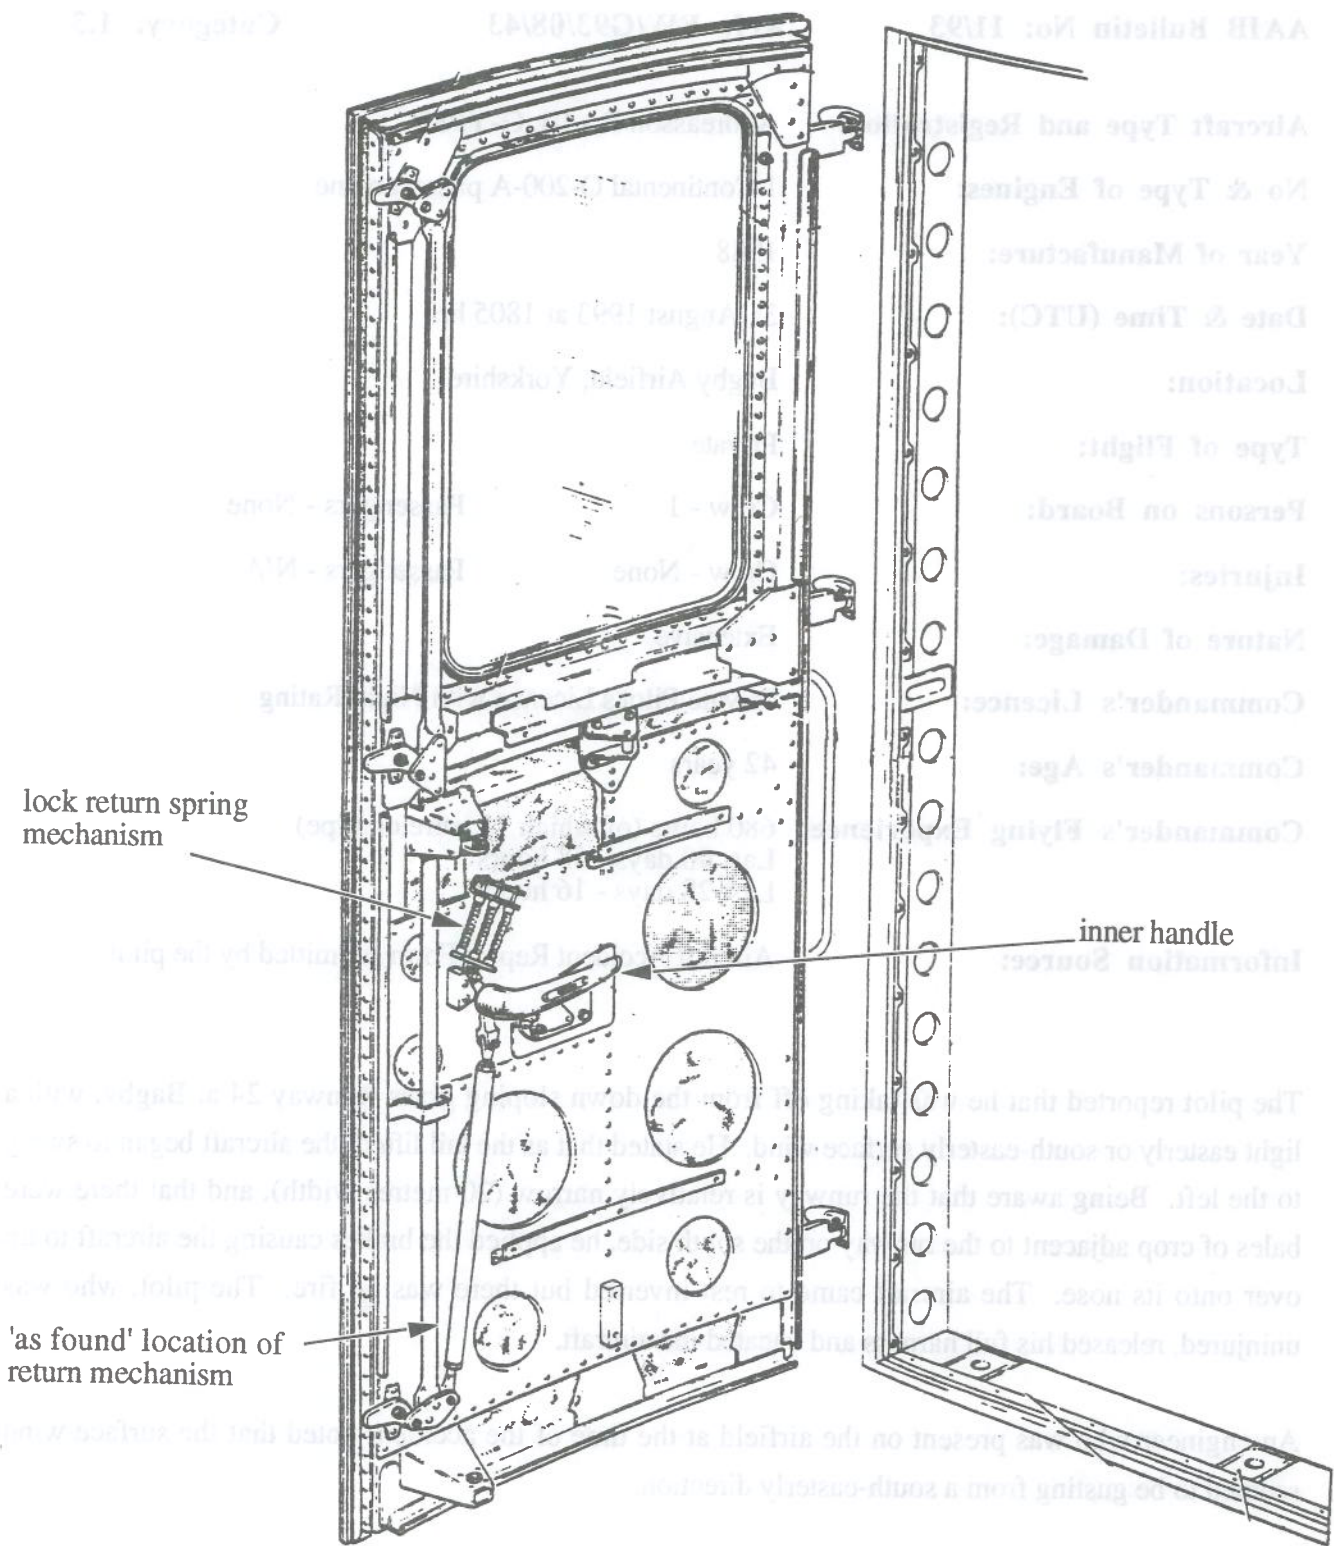
It was therefore decided to strip away the internal trim to reveal the mechanism. Having done this it was obvious that the lock return mechanism shown in the diagram had not been fitted. It was actually recovered lying loose in the door at the position shown. There could be no doubt that it had been omitted since it is fitted prior to, and on the same square-section shaft as the inner handle, the latter having been fitted without the return mechanism. The parts had evidently been in this location for some time since there was corrosion on the surfaces which should have interfaced whilst there was shiny chafing where the loose return mechanism had lain against the structure.

The evidence was consistent with the handles being free to move under gravity and inertia with other variables such as air loads affecting the amount of friction preventing movement of the mechanism. The pilot recalled that, at the time, the aircraft was running over a particularly bumpy part of the grass runway.

**G-OVAN.** View of crew door with trim removed to show handle mechanism
