ACCIDENT

Aircraft Type and Registration:	Evans VP-1 Volksplane, G-BFJJ
No & Type of Engines:	1 Volkswagen 1800 piston engine
Year of Manufacture:	1979
Date & Time (UTC):	20 April 2008 at 1810 hrs
Location:	Near Farley Farm Airfield, Winchester
Type of Flight:	Private
Persons on Board:	Crew - 1 Passengers - None
Injuries:	Crew - 1 (Minor) Passengers - N/A
Nature of Damage:	Aircraft sustained substantial damage
Commander's Licence:	Private Pilot's Licence
Commander's Age:	50 years
Commander's Flying Experience:	467 hours (of which 4 were on type) Last 90 days - 5 hours Last 28 days - 2 hours
Information Source:	AAIB Field Investigation

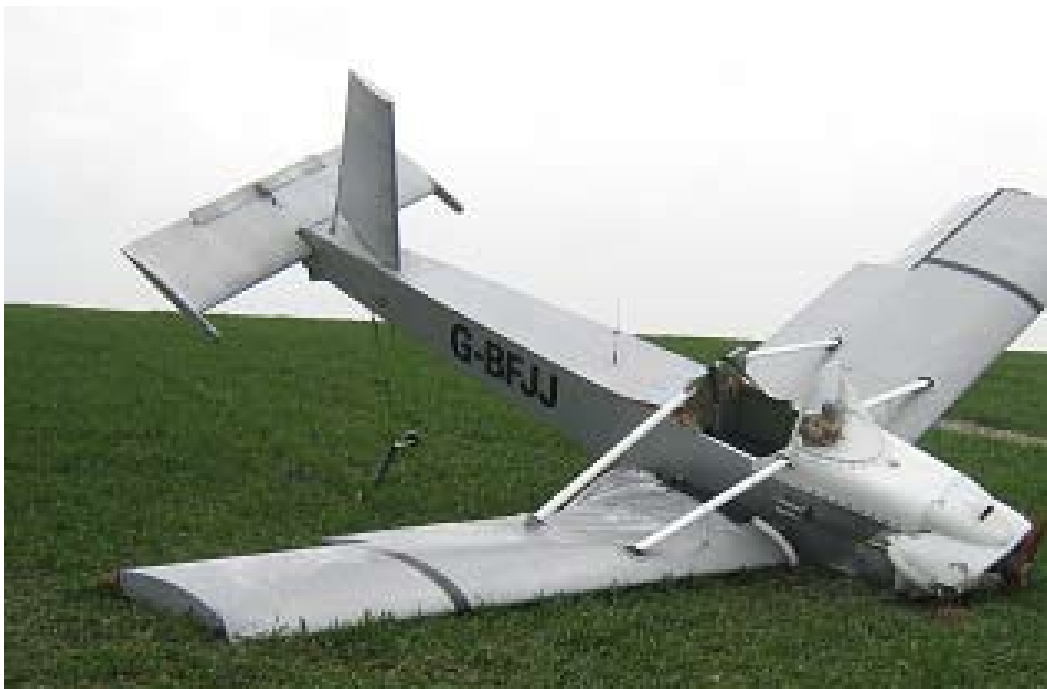
Figure 1

G-BFJJ is a single engine, low wing monoplane, with two steel bracing struts on each wing (Figure 1). One end of each strut is fixed to the structure of the wing and the other end is connected to the fuselage. The front two bracing struts are connected to a carry-through-structure, which goes through the front of the cockpit, and to which the instrument panel is attached. The rear two bracing struts are connected to an extended bulkhead containing a carry-through-structure, which forms the rear face of the cockpit compartment. The shoulder straps of the pilot's restraint harness are attached to the rear carry-through-structure at the top of this bulkhead.

Bracing strut orientation
