**ACCIDENT**

<b>Aircraft Type and Registration:</b>	1) Vans RV-6A, G-RVGC 2) DA 40D Diamond Star, G-CEZR
<b>No &amp; Type of Engines:</b>	1) 1 Lycoming 0-320-D3G (Modified) piston engine 2) 1 Thielert TAE 125-02-99 piston engine
<b>Year of Manufacture:</b>	1) 2004 2) 2008
<b>Date &amp; Time (UTC):</b>	4 July 2011 at 1528 hrs
<b>Location:</b>	Shoreham Airport, West Sussex
<b>Type of Flight:</b>	1) Post-modification test flight 2) Training
<b>Persons on Board:</b>	1) Crew - 1                      Passengers - None 2) Crew - 2                      Passengers - None
<b>Injuries:</b>	1) Crew - 1 (Fatal)          Passengers - N/A 2) Crew - None                Passengers - N/A
<b>Nature of Damage:</b>	1) Destroyed 2) Propeller and gearbox detached, damage to left wing
<b>Commander's Licence:</b>	1) Private Pilot's Licence 2) Airline Transport Pilot's Licence
<b>Commander's Age:</b>	1) 62 years 2) 60 years
<b>Commander's Flying Experience:</b>	1) about 20,600 hours (of which n/k were on type) Last 90 days - n/k hours Last 28 days - n/k hours 2) 3,450 hours (of which 32 were on type) Last 90 days - 35 hours Last 28 days - 13 hours

<b>Information Source:</b>	AAIB Field Investigation

**Syn

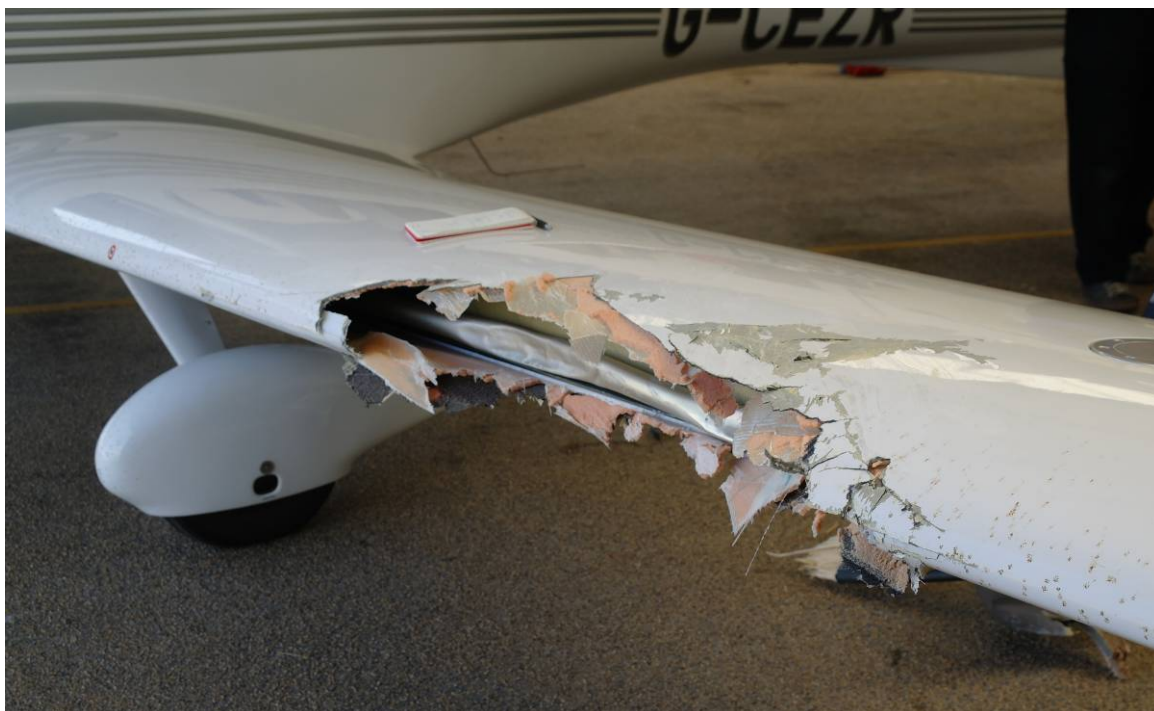
**Figure 4**

The aircraft had been towed to the Police Air Support Unit’s secure hangar before the AAIB examination. It was immediately apparent that the propeller was missing, as a result of fracturing in the reduction gearbox which connected it to the engine. There was a 90 cm section of the left wing composite leading edge missing, at about mid-span, (Figure 4) and a piece of the fin structure from GC was lodged in the left aileron control horn. There was other minor damage to the aileron and flap on the left wing, and the nosewheel. Apart from these, there appeared to be no further damage to ZR.

Leading edge damage to G-CEZR

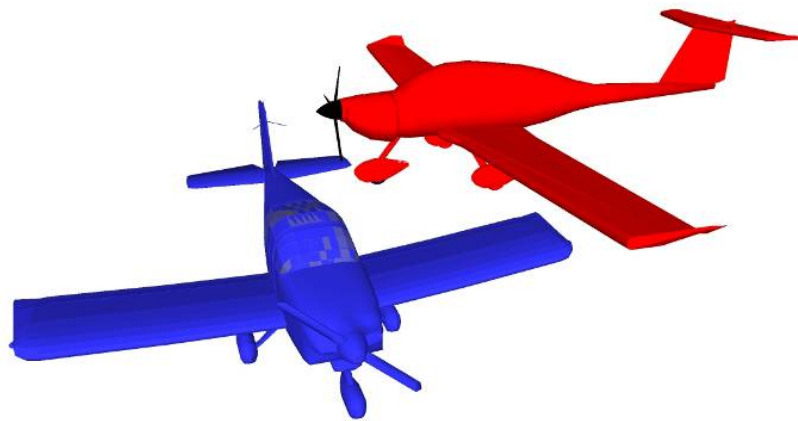
**Figure 6a**

The first contact was between one propeller blade of ZR (rotating clockwise when viewed from behind) and the tailplane and elevator of GC, removing the tips of the left tailplane and elevator and destroying the wooden propeller blade of ZR (see Figure 6a).

Modelling of collision sequence (G-CEZR in red and G-RVGC in blue)

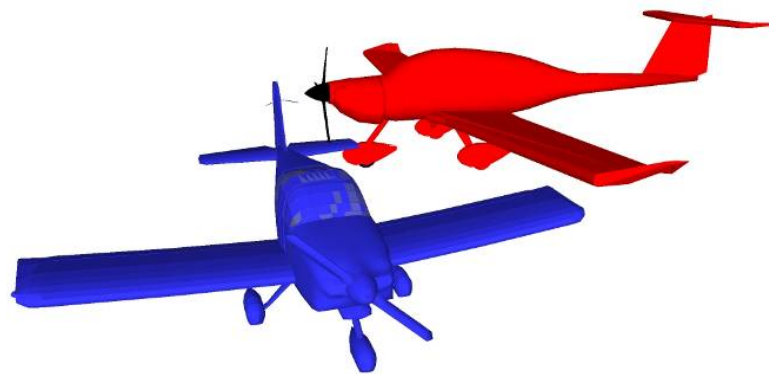
**Figure 6b**

As relative movement of both aircraft continued, a second propeller blade from ZR was in contact with the elevator further inboard, separating it into two halves (see Figure 6b). The severe out-of-balance forces rapidly fractured ZR's reduction gear casing and the propeller detached.

Modelling of collision sequence

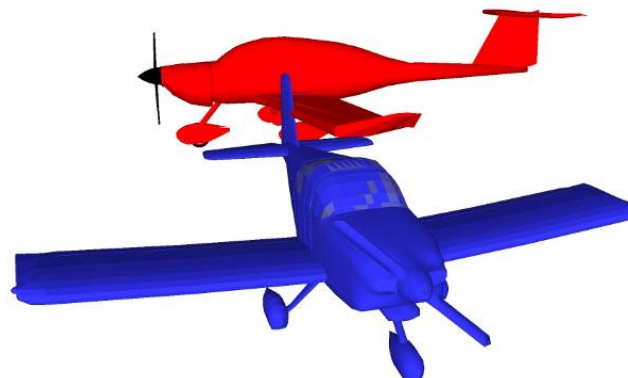
**Figure 6c**

Modelling of collision sequence

There was no further contact between the two aircraft, but GC would have been left with no yaw control and severely impaired (or possibly jammed) longitudinal control. The leading edge damage to ZR would have caused some drag increase on the left side but clearly the pilot was able to overcome this and perform a successful forced landing without power.
