Aircraft type and registration: Piper PA36-375 Brave G-BIPJ (single engine light aircraft — crop sprayer)

Date and time (GMT): 6 July 1984 at 0900 hrs

Location: On farm near East Dean, Sussex

Nature of damage: Damage to left undercarriage, left wing and lower fuselage

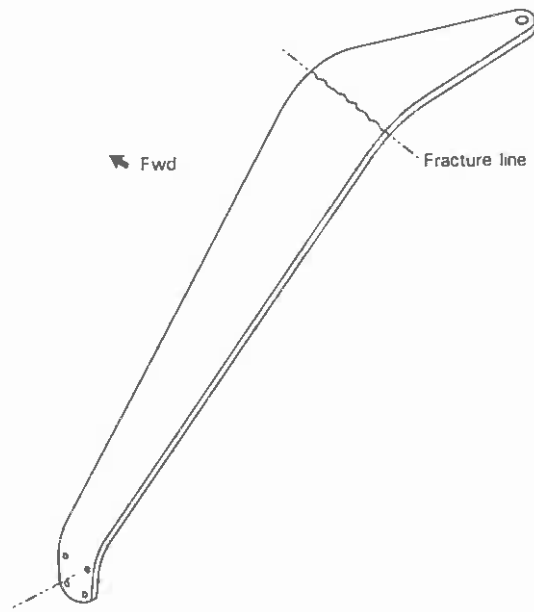
Figure 1

Each main undercarriage on this aircraft is a single leaf steel spring, 0.9" thick and tapering from 6.5" in width at its upper end to 2.5" at the wheel axle mounting position. It is manufactured from rectangular section steel bar cut to the appropriate shape and formed through two approximately 45° bends, such that one is situated just above the wheel, the other just outboard of the fuselage. The left undercarriage had failed across the section at a position approximately half way round the upper bend, ref figure (1). Metallurgical examination of the fracture surfaces revealed that failure had occurred predominantly by fast fracture from a number of origins along the lower surface. Overall rupture features were indicative of low ductility over the major part of the fracture, as evidenced by the very small shear decohesion lips extending along the lower surface, either side of these origins, ref figure (2).

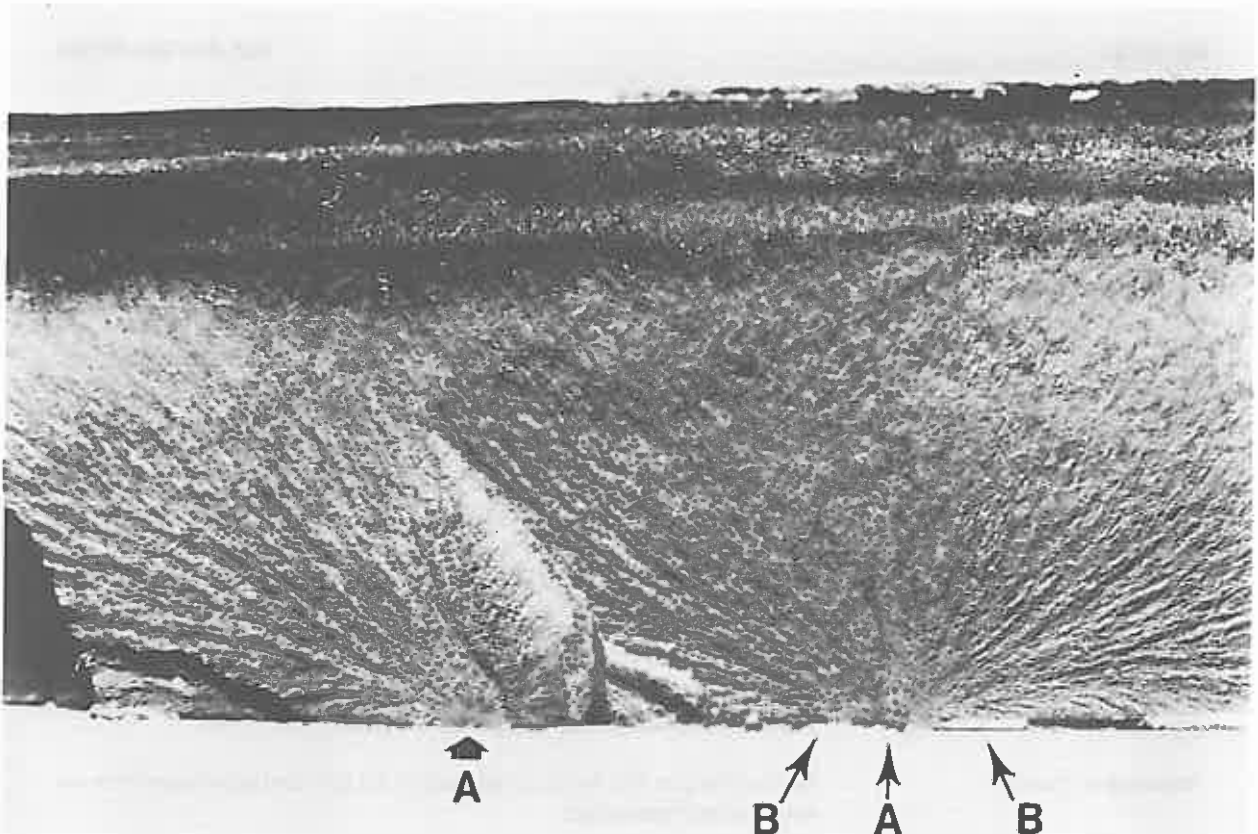
Fig 2

It was evident that two metallurgical factors influenced the failure; the high strength of the steel combined with the presence of corrosion pitting on the tensile surface of the leg. The presence of these pits and the subsequent development of small fatigue cracks have been sufficient, given the low ductility of the steel at the high strength, to cause the leg to fail in a predominantly brittle manner.

Detail of fracture showing two origins, A, and shear lips, B

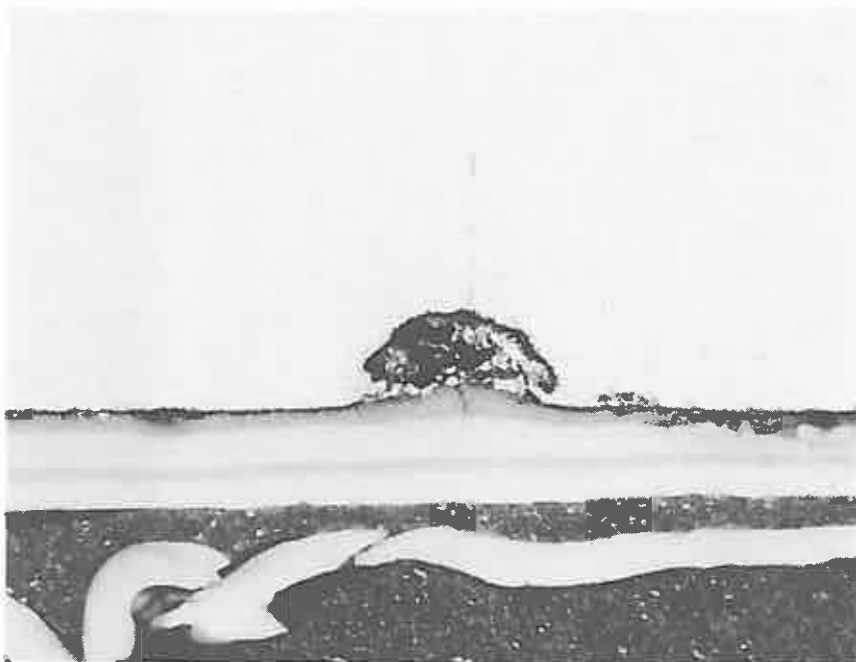
Fig 3

The origins themselves were characterised by a smooth semi-circular region of fatigue growth ranging in size from 1.2 mm to 3.8 mm in diameter and were each centered on a pit of surface corrosion. Adjacent to the fracture were numerous similar pits, the majority of these being filled with paint and with small cracks emanating from many of them. A number of these were detected beneath the largely intact layer of paint, ref figure (3). Microscopic examination of the origins did not reveal any data relating to rate of crack growth.

The fact that pits and some associated fatigue cracks were discovered beneath the intact layer of paint indicated that both were present at the last occasion on which the leg was stripped and repainted. However, whereas the pits at which cracks initiated are likely to have been readily detectable at that time, the cracks themselves would have been difficult to detect as distinct features beyond the pits.

Pit with fatigue crack under paint layer
