No: 9/91

Ref: EW/C1193

**Aircraft Type and Registration:** Boeing 757-23A, PH-AHK

**Nature of Damage:** No. 6 landing gear wheel, bearing and axle damaged beyond repair

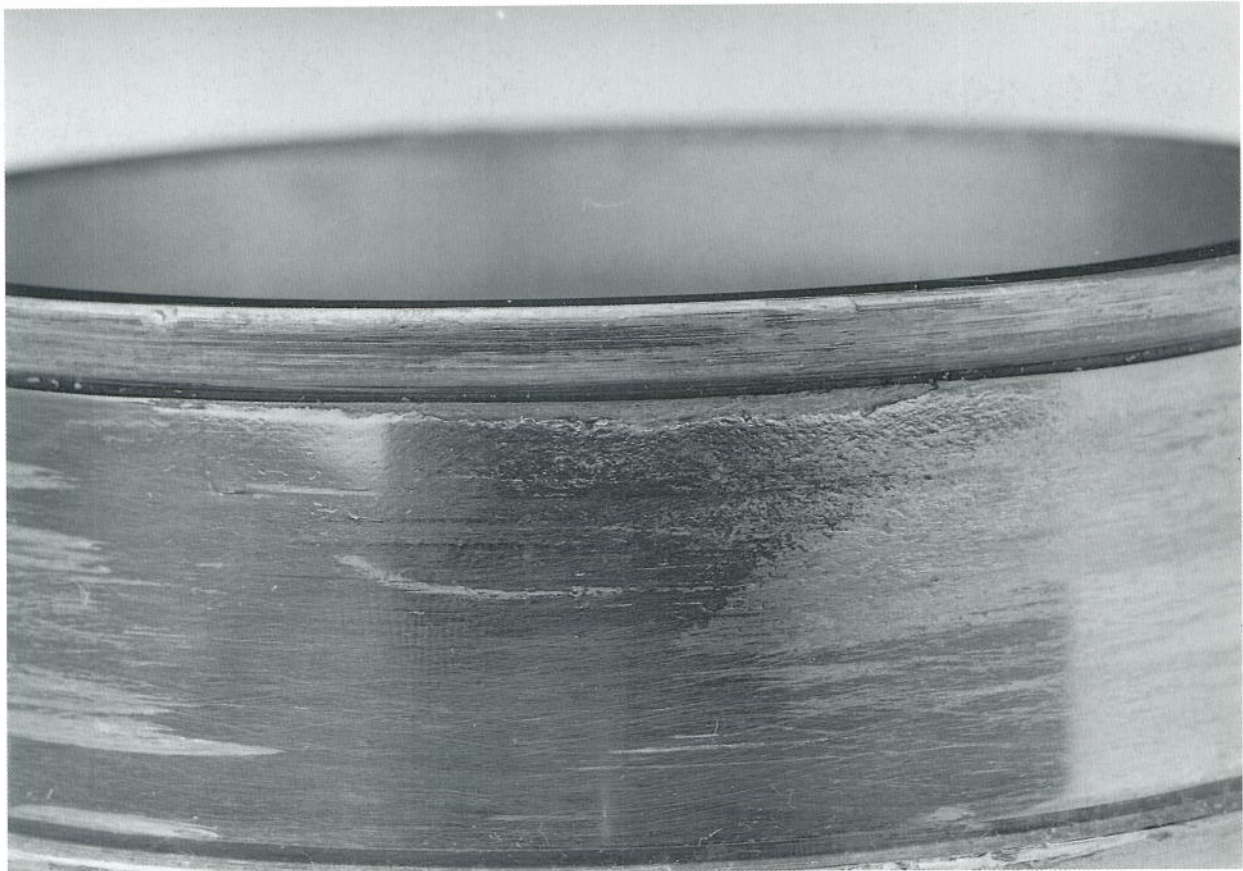
Photograph No.1 Geometric stress concentrations (GSC), a form of fatigue, over 20 degrees of the inner bearing cone, caused by heavy contact with the rollers.

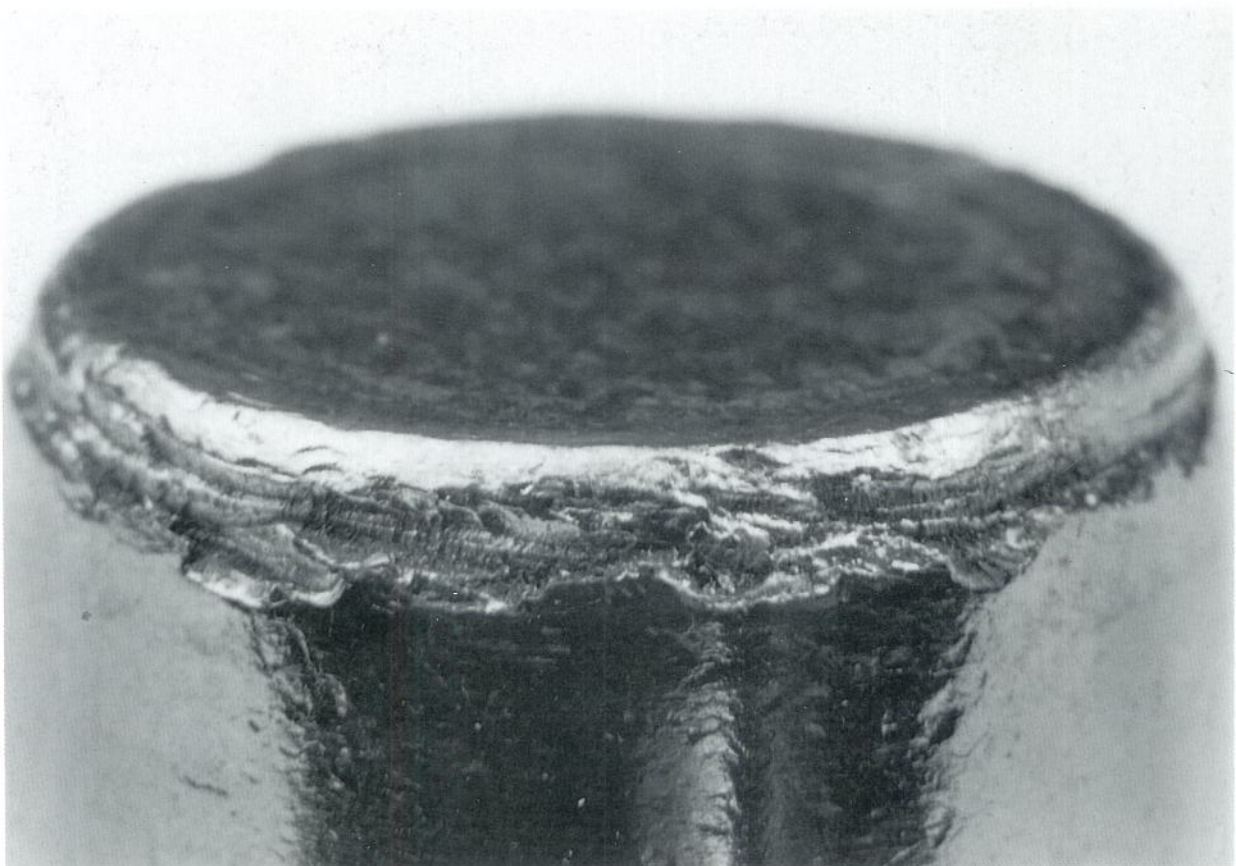
Photograph No.2 Heavy GSC spalling at the small roller ends caused by heavy contact with the cone.
