**ACCIDENT**

<b>Aircraft Type and Registration:</b>	Learjet 45, D-CNIK
<b>No &amp; Type of Engines:</b>	2 Honeywell TFE731-20 turbofan engines
<b>Year of Manufacture:</b>	2003
<b>Date &amp; Time (UTC):</b>	17 March 2006 at 2029 hrs
<b>Location:</b>	London Gatwick Airport
<b>Type of Flight:</b>	Public Transport
<b>Persons on Board:</b>	Crew - 2                      Passengers - None
<b>Injuries:</b>	Crew - 1 (Serious)      Passengers - N/A
<b>Nature of Damage:</b>	Fuselage and entry door plus damage to a parked motor vehicle
<b>Commander's Licence:</b>	Airline Transport Pilot's Licence
<b>Commander's Age:</b>	42 years
<b>Commander's Flying Experience:</b>	9,500 hours (of which 2,450 were on type) Last 90 days - 54 hours Last 28 days - 26 hours
<b>Information Source:</b>	AAIB Field Investigation

**Synopsis**

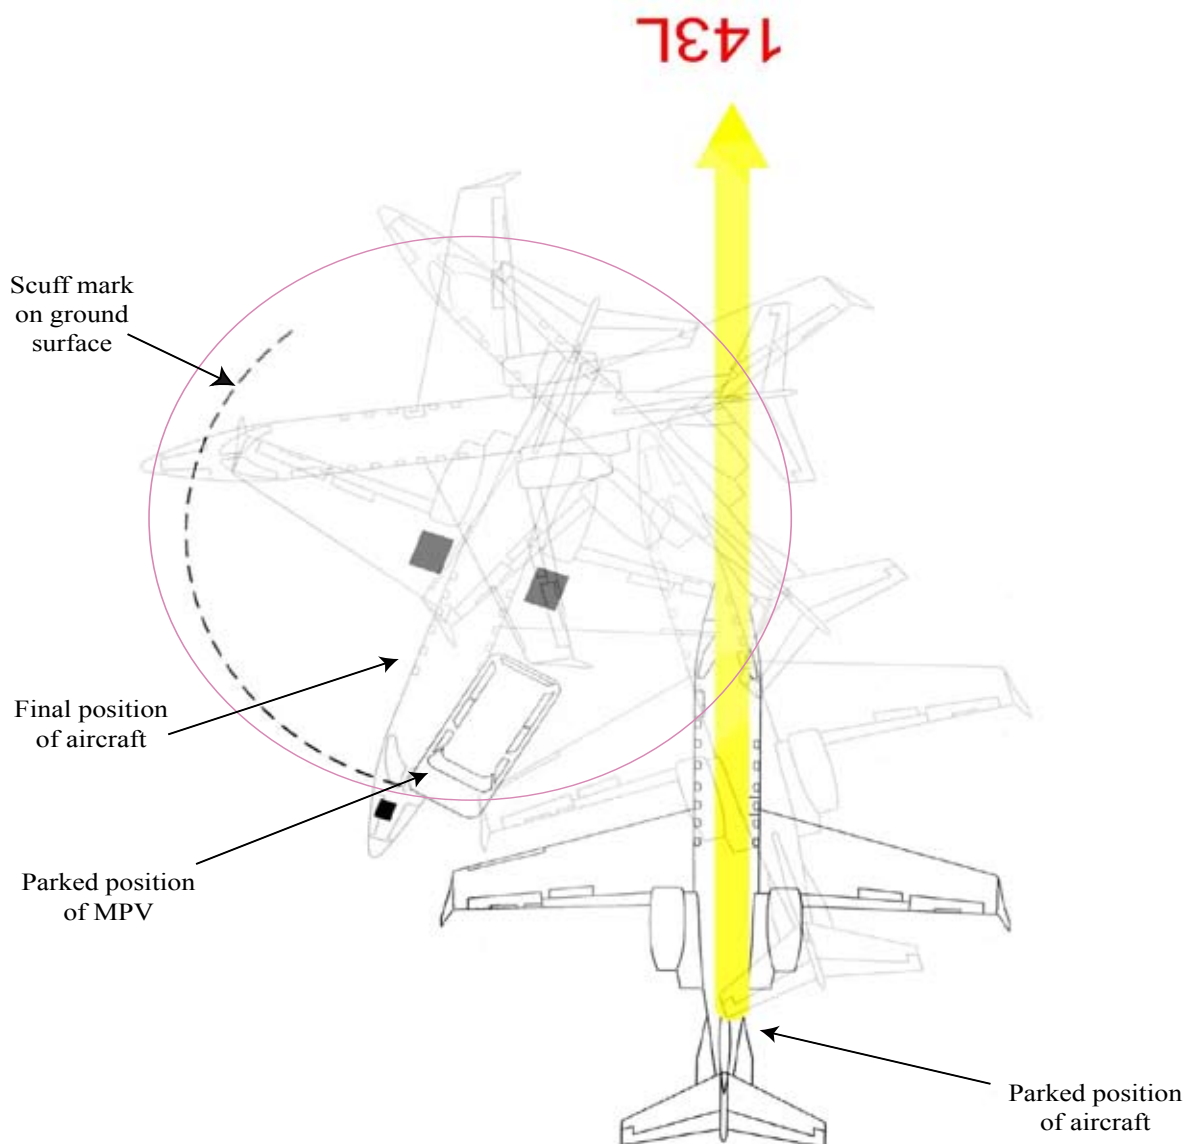
**Figure 1**

The aircraft had been parked with the nose wheel aligned with the painted central guidance line for stand 143L on a heading of 169°M. Alongside the aircraft was a Volkswagen 'Sharan' Multi-Purpose Vehicle (MPV) acting as a ground support vehicle (see Figure 1). The aircraft had moved forward and initially struck the left hand side of the MPV, and had then turned to the left around the rear of the ground support vehicle. It had then struck the right side of the MPV, coming to rest against the vehicle on a heading of 013°M, approximately 8.6 m from the centre of the stand marking. The MPV had been pushed sideways in the final impact and moved approximately 0.6 m, forcing the left front tyre off its rim.

At some stage during the aircraft movement the commander had fallen to the ground outside the aircraft. The trailing edge of the nose landing gear door had been bent by impact with the commander and there was a faint mark on the concrete surface of the stand that had been made by his clothing. The mark followed an arc corresponding to the path of the nosewheel (see Figure 1) as he was dragged by the aircraft.

Location of aircraft and ground support vehicle

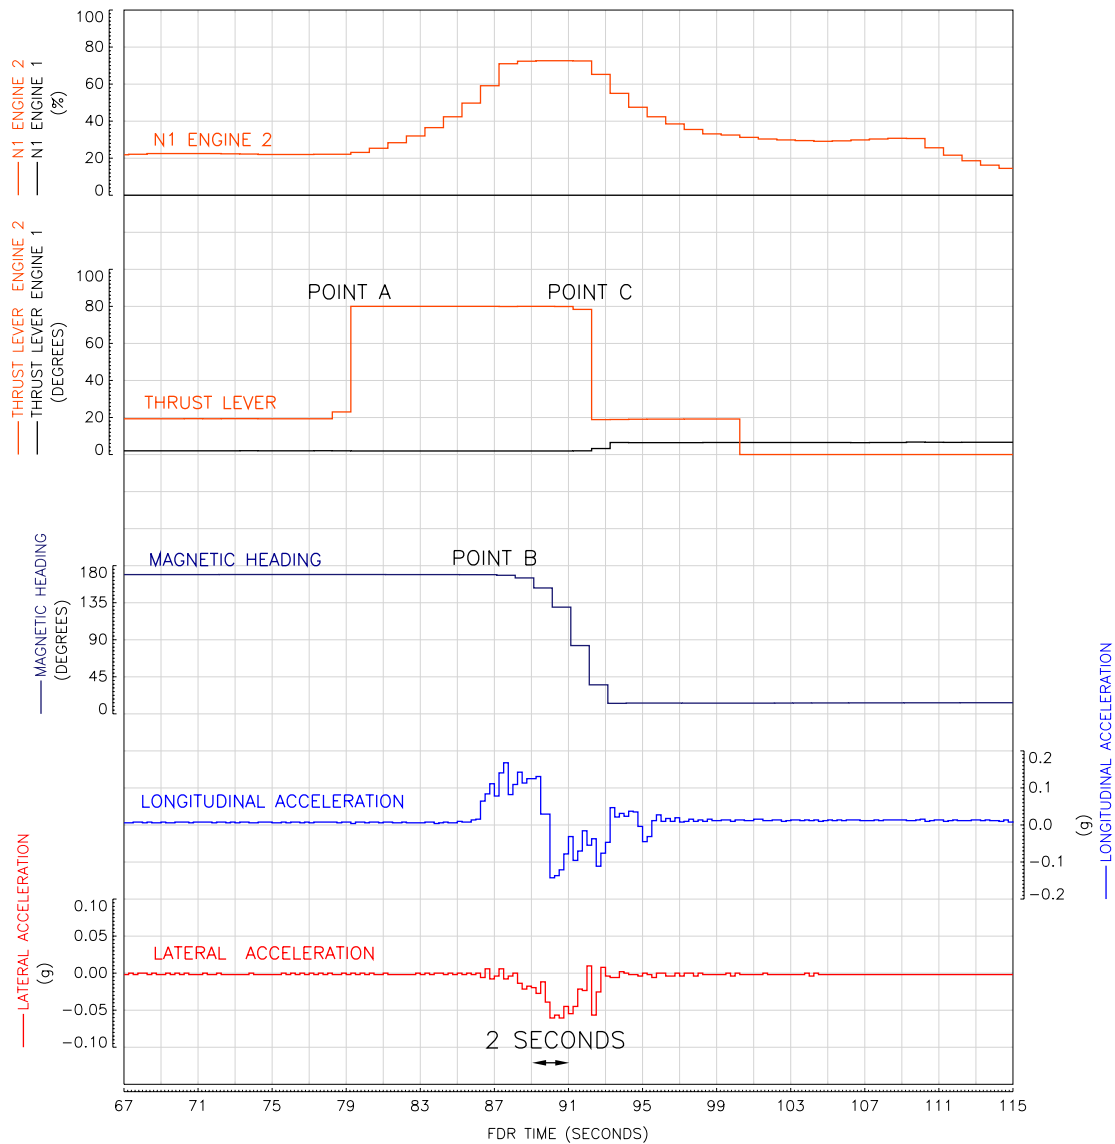
**Figure 2**  
Selected data from FDR and CVR

Figure 1 provides the salient parameters of the accident. The No 2 engine thrust lever was set to about  $19^{\circ}$ <sup>1</sup> and shortly afterwards the No 2 engine  $N_1$  shaft speed started to increase. As the engine was started there was a short conversation on the flight deck that lasted about six seconds. As the aircraft's avionics systems powered up the magnetic heading parameter became active, indicating that the aircraft was on a magnetic heading of  $169^{\circ}$ . The number two engine  $N_1$  shaft speed continued to increase until it settled at idle thrust, which was about 21%  $N_1$ . Some 10 seconds later the bleed air was heard to be selected ON.

The No 2 engine thrust lever remained at the idle thrust position until about 17 seconds later when it was quickly advanced to about  $80^{\circ}$ , some  $12^{\circ}$  before it would have entered the MCR<sup>2</sup> position. Just prior to and also

coincident with the movement of the No 2 engine thrust lever, a series of clicks was heard on the flight deck, but the exact origin of those noises could not be determined. The No 2 engine  $N_1$  shaft speed started to increase from idle thrust until about eight seconds later it had reached 59%, at which time the aircraft began to move forwards. The  $N_1$  speed increased until it reached 72%, at about which time the aircraft then started to accelerate rapidly forwards and turn to the left. About five seconds later the No 2 engine thrust lever was quickly moved to the idle position and the  $N_1$  shaft speed started to reduce. Almost coincident with the No 2 thrust lever moving to idle, a noise was recorded that was similar to brakes being applied. About one second later the aircraft stopped turning. The aircraft had turned onto a magnetic heading of  $013^{\circ}$  having turned through  $154^{\circ}$  in 6 seconds.
