No: 4/91

Ref: EW/G91/02/05

Aircraft Type and Registration: Reims Cessna F152, G-BFKH

Location: Ash, near Sandwich, Kent

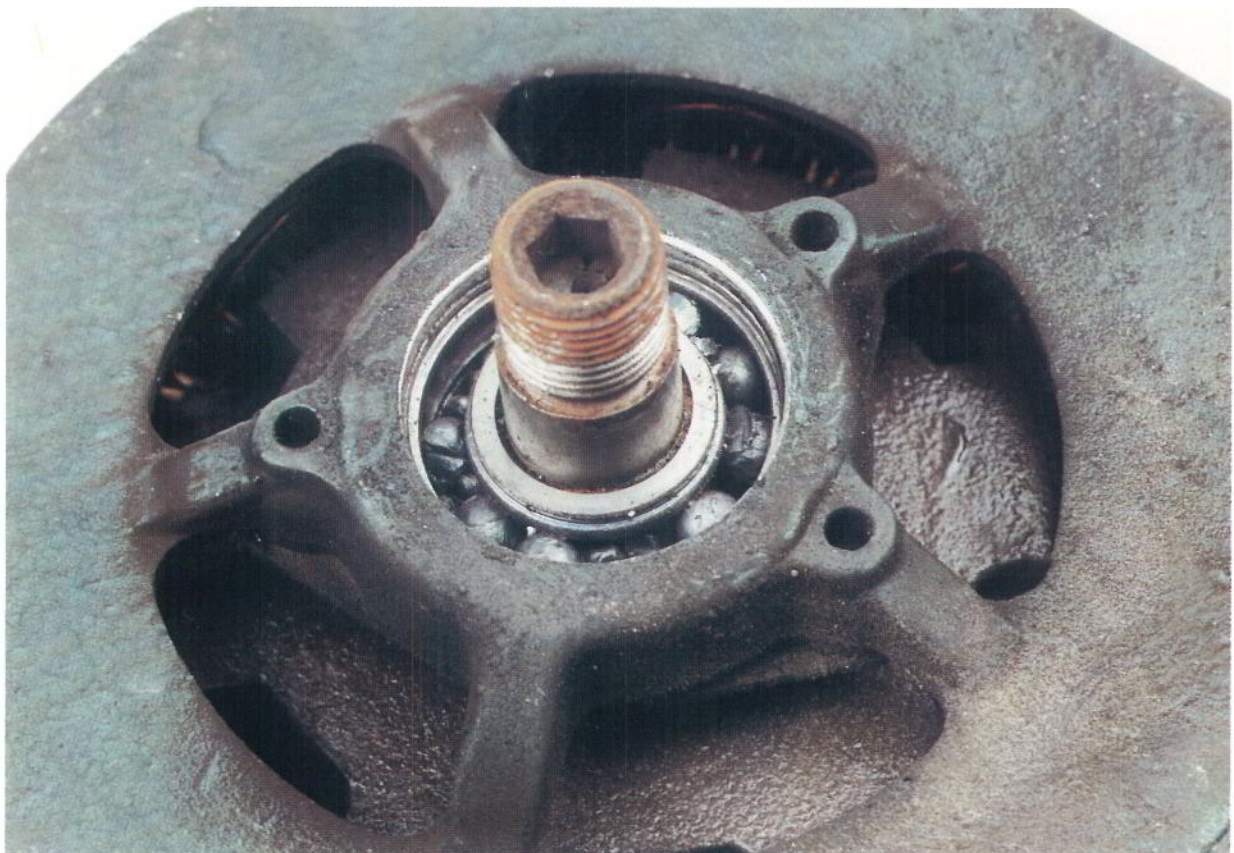
Subsequent examination of the aircraft revealed that the alternator had seized and had caused the drive-belt to 'slip' on the alternator-pulley. This had led to the drive belt burning, due to friction-induced overheating and its failure. Detailed examination of the alternator showed that the bearing at the pulley

end had broken-up due to a lack of lubricant. Since there is no requirement for log cards to be raised on alternators, it was not possible to establish how many hours this unit had performed since new/overhaul.

FAILED ALTERNATOR BEARING
