INCIDENT

Aircraft Type and Registration:	Airbus A320-200, I-BIKE
No & Type of Engines:	2 CFM-56 turbofan engines
Year of Manufacture:	1999
Date & Time (UTC):	25 June 2005 at 0740 hrs
Location:	On approach to Runway 09L at London Heathrow Airport
Type of Flight:	Public Transport (Passenger)
Persons on Board:	Crew - 6 Passengers - 98
Injuries:	Crew - None Passengers - None
Nature of Damage:	Failure of No 1 and 3 ADIRUs
Commander's Licence:	Airline Transport Pilot's Licence
Commander's Age:	41 years
Commander's Flying Experience:	8,300 hours (of which 1,300 were on type) Last 90 days - 130 hours Last 28 days - 50 hours
Information Source:	AAIB Field Investigation

Synopsis

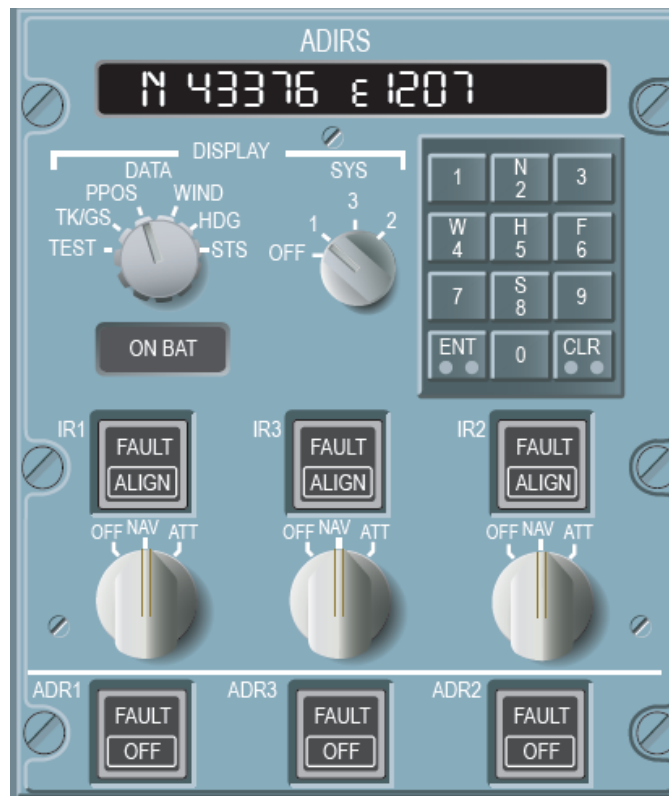
Figure 2

The ADIRS is controlled via the ADIRS control panel on the overhead panel, Figure 2. In normal operation, the rotary selector mode switches are set to the NAV position. In this configuration, the No 1 and 2 ADIRUs supply data to the commander's and co-pilot's EFIS displays respectively, with No 3 ADIRU available as a standby. Following loss of the ADR and/or IR function of either the No 1 or 2 ADIRU, rotary selector switches on the SWITCHING panel on the centre pedestal, Figure 3, enable air data and/or inertial data from the No 3 ADIRU to be selected to replace the data from the failed unit.

ADIRS Control Panel

an associated caution message on one of the ECAM displays. A flashing amber light indicates that the affected system has lost the ability to navigate, but attitude and heading information may be recovered by setting the mode rotary selector switch to the ATT position and performing an alignment procedure. An ADR failure is indicated by a steady amber FAULT light on the corresponding ADR push button and an associated ECAM caution message. In the event of an ADR failure in an ADIRU, the air data output may be switched off by pressing the appropriate ADR push button switch on the ADIRS control panel.
