ACCIDENT

Aircraft Type and Registration:	Robinson R44 II, Raven II, G-ROTG	
No & Type of Engines:	1 Lycoming IO-540-AE1A5 piston engine	
Year of Manufacture:	2006	
Date & Time (UTC):	24 July 2011 at 1427 hrs	
Location:	Marhamchurch, near Bude, Cornwall	
Type of Flight:	Private	
Persons on Board:	Crew - 1	Passengers - None
Injuries:	Crew - 1 (Fatal)	Passengers - None
Nature of Damage:	Helicopter destroyed	
Commander's Licence:	Private pilot's licence	
Commander's Age:	45 years	
Commander's Flying Experience:	285 ¹ hours (of which 221 were on type) Last 90 days - 6 hours Last 28 days - n/k hours	
Information Source:	AAIB Field Investigation

Synopsis

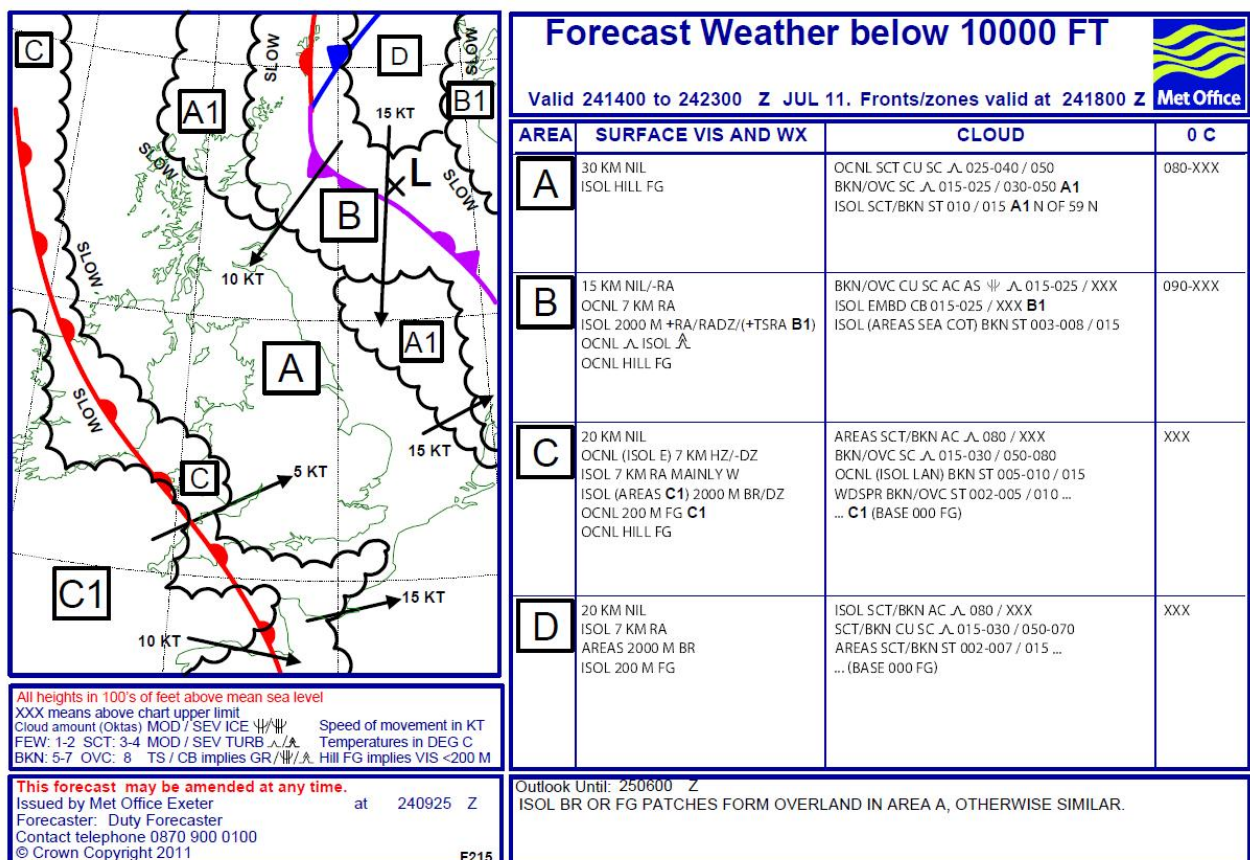
The Met Office forecast form F215, period 1400 hrs to 2300 hrs, is shown in Figure 1 below. It predicted that the weather and visibility likely to be encountered in the area west of Okehampton (areas C and C1 in Figure 1) would be 20 km, occasionally 7 km in haze and light

Met Office Form 215 for 24 July 2011

drizzle with isolated visibility of 7 km in moderate rain to the west of the area. There would be isolated areas where visibility of 2,000 m in mist and drizzle could be expected with occasional 200 m visibility in fog in area C1 and occasional hill fog.

It forecast scattered² or broken³ altocumulus with a base of 8,000 ft amsl. Additionally there was likely to be broken or overcast⁴ stratocumulus cloud with a base of 1,500 to 3,000 ft amsl, with occasional (isolated over the land) broken stratus base of 500 to 1,000 ft amsl with widespread broken or overcast stratus base 200 to 500 ft amsl. In C1 there was expected to be extensive hill fog at sea level.

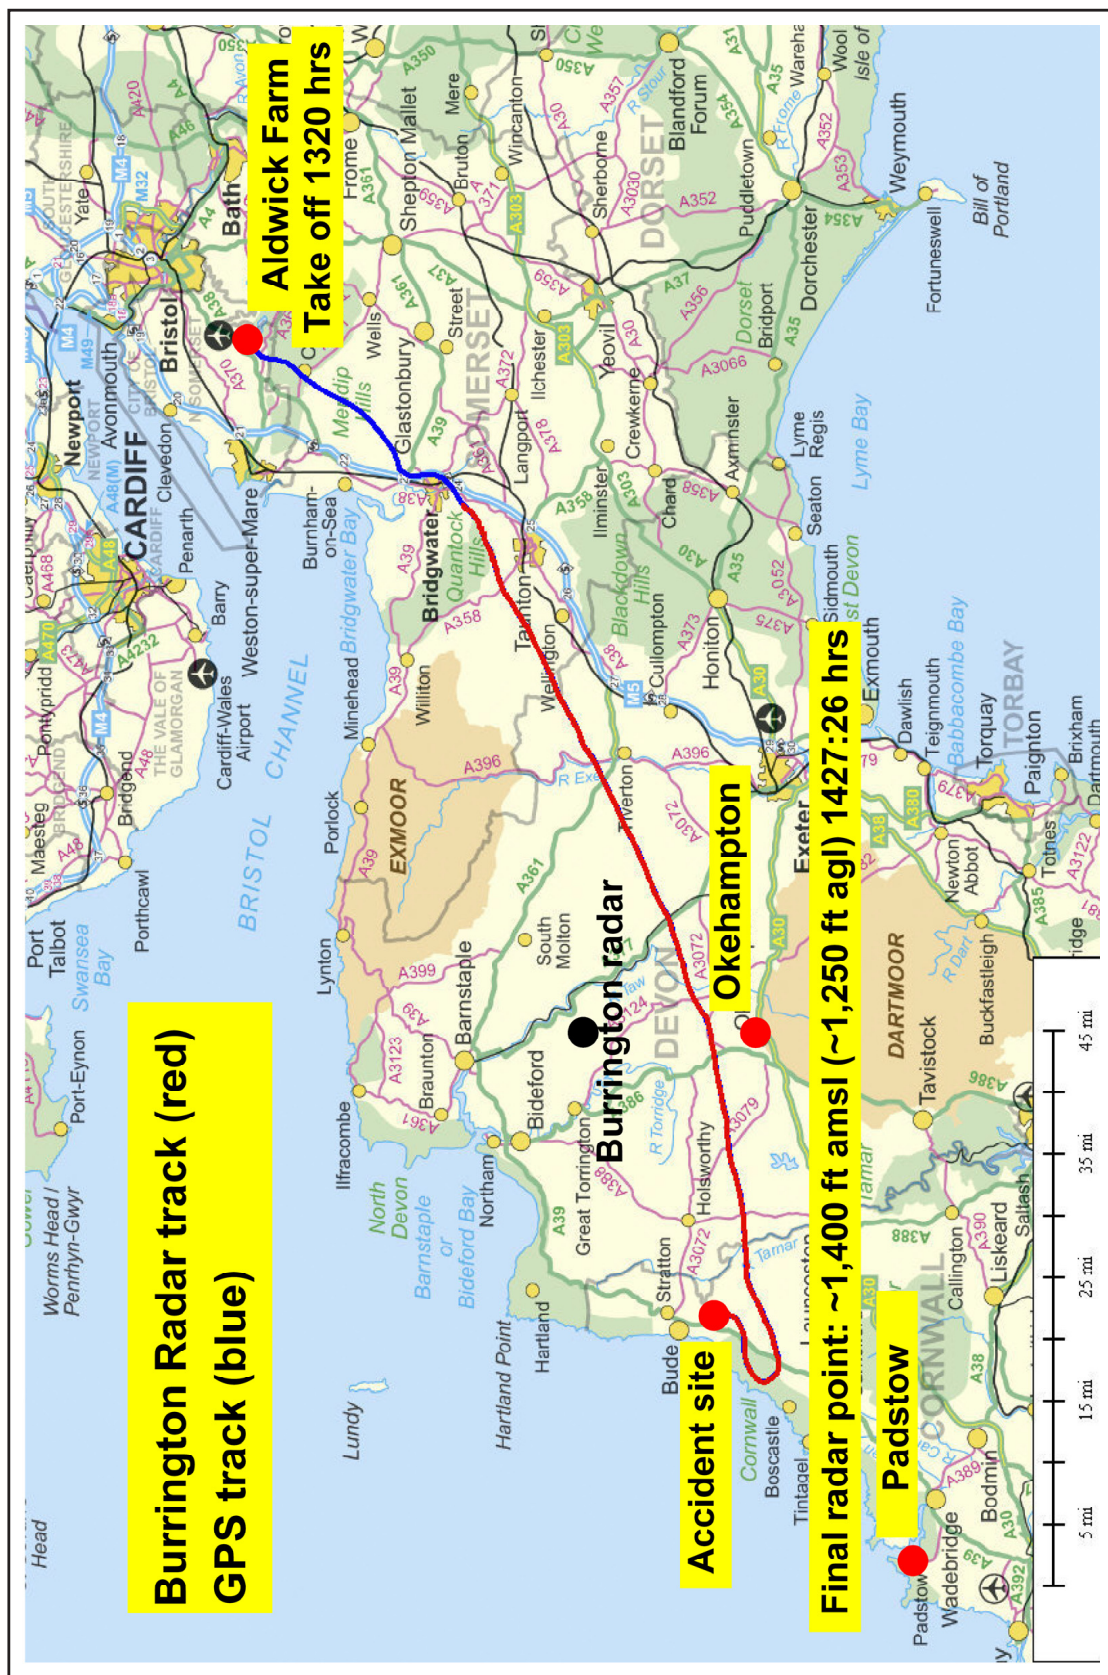
The first GPS data point was recorded at 1320:56 hrs as the helicopter took off from the pilot's private site (refer to Figure 2 and Figure 3).

Approaching Okehampton, the helicopter momentarily climbed from 1,300 ft to about 1,900 ft (Figure 3 – Point A), whilst also altering track by about 10°, from 253°(M) to 263° (deviating from a direct track to the town of Padstow), but as it passed to the north of Okehampton, it started to descend progressively. When the helicopter was at about 11 nm west of Okehampton it levelled off at about 950 ft (approximately 500 ft

G-ROTG - GPS and Radar flight track

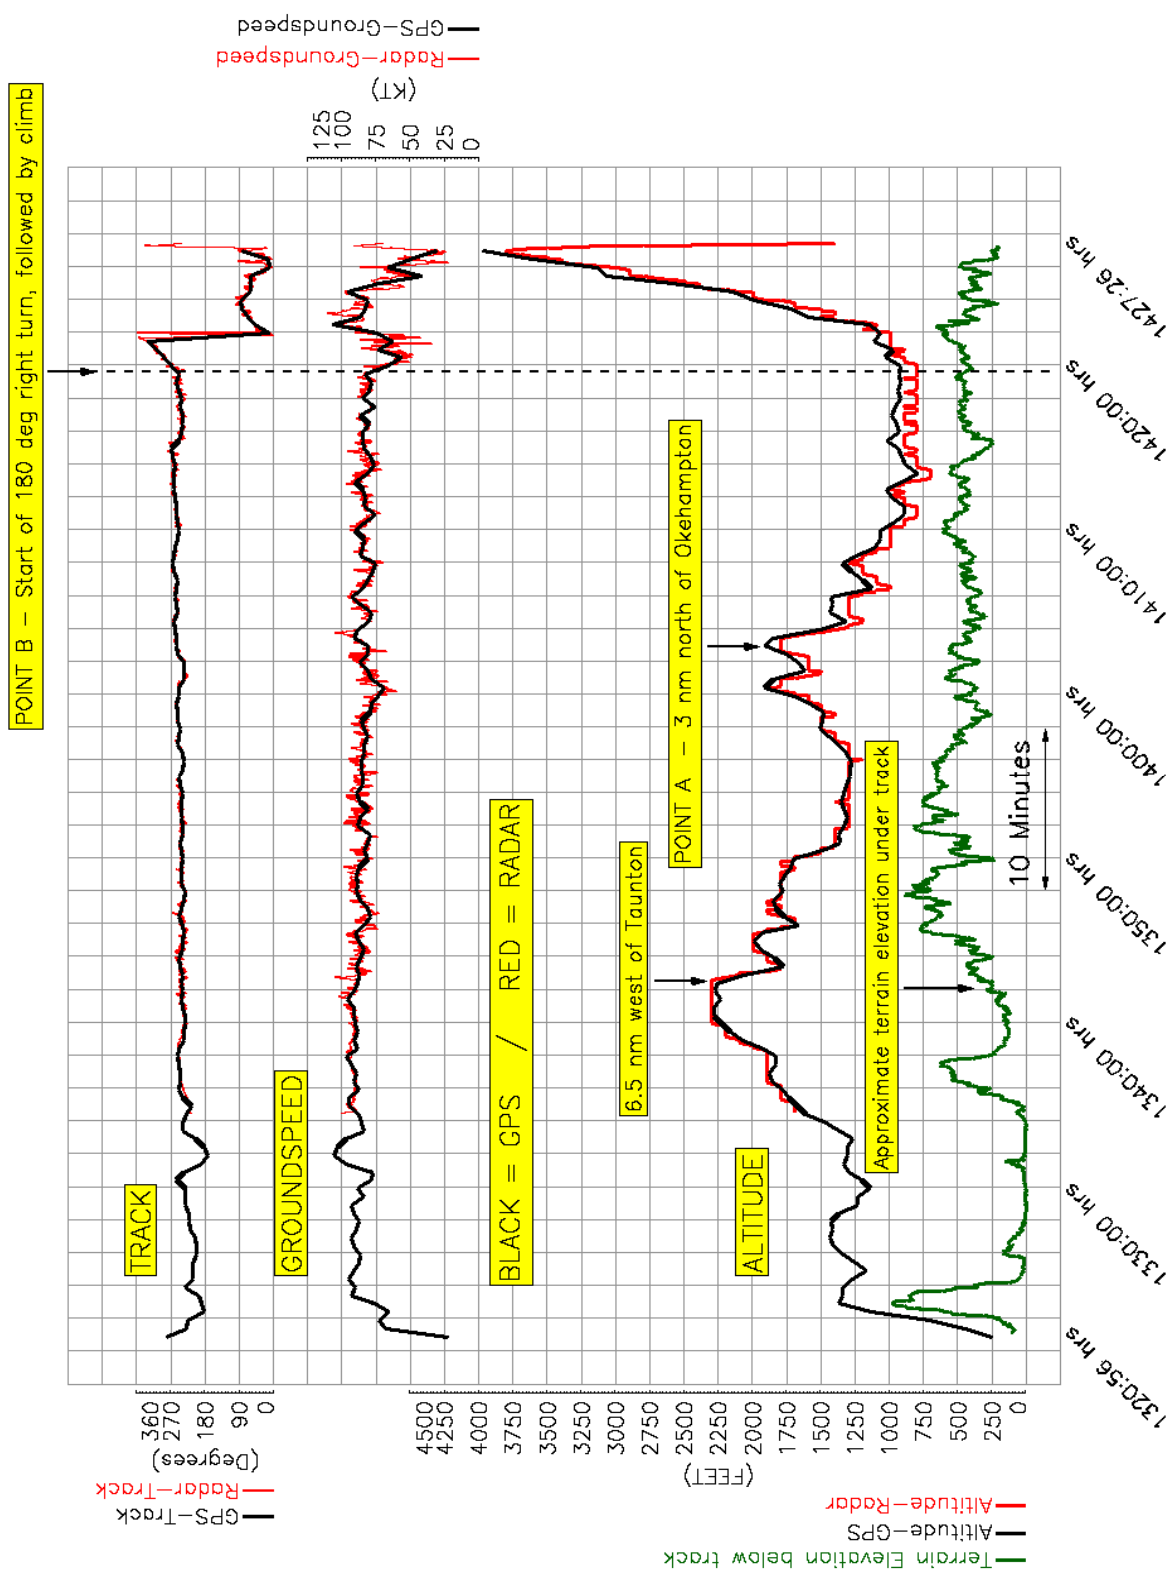
Figure 3
G-ROTG - GPS and Radar altitude profile

agl). At 1415 hrs, the helicopter made a left turn to track 245°, establishing a track towards the north of Padstow by about 9 nm.
