**ACCIDENT**

<b>Aircraft Type and Registration:</b>	1) DHC-8-402 Dash 8, G-JEDO 2) DHC-8-402 Dash 8, G-ECOO
<b>No &amp; Type of Engines:</b>	1) 2 Pratt & Whitney Canada PW150A turboprop engines 2) 2 Pratt & Whitney Canada PW150A turboprop engines
<b>Year of Manufacture:</b>	1) 2003 2) 2008
<b>Date &amp; Time (UTC):</b>	16 January 2012 at 0700 hrs
<b>Location:</b>	Southampton International Airport
<b>Type of Flight:</b>	1) Commercial Air Transport (Passenger) 2) Commercial Air Transport (Passenger)
<b>Persons on Board:</b>	1) Crew - 4                      Passengers - 66 2) Crew - 4                      Passengers - 52
<b>Injuries:</b>	1) Crew - None                  Passengers - None 2) Crew - None                  Passengers - None
<b>Nature of Damage:</b>	1) Right elevator 2) Tailcone
<b>Commander's Licence:</b>	1) Airline Transport Pilot's Licence 2) Airline Transport Pilot's Licence
<b>Commander's Age:</b>	1) 41 years 2) 37 years

**Synopsis**

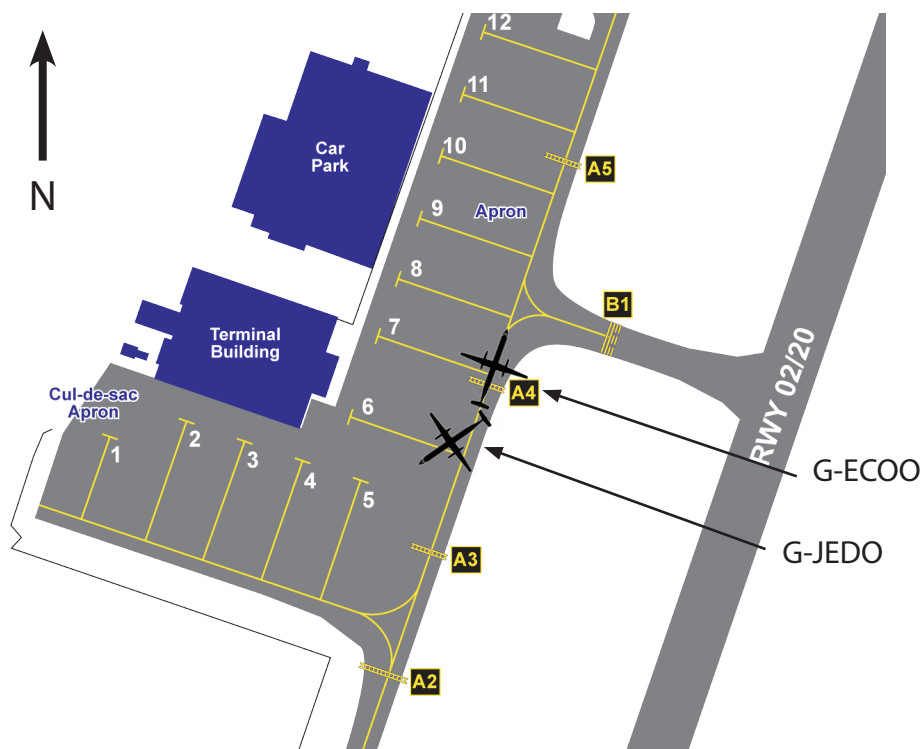
**Figure 1**

Apron layout and approximate position of aircraft at the time of the collision

completion it slowed and then stopped on a heading of approximately 220°. The headset operative asked the commander to confirm that the aircraft's brakes were OFF, which they were, then reported that they could not push the aircraft any further and asked for the aircraft's brakes to be set ON. A passing Airside Operations vehicle reported to ATC that there was an "AIRCRAFT TO AIRCRAFT CONFLICT ON STAND 6." G-ECOO then transmitted to ATC "WE JUST FELT A BUMP" and asked for confirmation that they had been hit. After photographic evidence had been acquired, both aircraft were pulled back onto stand.

G-JEDO sustained damage to its right elevator, G-ECOO sustained damage to its tail cone.

As a result of this incident ATC, the airport operator and the aircraft handling agent will implement new pushback procedures and new holding points.

Additionally ATC will introduce procedures that do not permit aircraft to push back in proximity to each other, and review taxi clearances and holding points to ensure non-standard manoeuvres are removed.
