RECONSTRUCTION DRAWING SHOWING MAJOR PARTS WHICH BECAME DETACHED IN THE AIR

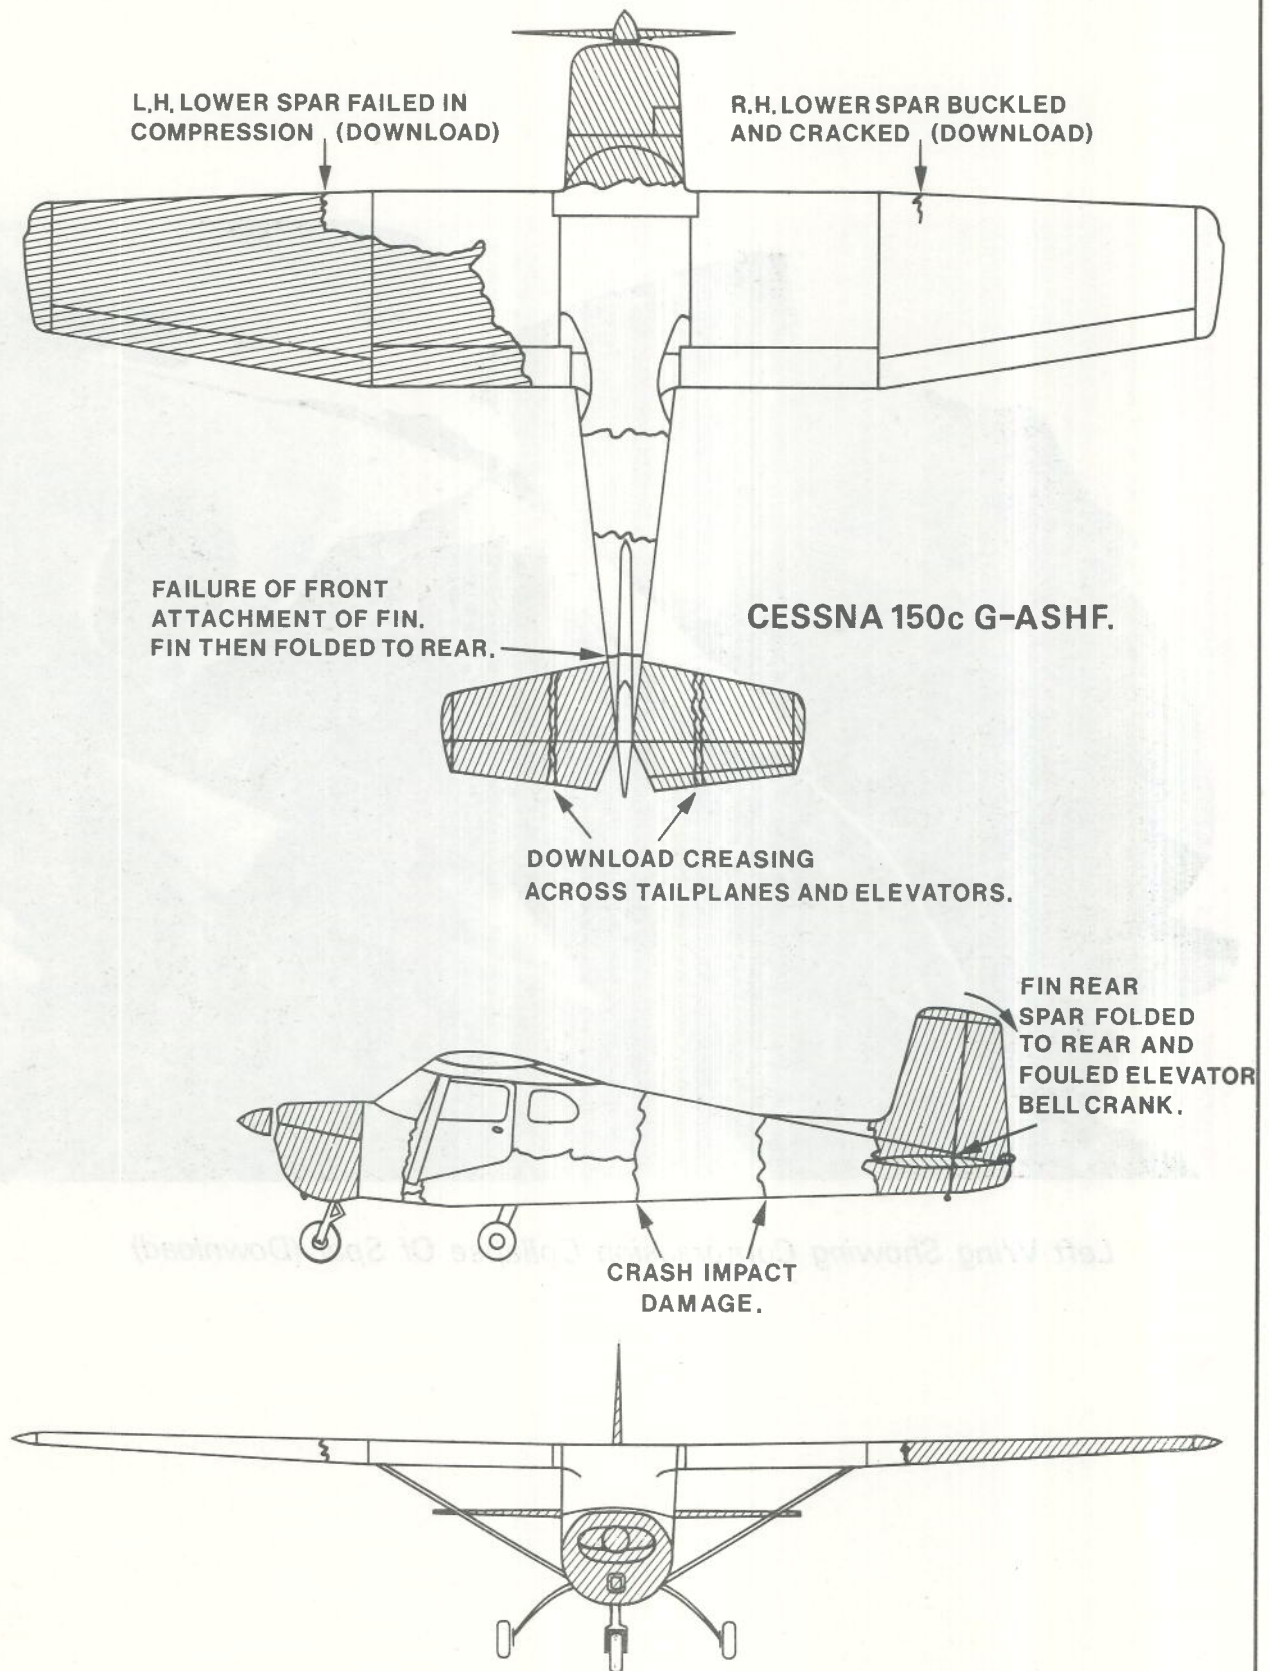
FIG. 1.

The parts shaded became detached in the air.

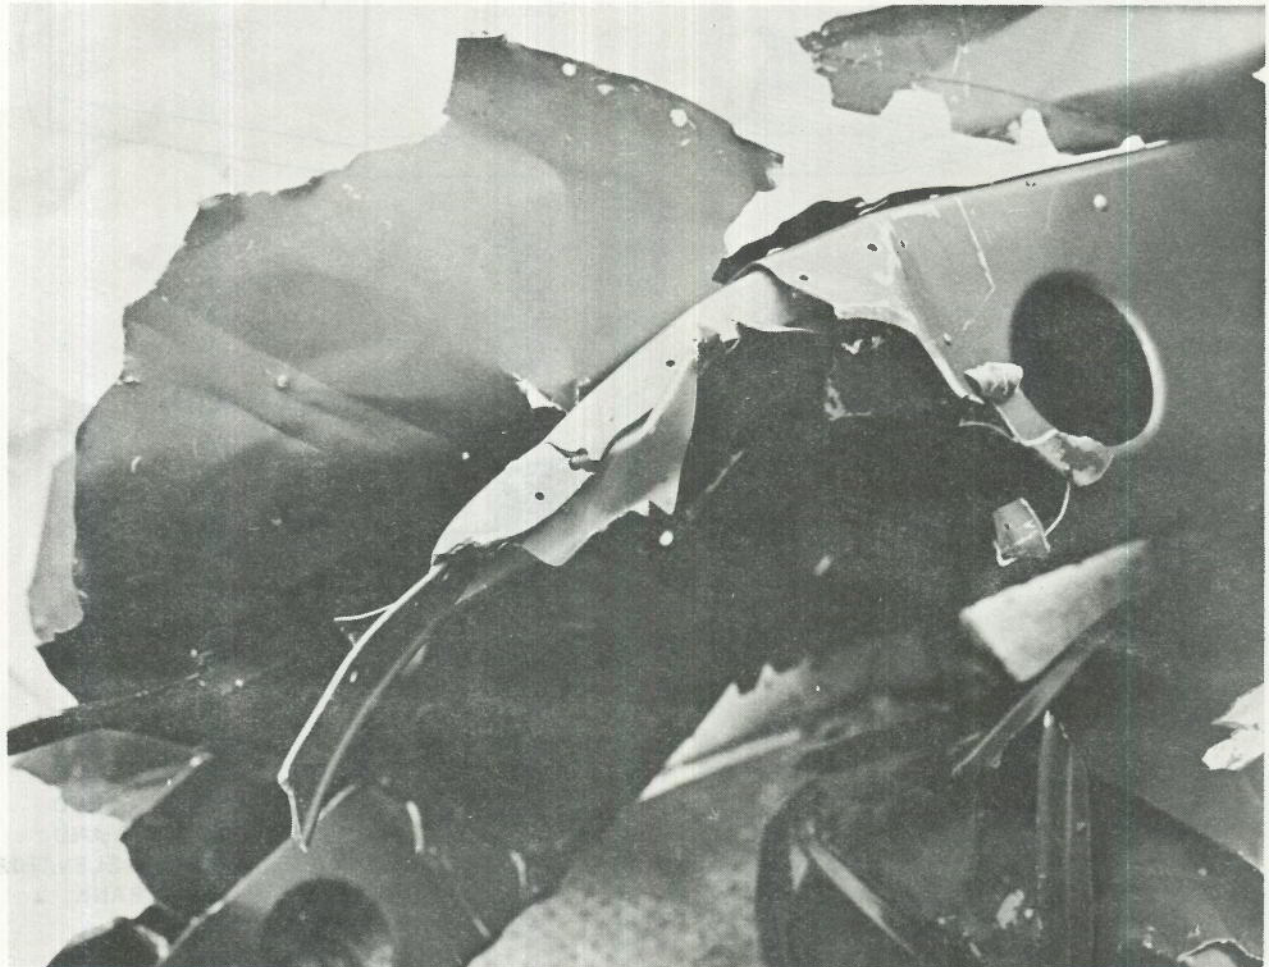
*Fig 2.*

*Left Wing Showing Compression Collapse Of Spar (Download)*

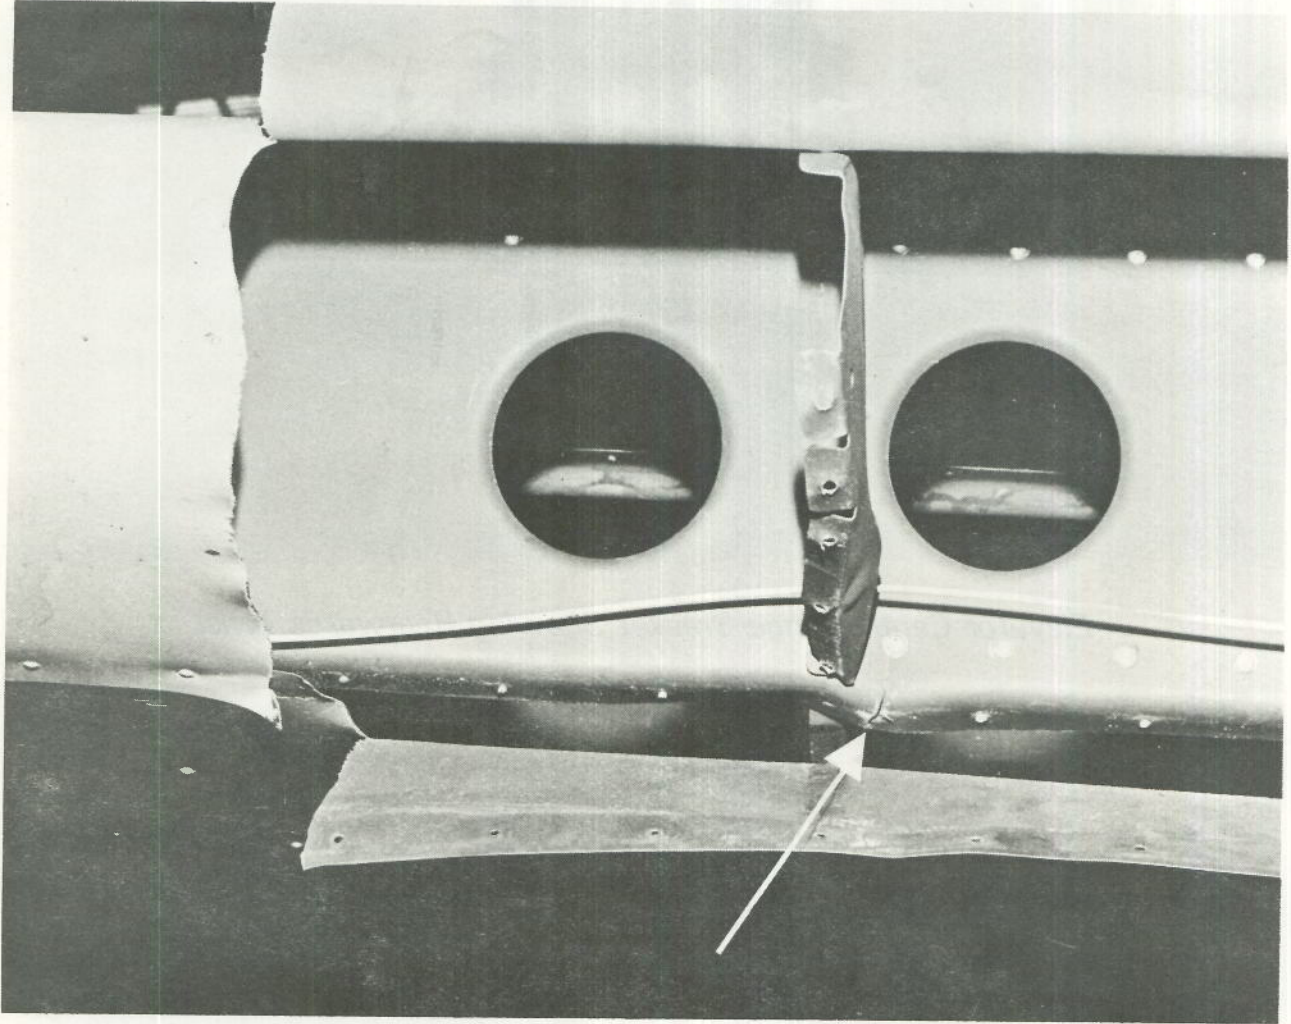
*Right Hand Wing Lower Spar Showing Compression Buckle And Fracture*

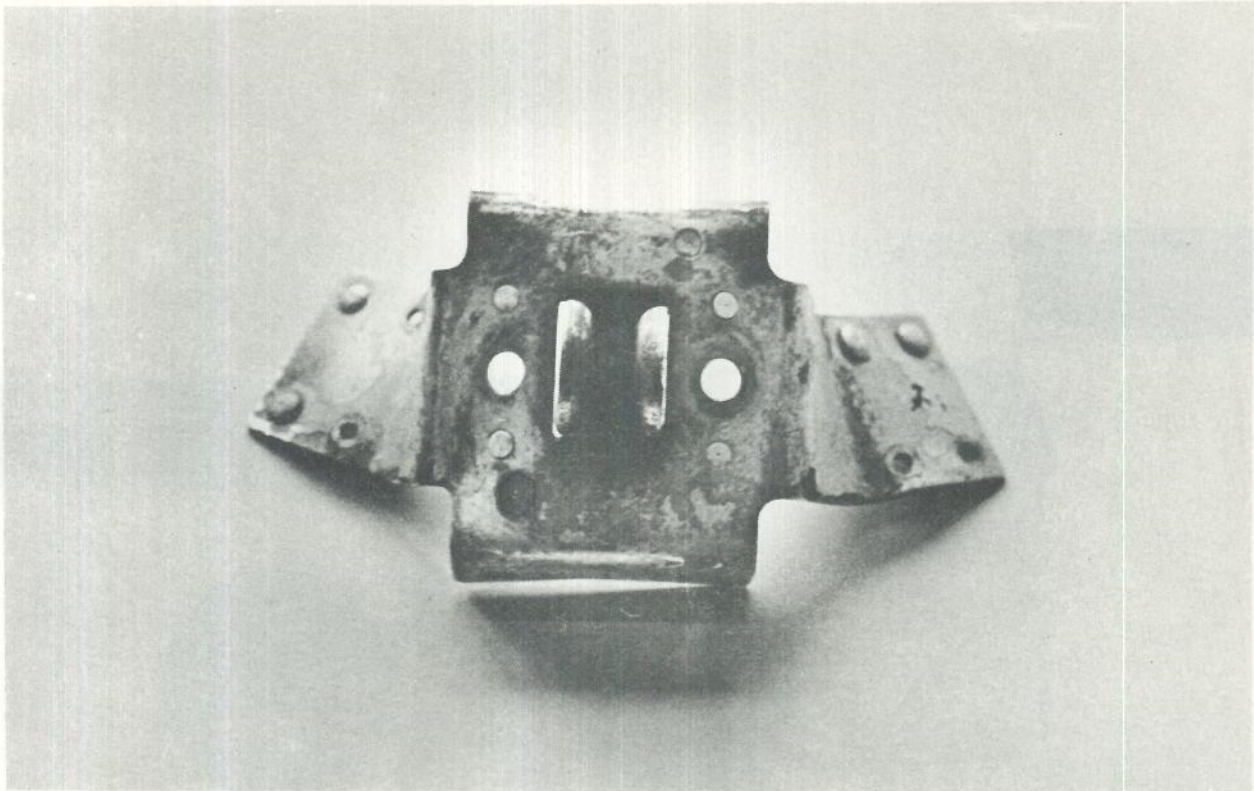
*Fig 4.*

*Elevator Centre Hinge Bracket Showing Rearwards Twist  
And Elongation Of Bolt Holes.*

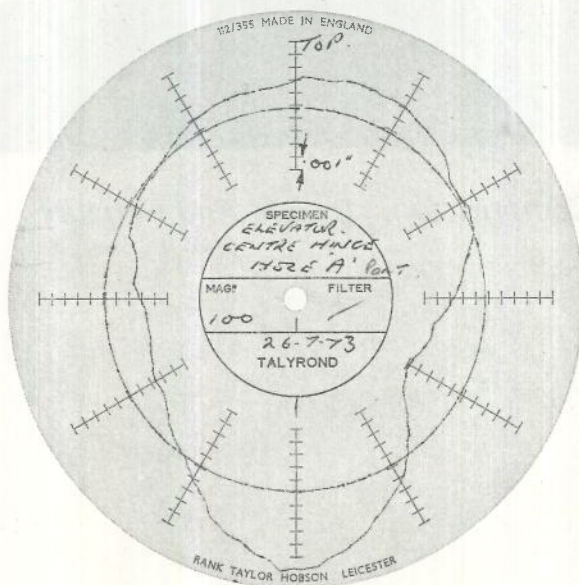
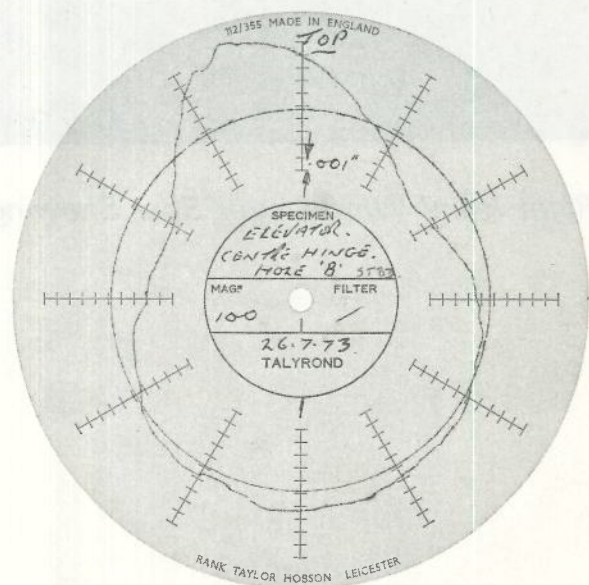
*Fig 5.*

*Left Hand Hole.*

*Right Hand Hole.*

*Enlarged View Of Bolt Holes Showing Wear And Elongation.*

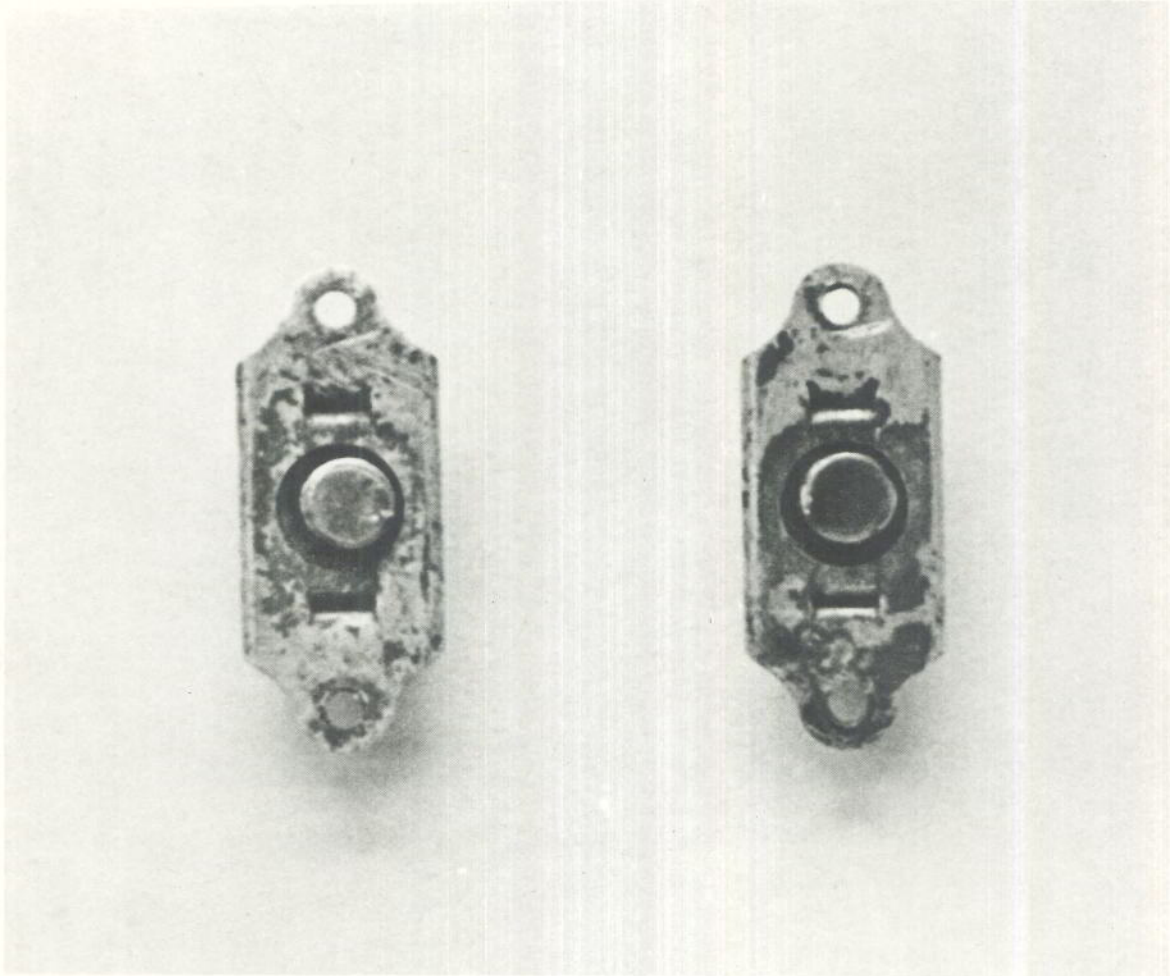
*Showing Sheared Bolts Tail-Fin Attachments.*
