INCIDENT

Aircraft Type and Registration:	Boeing 747-300, ZS-SAT	
No & Type of Engines:	4 Pratt & Whitney JT9 7R4 G2 turbofan engines	
Year of Manufacture:	1982	
Date & Time (UTC):	4 December 1992 at 0645 hrs	
Location:	London Heathrow Airport, Stand B25	
Type of Flight:	Public Transport	
Persons on Board:	Crew - 25	Passengers - 280
Injuries:	Crew -None	Passengers - None
Nature of Damage:	Left wing-to-body fairing holed	
Commander's Licence:	Airline Transport Pilot's Licence	
Commander's Age:	51 years	
Commander's Flying Experience:	Approximately 15,000 hours (of which 4,000 were on type)	
Information Source:	AAIB Field Investigation

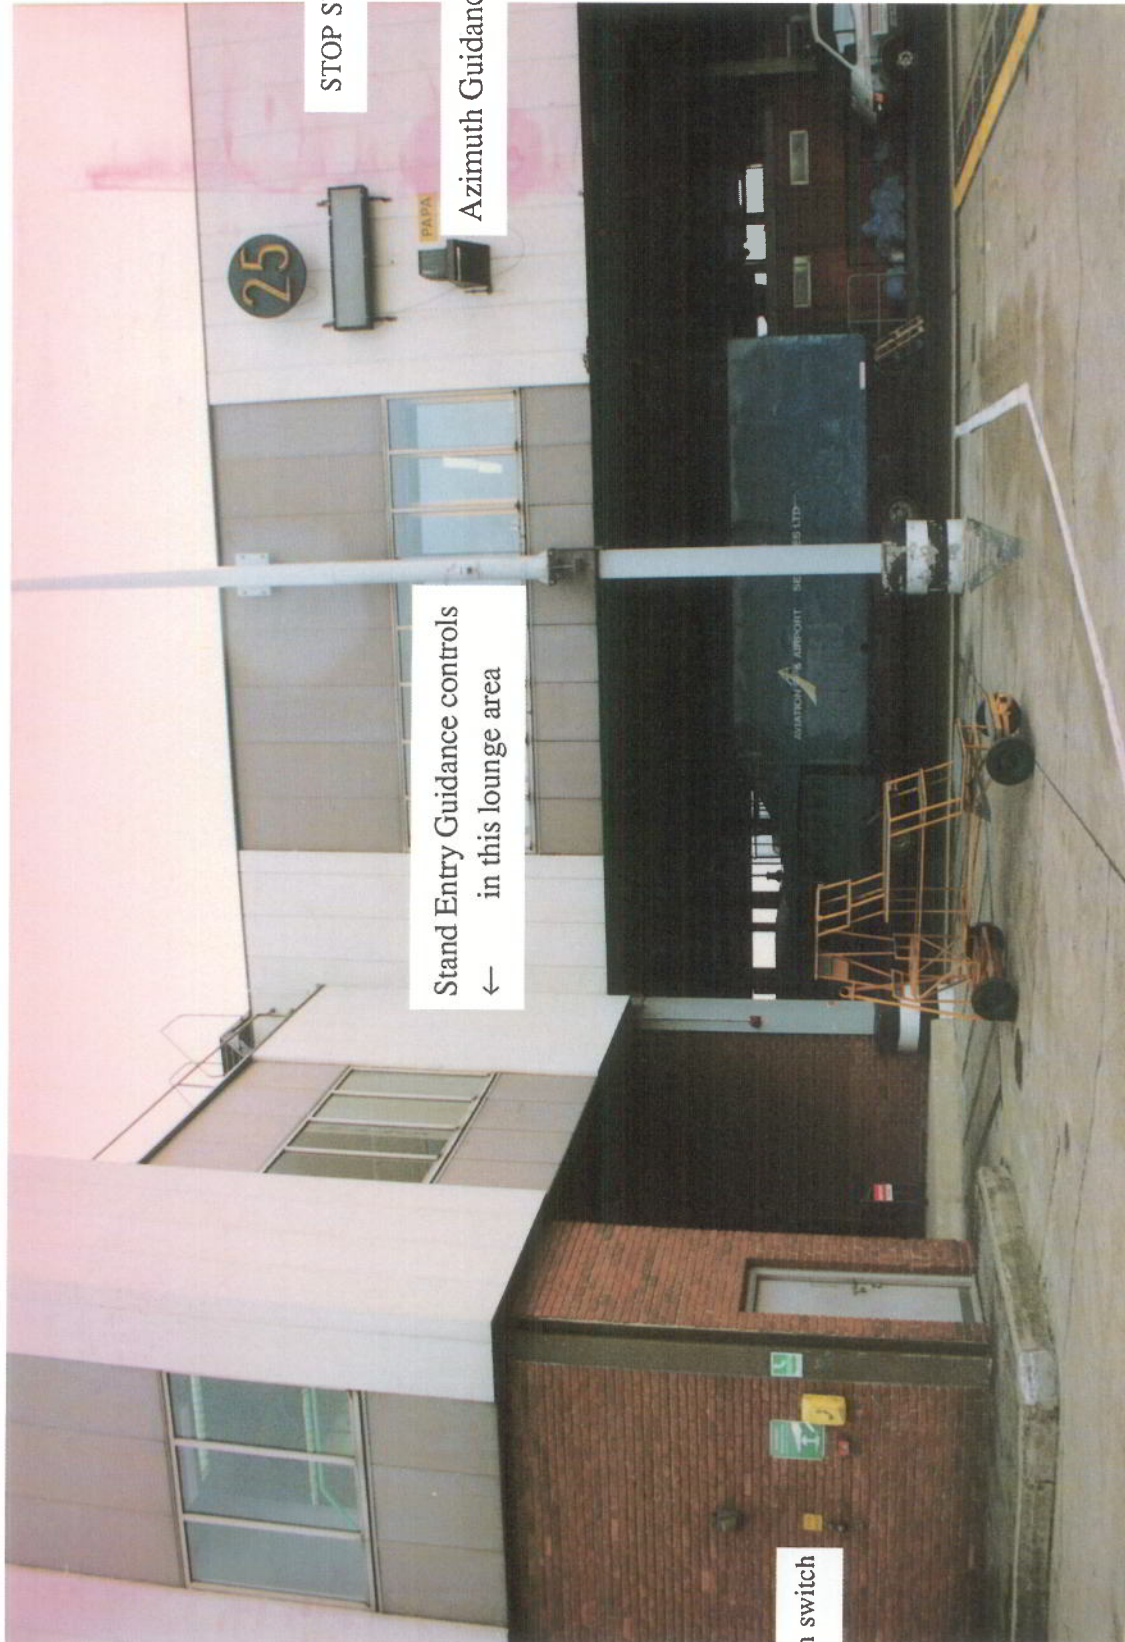
The B25 stand, along with most stands equipped with Passenger Loading Bridges, has a Stand Entry Guidance (SEG) system, see Photograph. This comprises an AGNIS, a PAPA, and a red STOP SHORT light. AGNIS consists of a unit emitting red and/or green light signals used to centreline the aircraft - mounted on the front of the pier at pilot's eye level - aligned for interpretation by the pilot in the left hand seat. PAPA consists of a board with reference marks allied to specific aircraft types, and a horizontal slot running across its centre with a fluorescent tube mounted vertically behind; correct stopping position is reached when the tubular light registers in line with the appropriate aircraft reference mark. The STOP SHORT light is displayed above the AGNIS lights. Whenever this STOP SHORT light is illuminated, in the absence of any guidance, the crew should stop the aircraft short in a position which is safe and clear of any obstruction on the stand. The main SEG switches are located at the lounge level; a second switch to activate the STOP SHORT light, is located outside at apron level.

The dispatcher was aware that a STOP SHORT light switch existed at apron level, but thought that the switch was no longer functioning, having been superseded by the controls at lounge level. A survey of all Terminal 1 in-use stands equipped with Passenger Loading Bridges showed that all except one had STOP SHORT lights fitted with serviceable apron level switches. A poll of 14 of the airline's dispatchers revealed that half of them were unaware of the apron level STOP SHORT light switches and

PART OF STAND B25 STAND ENTRY GUIDANCE SYSTEM
(PAPA not shown, Passenger Loading Bridge behind photographer)

93-17 Stand Entry Guidance (SEG) Controls HAL should review the need to provide SEG controls, at the despatcher's station, at the end of the Passenger Loading Bridges. (Issued 18 March 1993)
