AAIB Bulletin S1/2013

SPECIAL

ACCIDENT

Aircraft Type and Registration:	Agusta A109E G-CRST
No & Type of Engines:	2 x Pratt & Whitney Canada PW206C
Year of Manufacture:	1998
Location	St George Wharf, Vauxhall, London
Date & Time (UTC):	16 January 2013 at 0759 hrs
Type of Flight:	Commercial Air Transport (Passenger)
Persons on Board:	Crew -1 Passengers - None
Injuries:	Crew - 1 (Fatal) Passengers - N/A
Nature of Damage:	Helicopter destroyed
Commander's Licence:	Air Transport Pilot's Licence
Commander's Age:	50 years
Commander's Flying Experience:	To be confirmed
Information Source:	AAIB Field Investigation

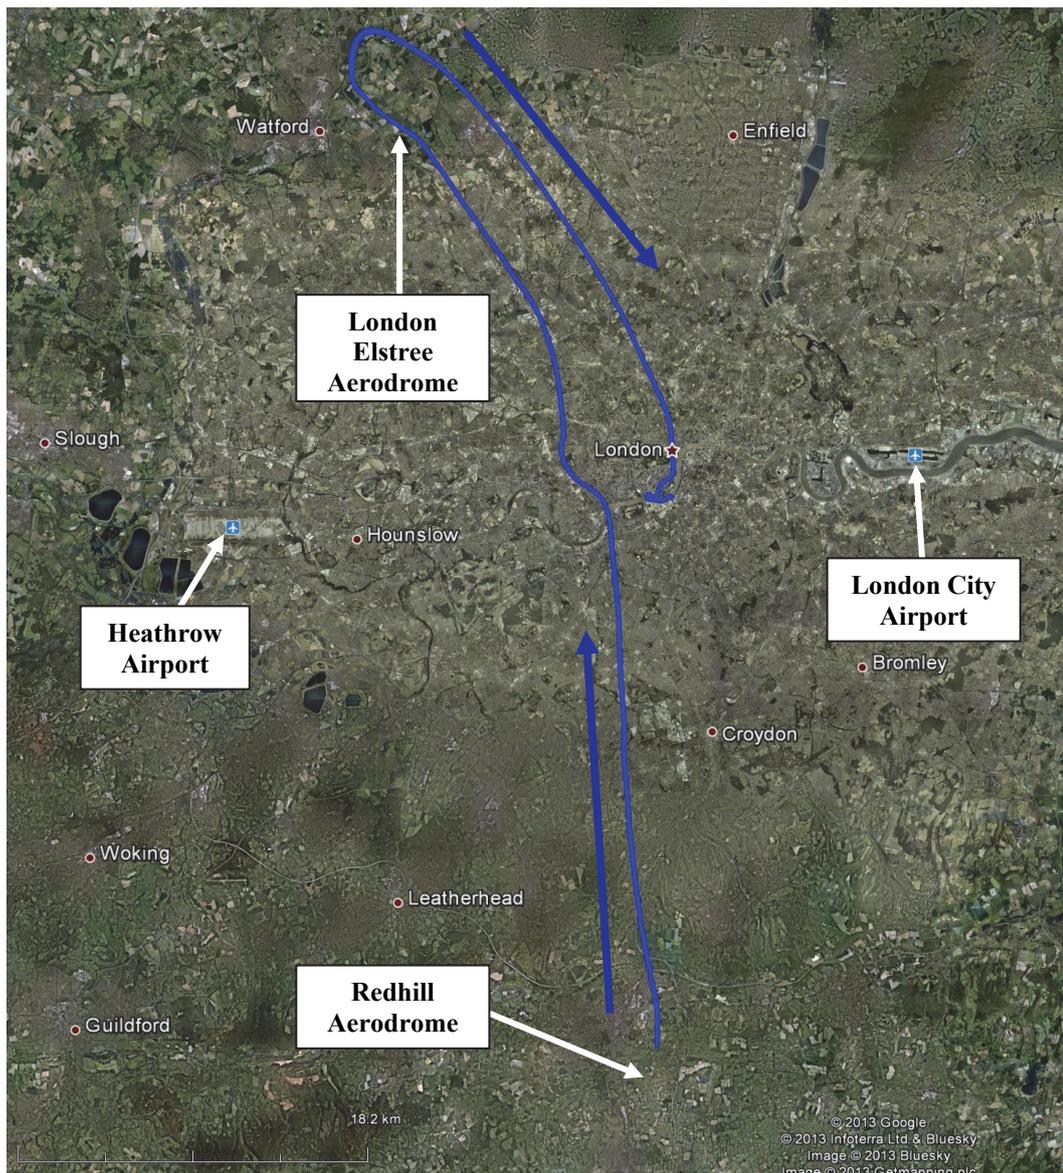
Figure 1

The helicopter, callsign Rocket 2, lifted at 0735 hrs and departed to the north climbing to 1,300 ft amsl¹ (see Figures 1 - 3). The pilot called Thames Radar on frequency 125.625 MHz and stated that he was en route from Redhill Aerodrome to Elstree Aerodrome and wished to route overhead London Heliport (near Battersea) with a Special VFR (SVFR) clearance. He was cleared to transit the London Control Zone (CTR)

G-CRST radar track

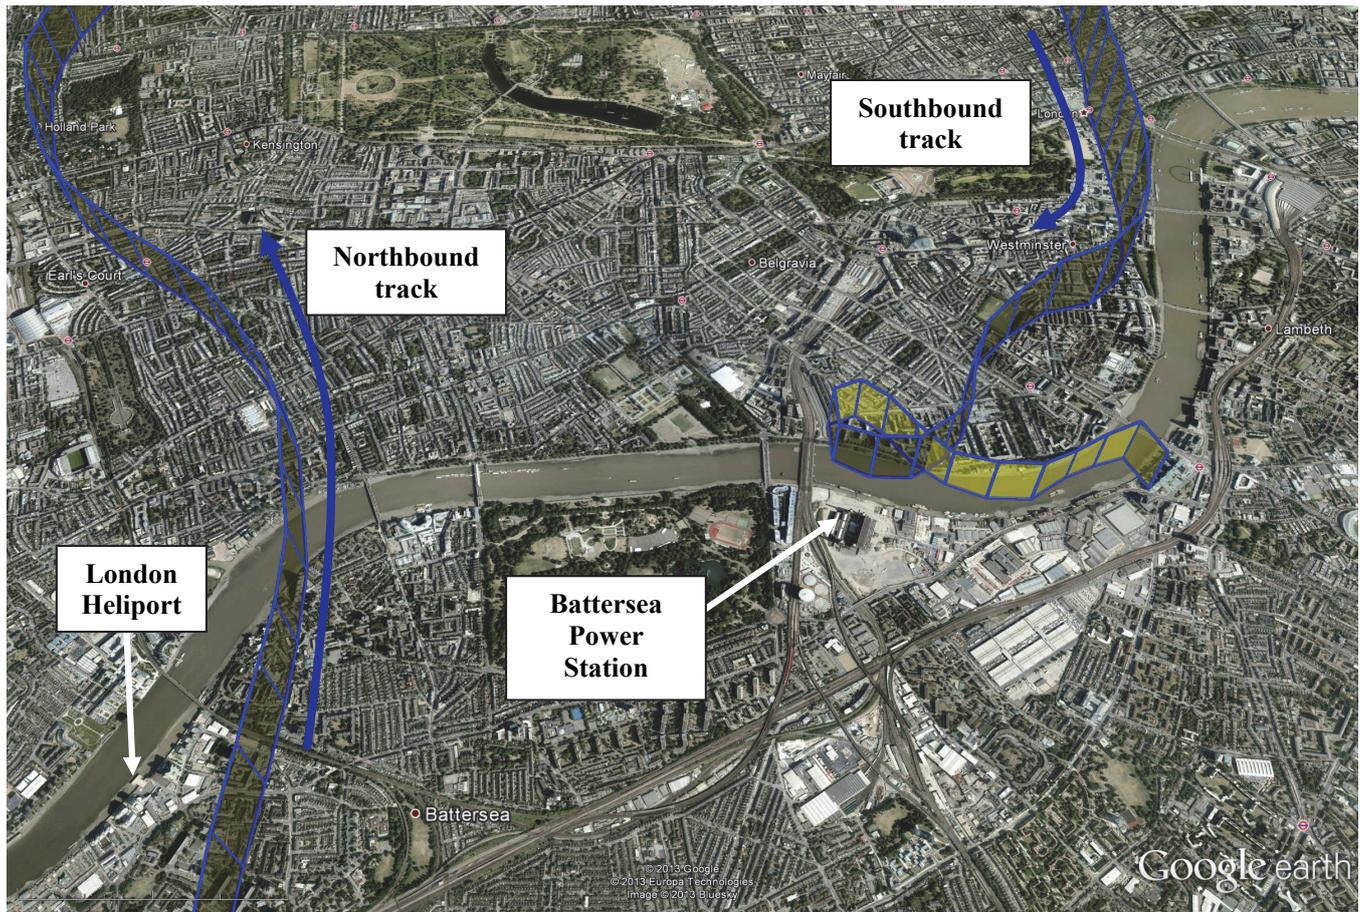
Figure 2

G-CRST radar track showing London Heliport

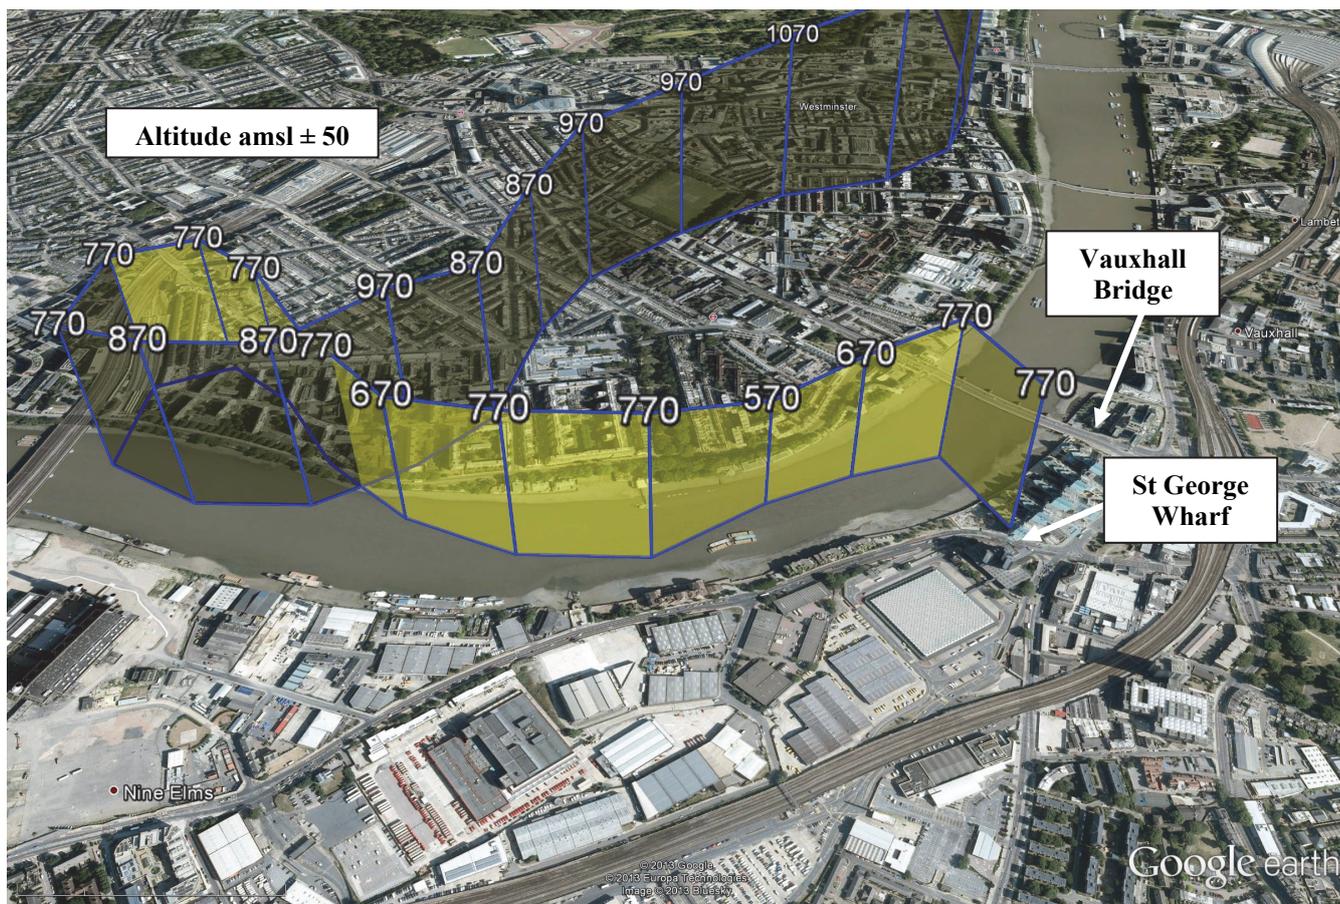
Figure 3

The helicopter arrived over the River Thames adjacent to Battersea Power Station at 07:58:35 hrs at a recorded altitude of 900 ft before performing a right turn to track along the river towards Vauxhall Bridge. The final two recorded positions show a turn to the right abeam St George Wharf at 800 ft, with the final position recorded at 07:59:24 hrs.

G-CRST radar track final positions showing altitude amsl
