No: 5/90

Ref: EW/G89/06/39

1. Boeing 757-236, G-BMRH
2. Boeing 747, HS-TGB

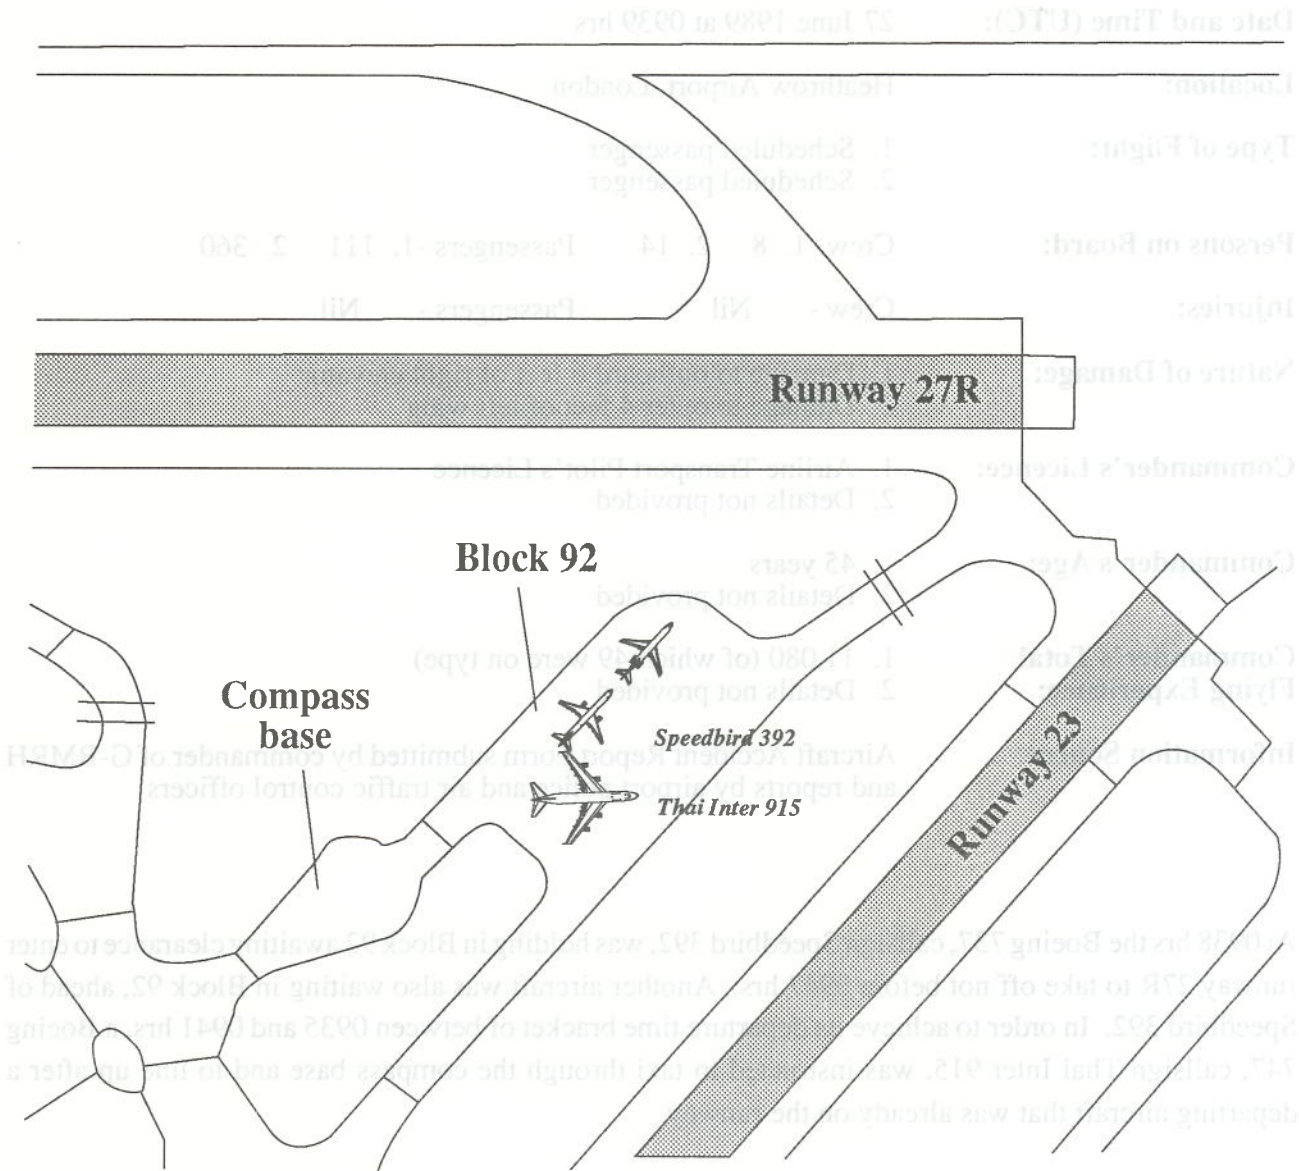
At 0938 hrs the Boeing 737, callsign Speedbird 392, was holding in Block 92 awaiting clearance to enter runway 27R to take off not before 0947 hrs. Another aircraft was also waiting in Block 92, ahead of Speedbird 392. In order to achieve its departure time bracket of between 0935 and 0941 hrs, a Boeing 747, callsign Thai Inter 915, was instructed to taxi through the compass base and to line up after a departing aircraft that was already on the runway.

As Thai Inter 915 taxied through the compass base, he advised ATC that he was unable to pass a Boeing 757 holding in Block 92. ATC accordingly asked Speedbird 392 to move forward. Speedbird 392 moved forward until further movement was blocked by the aircraft ahead of him. During the Thai

aircraft's attempt to pass, the outer 4 feet of its wingtip collided with the right elevator of Speedbird 392. Both aircraft returned to their respective stands.
