ACCIDENT

Aircraft Type and Registration:	Speedtwin ST2, G-STDL	
No & Type of Engines:	2 LOM M332B piston engines	
Year of Manufacture:	2007	
Date & Time (UTC):	22 April 2009 at 1515 hrs	
Location:	Near Woodbridge Airfield, Suffolk	
Type of Flight:	Private	
Persons on Board:	Crew - 2	Passengers - None
Injuries:	Crew - None	Passengers - N/A
Nature of Damage:	Right and left propellers, right engine cowls, and front fuselage	
Commander's Licence:	Airline Transport Pilot's Licence	
Commander's Age:	51 years	
Commander's Flying Experience:	9,600 hours (of which 22 were on type) Last 90 days - 61 hours Last 28 days - 23 hours	
Information Source:	Aircraft Accident Report Form submitted by the pilot and subsequent AAIB examination of the propellers

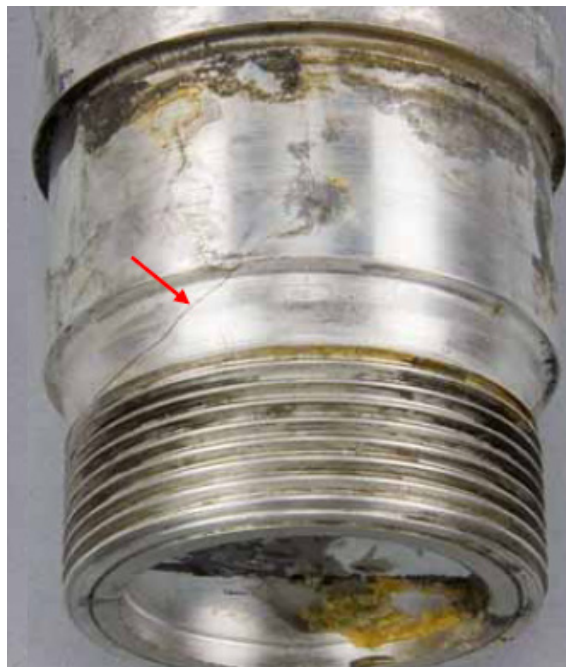
Figure 3

Examination of the damaged left propeller revealed a spiral crack running around the root section of one blade, Figure 3. It was concluded that this was an overload feature that occurred as a result of being struck by the failed right hand blade. The root sections of the remaining left and right blades revealed no sign of cracks, although all displayed evidence of moisture ingress and associated spots of corrosion.

View showing crack in root of one blade from the left propeller
