ACCIDENT

Aircraft Type and Registration:	Piper PA-28R-201T, Turbo Cherokee Arrow III, G-JMTT	
No & Type of Engines:	1 Continental TSIO-360-FB piston engine	
Year of Manufacture:	1978	
Date & Time (UTC):	9 April 2007 at approximately 1050 hrs	
Location:	9 nm south of Oban (North Connel) Airport, Argyll and Butte, Scotland	
Type of Flight:	Private	
Persons on Board:	Crew - 2	Passengers - 1
Injuries:	Crew - 2 (Fatal)	Passengers -1 (Fatal)
Nature of Damage:	Aircraft destroyed	
Commander's Licence:	Private Pilot's Licence	
Commander's Age:	56 years	
Commander's Flying Experience:	324 hours (of which 43 were on type) ¹ Last 90 days - unknown Last 28 days - 2 hours ²	
Information Source:	AAIB Field Investigation

Synopsis

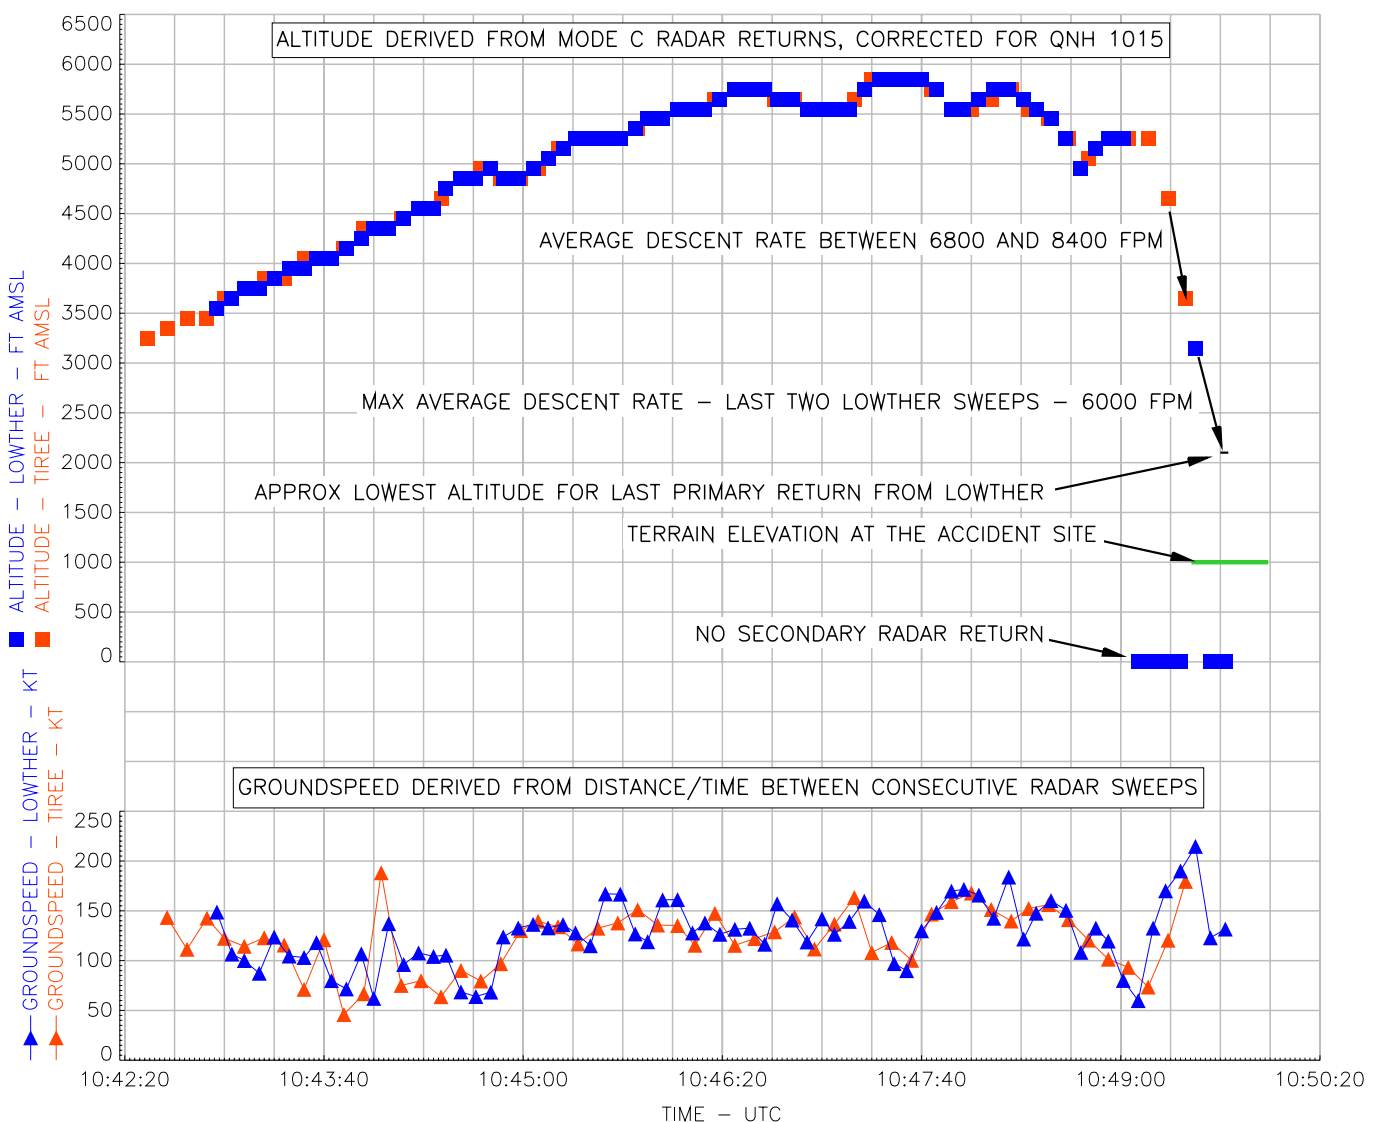
Figure 4
Altitude and time information for the Lowther and Tiree radar tracks

centred on a south-easterly track, carrying on the climb to approximately 5,800 ft and then varying in altitude between 5,600 ft and 5,900 ft. At 1048 hrs the aircraft altitude reduced to 5,300 ft. The radii of the turns during the roughly south-easterly track had been reducing during the flight. Approximately 30 seconds after levelling at 5,300 ft the aircraft entered a left turn with a radius of approximately a quarter of a nautical mile. Tیره radar recorded that the altitude during this turn dropped from 5,300 ft to 4,700 ft and then to 3,700 ft in under 16 seconds, indicating an initial descent rate of between 3,800 and 5,300 feet per minute (ft/min), accelerating to between 6,800 and 8,400 ft/min. This altitude loss was during a period when Lowther had lost secondary radar tracking of the aircraft for over 23 seconds. Lowther secondary radar then picked up a final secondary return at approximately 3,200 ft, further round in the turn. This was followed by two primary returns, showing the aircraft tracking north before dropping off radar entirely at 1049 hrs. It is calculated that Lowther primary radar can detect aircraft down to approximately 2,100 ft at the last radar return point. This limits the altitude loss between the last secondary return and the last primary return, 11.6 seconds later, giving a maximum descent rate of 6000 ft/min. This shows a reduction in the descent rate just before the track was lost.

While it is not known when the vacuum pump failed, the effects of the failure probably started to manifest themselves with erroneous AI indications just before the aircraft entered the left turn, approximately 24 seconds before the radar track was lost.

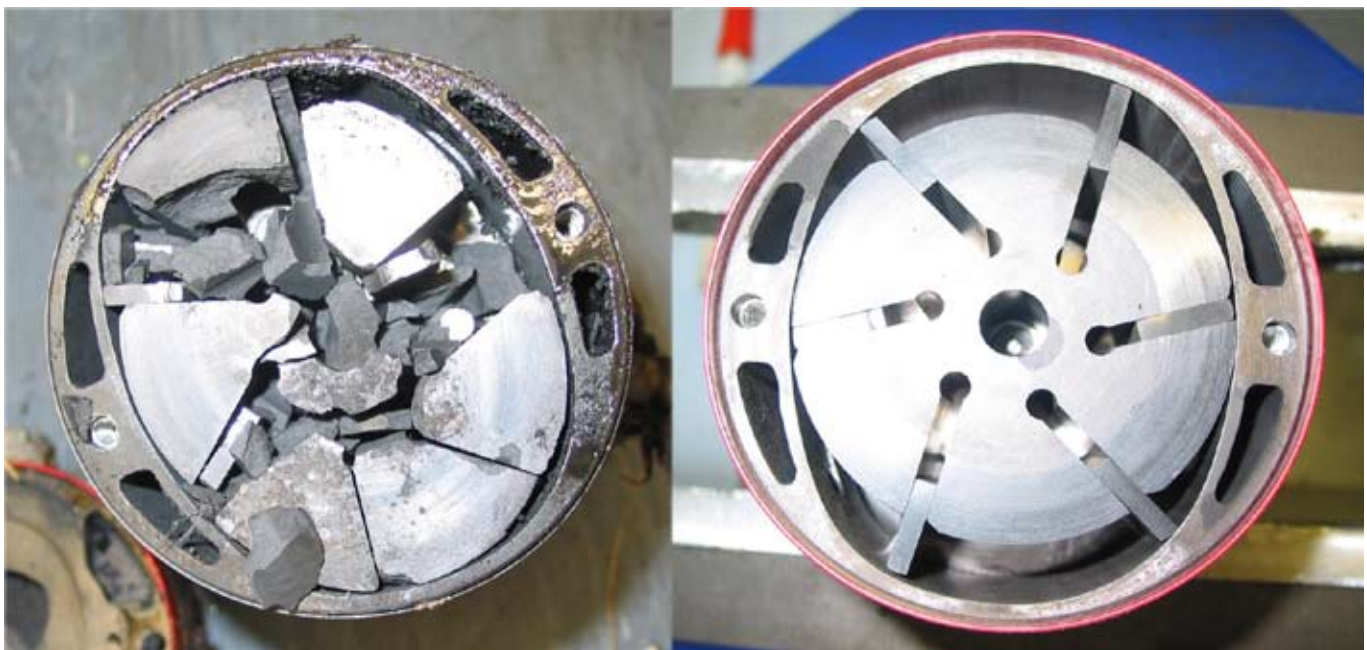
Figure 6

Damaged vacuum pump rotor and vanes from G-JMTT on left; intact version on right

The vacuum pump examination also revealed that there was significant carbon/fluid streaking emanating from the shaft assembly. The carbon bearing, rotor and vanes generate carbon dust particles as they wear. The component manufacturer reported that when liquids such as engine oil or engine cleaning liquids mix with the carbon dust, they create a thick slurry which increases friction leading to premature failure of the air pump. Some causes of liquid contamination are a leaking accessory drive pad seal or engine cleaning liquid being sprayed onto an unprotected air pump.
