ACCIDENT

Aircraft Type and Registration:	RAF 2000 GTX-SE, G-REBA	
No & Type of Engines:	One Subaru EJ22 piston engine	
Year of Manufacture:	2001	
Date & Time (UTC):	1 June 2006 at 0927 hrs	
Location:	West of Simon's Stone, Colliford Lake, Bodmin Moor, Cornwall	
Type of Flight:	Private	
Persons on Board:	Crew - 1	Passengers - None
Injuries:	Crew - 1 (Fatal)	Passengers - N/A
Nature of Damage:	Gyroplane destroyed	
Commander's Licence:	Private Pilot's Licence	
Commander's Age:	69 years	
Commander's Flying Experience:	242 hours (of which 191 were on type) Last 90 days - 5.4 hours Last 28 days - 1.5 hours	
Information Source:	AAIB Field Investigation

Synopsis

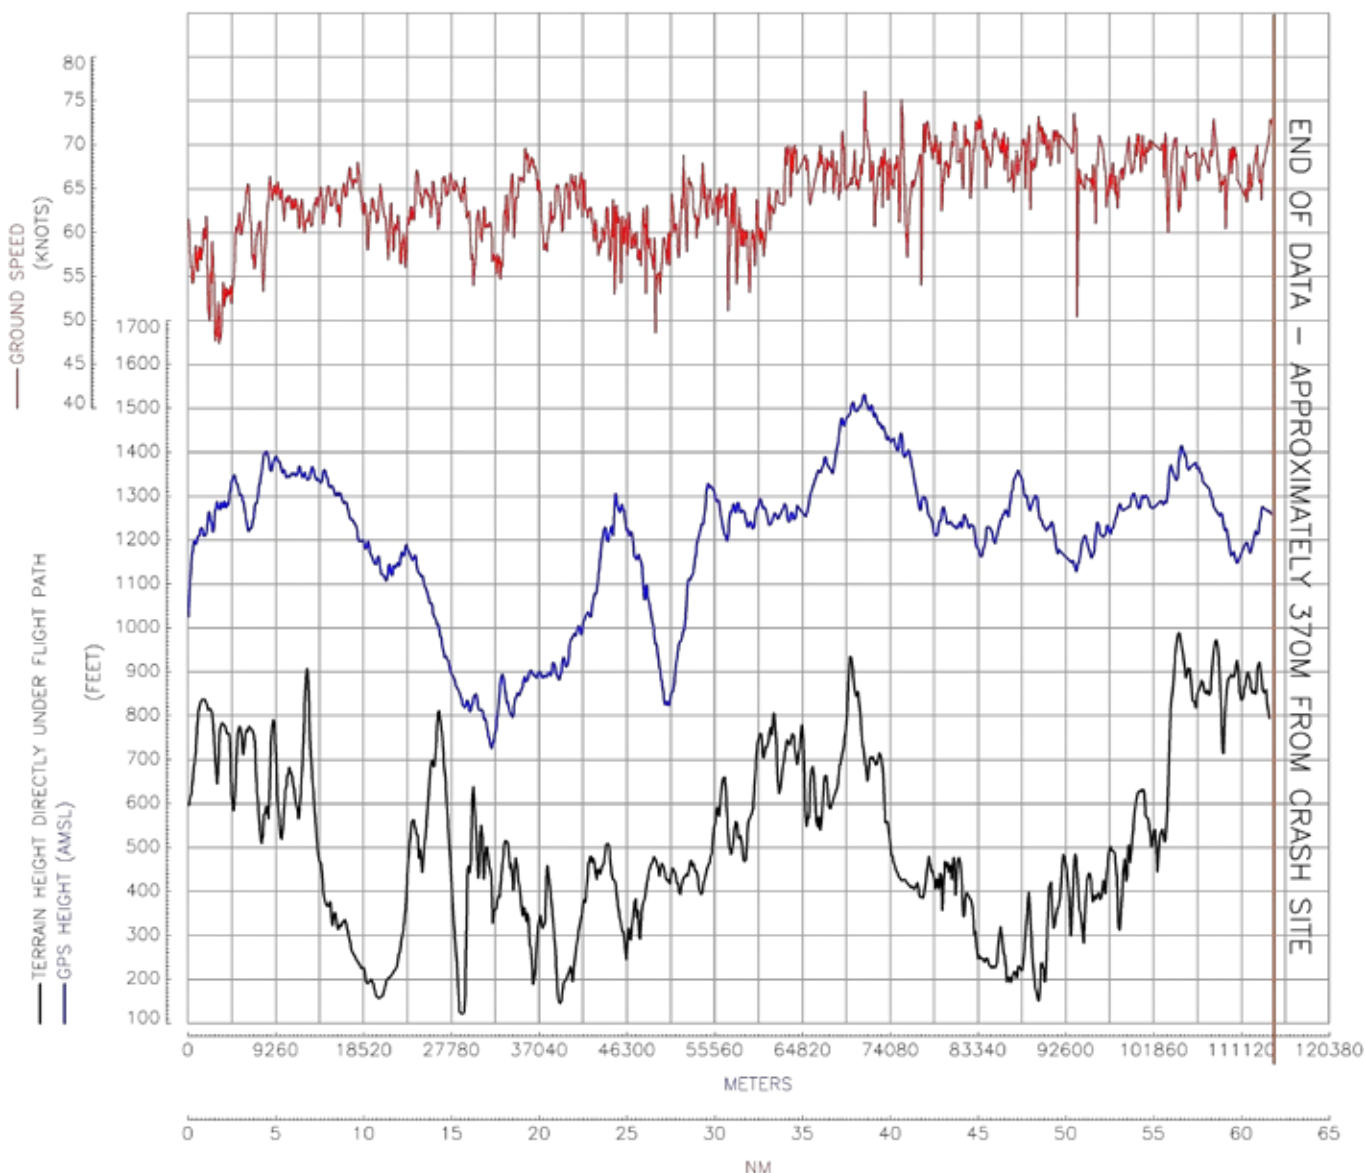
Figure 1
PDA GPS Data

The data indicated that the aircraft had flown a distance of 62.6 nm and the GPS calculated average speed was 55.3⁶ kt. Data points were on average recorded every 13 seconds with the aircraft travelling about 360 m between each data point. Table 1 details the final 12 data points recorded by the GPS. During the final three data points rapid changes in groundspeed can be observed.

If the aircraft track had been maintained, the aircraft would have passed almost overhead of Bodmin Aerodrome. Had the aircraft been maintaining the last recorded GPS height amsl, which was about 1,250 ft, the height agl would have been no less than about 500 ft before reaching Bodmin Aerodrome.

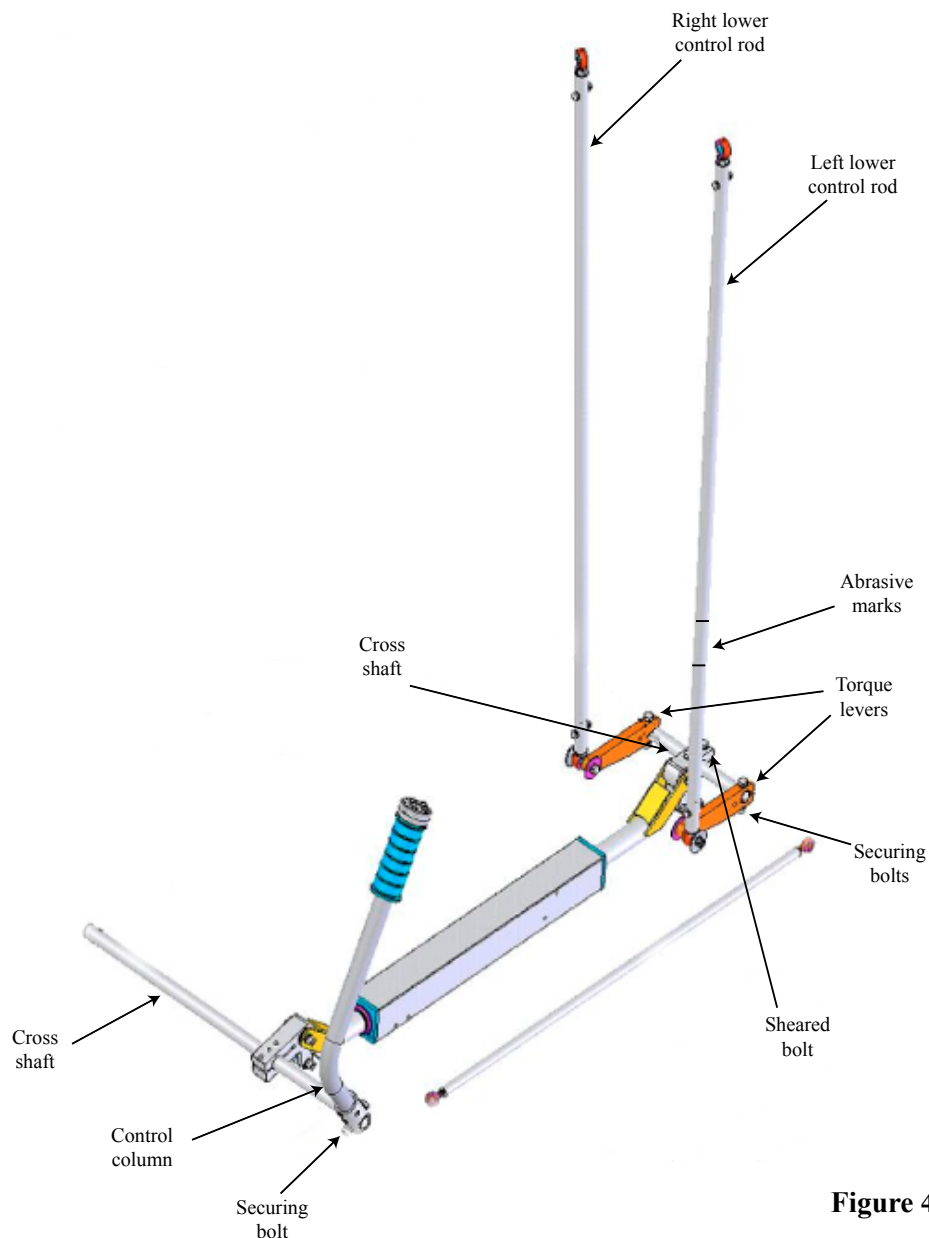
Figure 4
RAF 2000 flying controls

With the exception of the torque levers, continuity of the cyclic control was confirmed between the control column and the gimble activation arm. Both torque levers, which are mounted at the base of the mast, had failed at the point where the bolts secure the levers to the cross shaft (see Figure 4). The left lower control rod was badly bent during the impact and broke during the recovery of the gyroplane. At 34 cm from the bottom of the rod there were deep abrasion marks along the rod for approximately 40 mm. The lock nut on the lower fitting on the left upper control rod had been

fully wound off and the fitting was loose. Abrasion marks were also discovered at 80 mm and 35 cm from the bottom of the right lower control rod. The lock nut on the fitting on the right upper control rod was found to be loose. The bolt used to secure the pilot's control column to the cross shaft had four washers between the column and the nut. The bolt which secured the torque lever to the cross shaft had failed in shear. Both trim springs were still connected to the control rods. The trim indicators were in the fully down position and the trim cables were unwound from the barrels inside the trim mechanism, so that there was no tension in the trim springs and no trim force applied to the control system.

The left lower control rod failed as a result of bending overload separation. The deep abrasion marks 34 cm from the bottom of the control rod were identified as longitudinal fretting corrosion damage which had resulted from high contact pressures and large sliding movements. The metallurgist considered that the restriction resulting from this contact could have been sufficient to overload the torque levers.

The comparison also established that the abrasion marks at the base of the right lower control rod were probably caused by the trim springs rubbing against the control rod. It was noted that a number of other owners of RAF 2000 gyroplanes had identified this problem and introduced their own modifications using plastic sheaths and blade tape to protect the control rods from the trim springs. Whilst it is unlikely that the rubbing of the trim springs against the control rod played any part in this accident, on the 14 July 2006, in AAIB Special Bulletin S6/2006, the following Safety Recommendation was made to the Popular Flying Association.

Whilst operating the controls on one of the gyroplanes used in the comparison, it was noted that the excess safety chain, fitted to one of the trim springs, jammed between the lower control rod and undercarriage strut thereby restricting the roll control of the gyroplane. The chain on G-REBA had been set up such that there was no free hanging excess chain and, therefore, it is unlikely that it would have caused the control to jam. However, on the 14 July 2006, in AAIB Special Bulletin S6/2006, the following Safety Recommendation was made to the Popular Flying Association.

It is recommended that the Popular Flying Association considers introducing a modification to the lower control rods of the RAF 2000 to protect them from being damaged by the trim springs.

It is recommended that the Popular Flying Association takes the necessary immediate steps to ensure that the safety chain connected to the trim springs on the RAF 2000 does not jam the moving parts in the control system.
