ACCIDENT

Aircraft Type and Registration:	Piper PA-38-112 Tomahawk, G-RVRF	
No & Type of Engines:	1 Lycoming O-235-L2C piston engine	
Year of Manufacture:	1978	
Date & Time (UTC):	29 July 2011 at 1123 hrs	
Location:	Newlands Avenue, Eccles, Greater Manchester	
Type of Flight:	Private	
Persons on Board:	Crew - 1	Passengers - 1
Injuries:	Crew - 1 (Fatal)	Passengers - 1 (Serious)
Nature of Damage:	Aircraft destroyed	
Commander's Licence:	Private Pilot's Licence	
Commander's Age:	59 years	
Commander's Flying Experience:	426 hours (of which 302 were on type) Last 90 days - 3 hours Last 28 days - 1 hour	
Information Source:	AAIB Field Investigation

Synopsis

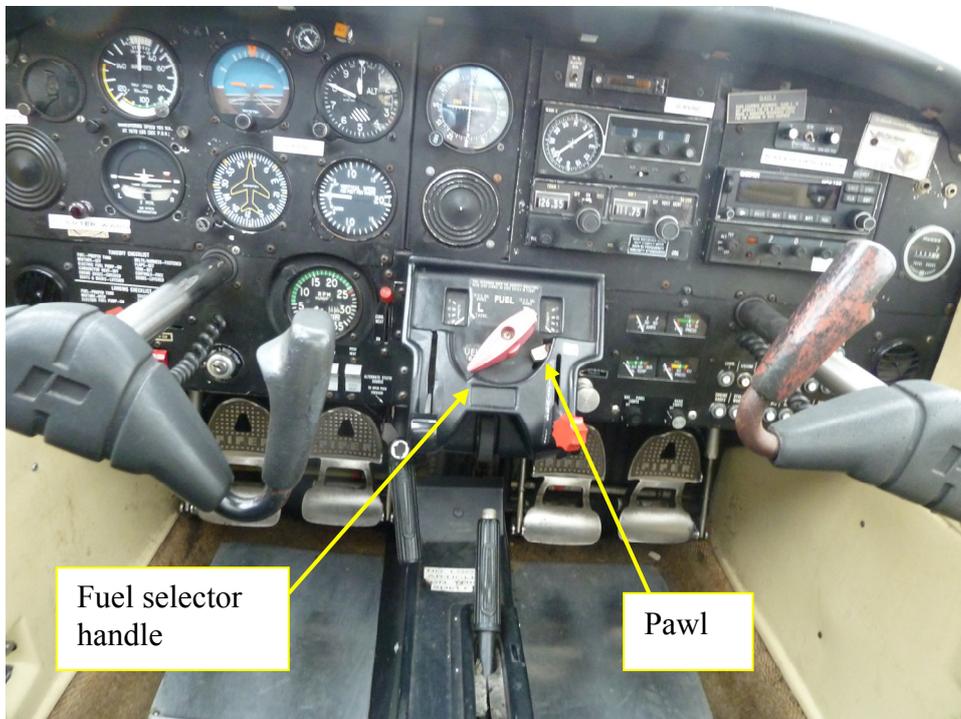
The aircraft fuel selector is a large, red, plastic, pointed handle in the centre of the instrument panel. The OFF position is with the handle pointing to the bottom left quadrant. The handle must be rotated clockwise to the top left quadrant to select the left fuel tank. It can then be rotated clockwise to the top right quadrant to select the right fuel tank. To return to the OFF position, the handle is rotated anti-clockwise. To ensure the fuel selector is not selected OFF inadvertently, a small pawl must be pushed against spring pressure to allow the rear of the handle to pass (see Figure 1).

Figure 1
Fuel selector handle in the OFF position

The fuel selector handle was found in the OFF position but the ridged washer above the valve plug was not located in the detent for the OFF position on the plug. The valve plug was exceptionally stiff and difficult to rotate and the edges of the recessed detents on the top of the plug were also noticeably worn. The dried lubricant on the valve plug contained small particles of the valve body material released by wear between the plug and the valve. The top of the valve stem, which located in a keyway recess on the end of the connecting rod, was also heavily worn, as was the recess into which it fitted. This allowed a degree of rotational movement of the rod without moving the valve, even with the retaining screw tightened and wire-locked. As the valve and fuel selector handle were not rigidly connected, it was possible for a variation to exist between the actual valve position and the position selected by the handle. No

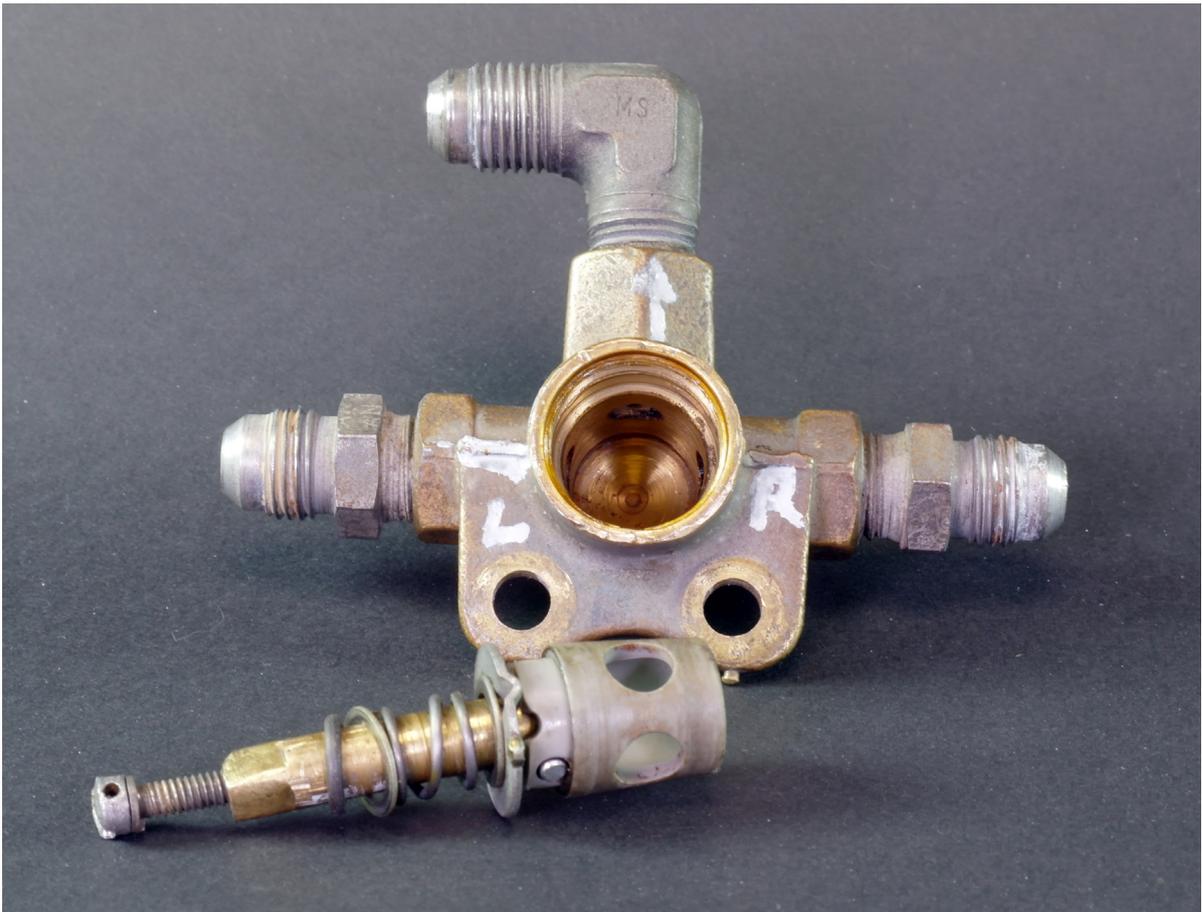
**Figure 2**

tank and one which passes through the firewall to deliver fuel to the engine. The stem of the valve is attached to a plastic plug with two holes in it, which rotates within the body of the valve. When the valve is in the OFF position the plug blanks off the engine delivery pipe. When the plug is rotated to select the left tank, the holes line up with the pipe from the left tank and the engine delivery pipe to allow the fuel to flow. Similarly when rotated again to select the right tank, the holes line up with the engine delivery pipe and the pipe from the right fuel tank. The top of the plug has four recesses aligned in a cross shape. Above this is a spring-loaded, non-rotating washer with a ridge across its diameter. In each of the defined positions of the valve, the ridge in the washer slots into the recesses on the plug, providing a positive detent to give tactile feedback that the holes in the plug are correctly orientated with the feed and exit pipes (see Figure 2).

Fuel selector valve (valve cap removed)

Following an initial inspection of the valve, connecting rod and handle, they were replaced in the aircraft and a test was carried out to assess the actual valve plug position against fuel selector handle position. The test identified that the detent position could not be confirmed when turning the selector handle. The results of the test showed that the holes in the valve plug did not align with the feed and exit pipes of the valve, despite the fuel selector handle visually indicating the correct position.

In 1982, the aircraft manufacturer issued Service Letter 944 to address a problem where fuel selector valves had become difficult to rotate, damaging the valve and preventing switching between fuel tanks. The Service Letter introduced a repetitive 400 hr valve disassembly, inspection and lubrication task. The logbook for the accident aircraft identified that this task was last carried out on 25 July 2010, 109 hours prior to the accident. The lubricant specified by the Service Letter has an operating temperature range of -30°C to +230°C.

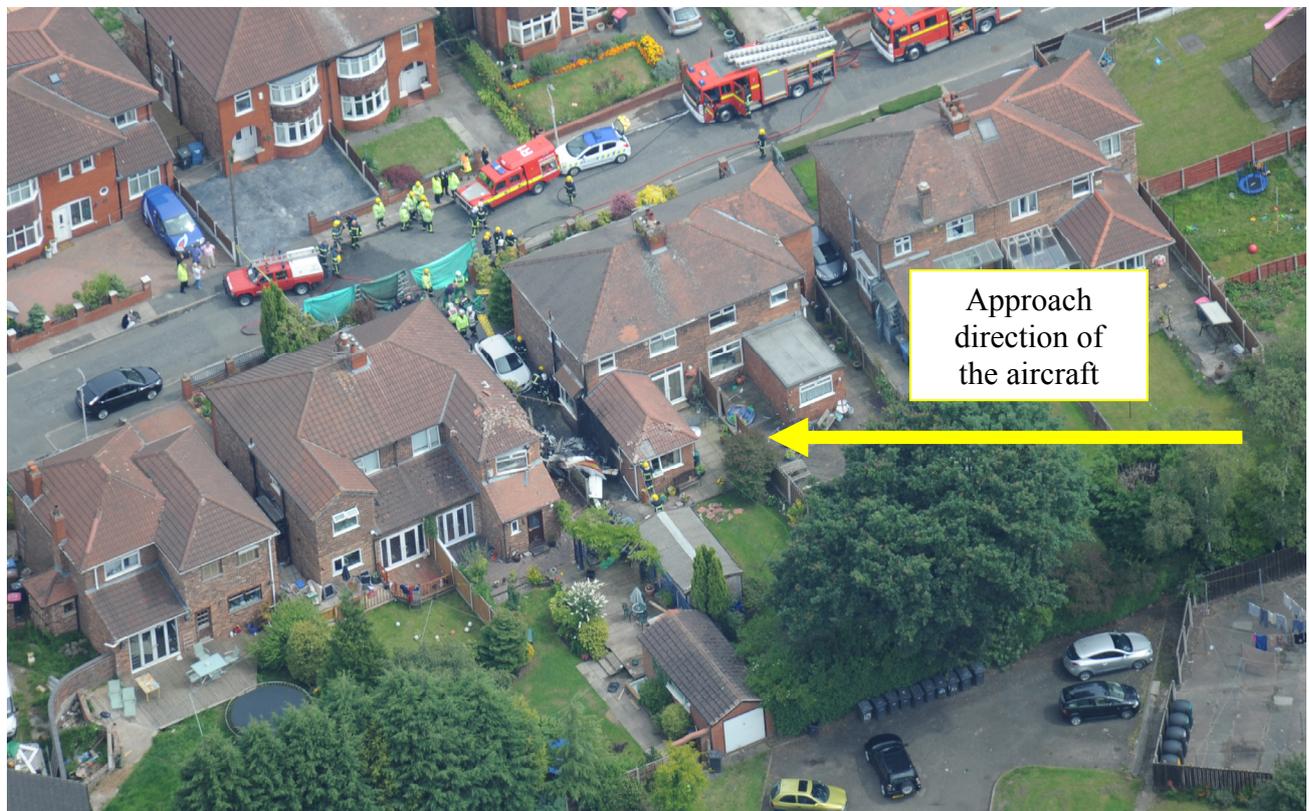
of the driveway had a two-storey extension in a mirror image position to the house on the right. The sidewall of this extension, facing the driveway, had a large hole at upper floor level through to the interior of the house. The adjacent wall and roof section also exhibited severe structural damage (see Figure 4). Both houses had suffered significant heat damage from the fire in the immediate area around the aircraft wreckage.

Figure 4
Accident site
