AAIB Bulletin No: 3/96

Ref: EW/C95/8/4

Aircraft Type and Registration: Sikorsky S61N Sea King, G-AYOM

Location: Claymore Accommodation Platform,
94 nm northeast of Aberdeen

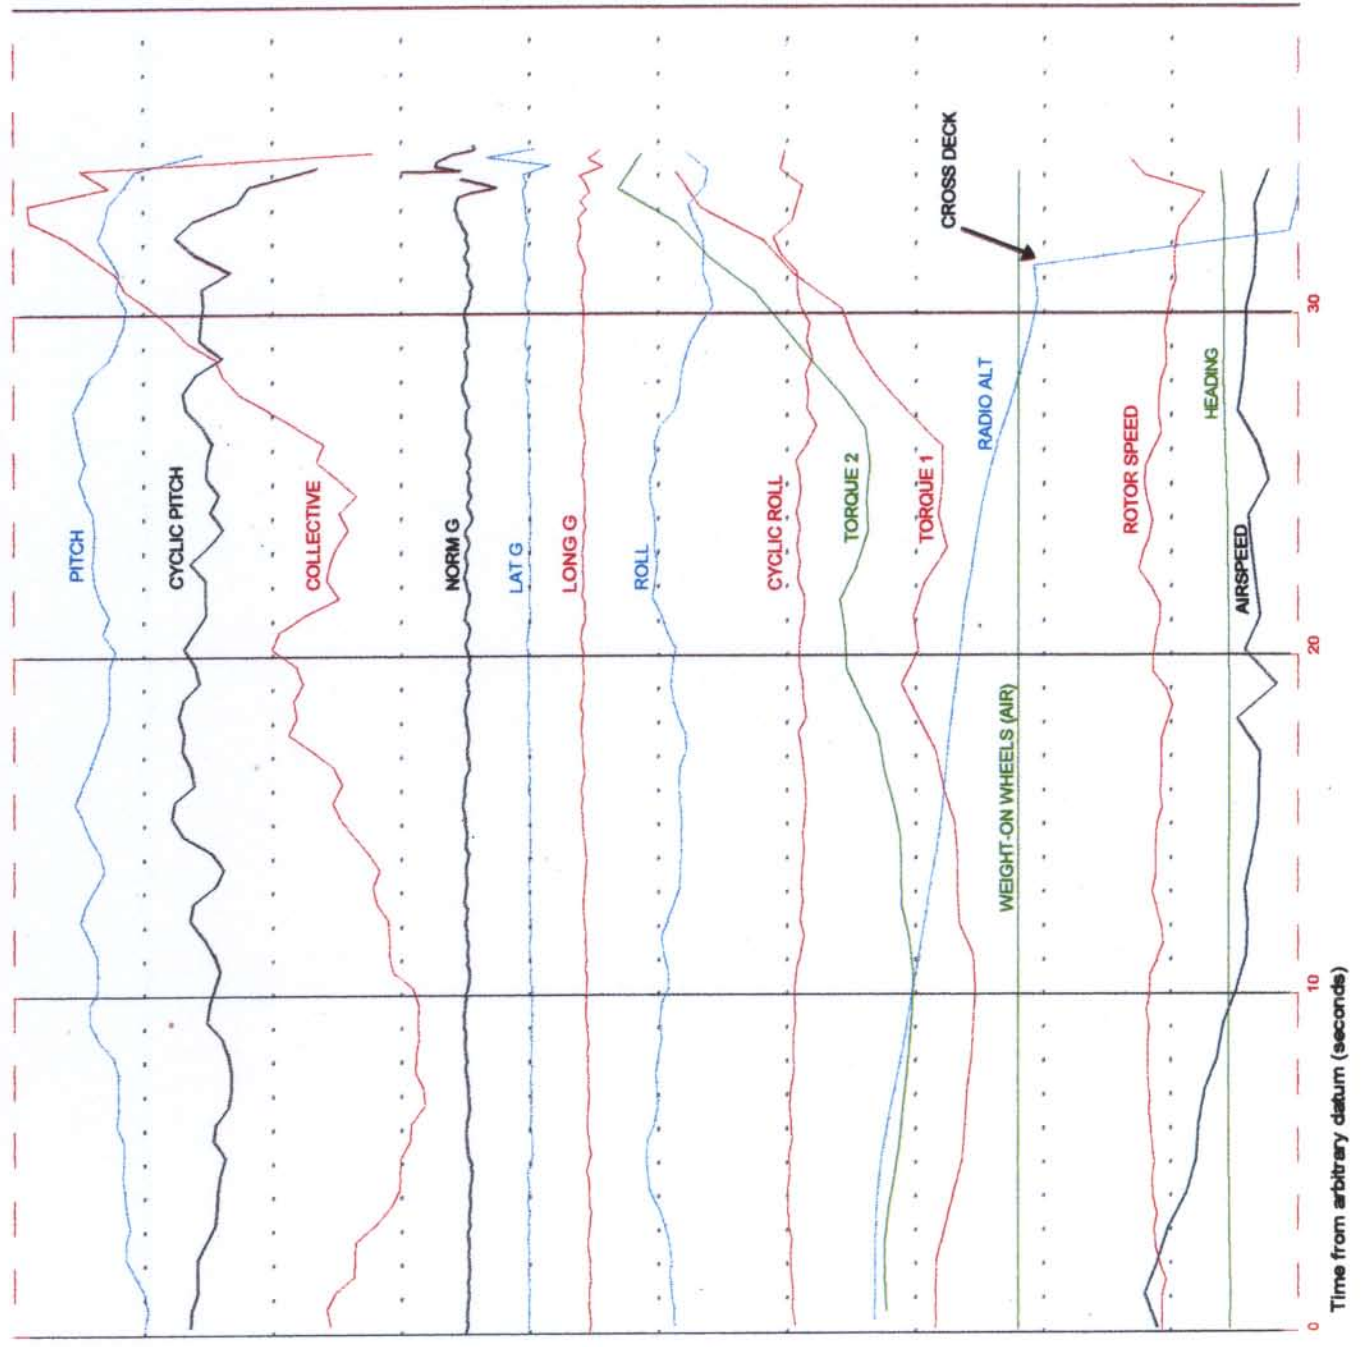
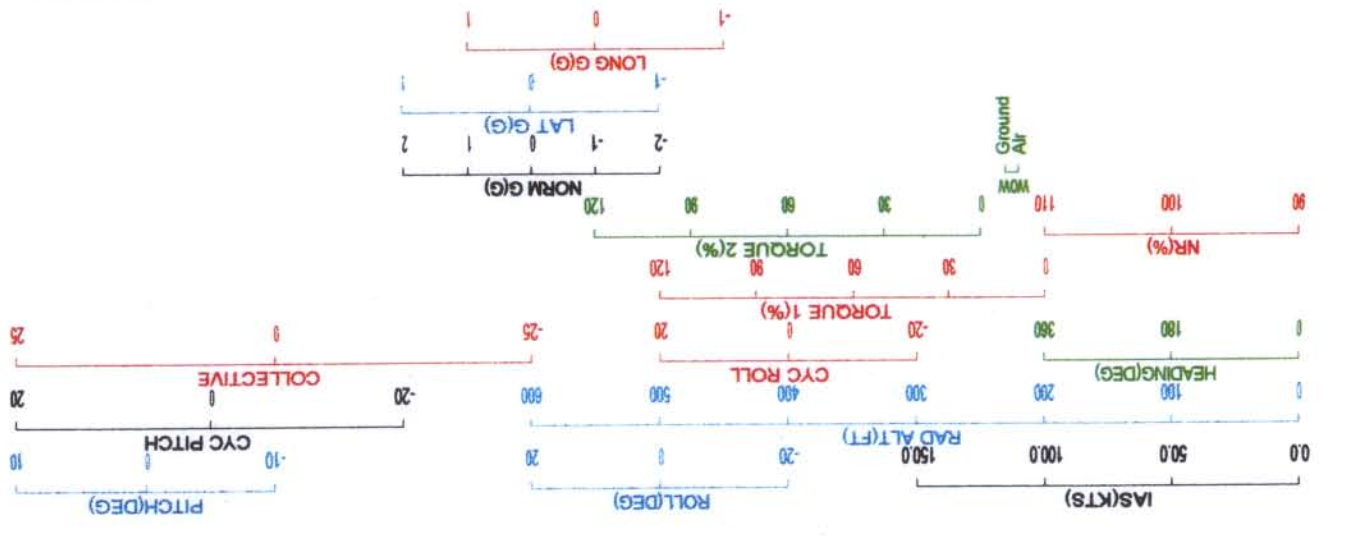
FIGURE 1. Selected Aircraft Parameters: Last 30 seconds of flight

designed to prevent the voice recording on the CVFDR from being overwritten, post impact, if power supplies to the recorder are maintained. Recorded data is shown in Figures 1 and 2.

The helicopter descended with the collective pitch at approximately the rigged position and the engine torques between 35% and 45%. This gave a rate of descent of approximately 320 feet per minute. Four minutes prior to touchdown and at an altitude of 550 feet, more collective was applied and the helicopter climbed to 630 feet over a period of one minute. At a distance of two miles from the rig and with just over two minutes to run, the collective was then lowered to just below the rigged position and, with the engine torques at approximately 40%, the helicopter descended at 350 feet per minute to an altitude of 250 feet. One hundred seconds prior to touchdown the collective was again raised and the helicopter climbed to an altitude of 360 feet.

Fifty seconds before the landing the data showed a large reduction in the collective pitch to 8% below the rigged position and the engine torques reduced to approximately 30%. The recorded rotor speed (NR) indicated variations between 102% and 104% and the indicated airspeed steadily decreased from 80 kt to less than 20 kt (indicated airspeed below approximately 40 kt are unreliable due to inaccuracies in the transducer system). As the helicopter commenced its final descent towards the rig the radio altimeter indicated a rate of descent of 200 feet per minute. Ten seconds before the landing the commander asked the first officer to call the engine torques. At the same time the descent rate suddenly increased to 440 feet per minute with no change in the controlling inputs. As the first officer was calling the torques the commander smoothly increased the collective pitch to the maximum extent over the next 7 seconds with the torques on both engines following the required demand. The radio altimeter indicated no reduction in the rate of descent as the edge of the helideck was crossed. The first recorded radio altitude over the helideck was 6.7 feet with 3 seconds to go before the end of the recording. At 2 seconds before the end the Engine No 1 and Engine No 2 torques were recorded as 106% and 112% and the first officer called "Overtorque". The rotor speed at that time was 97% and the radio altimeter was recorded as zero feet indicating that the main wheels were very close to or just touching the deck. The collective was then lowered rapidly and the aircraft yawed 5° the right. As the collective was lowered the rotor speed increased to its last recorded value of 103%.

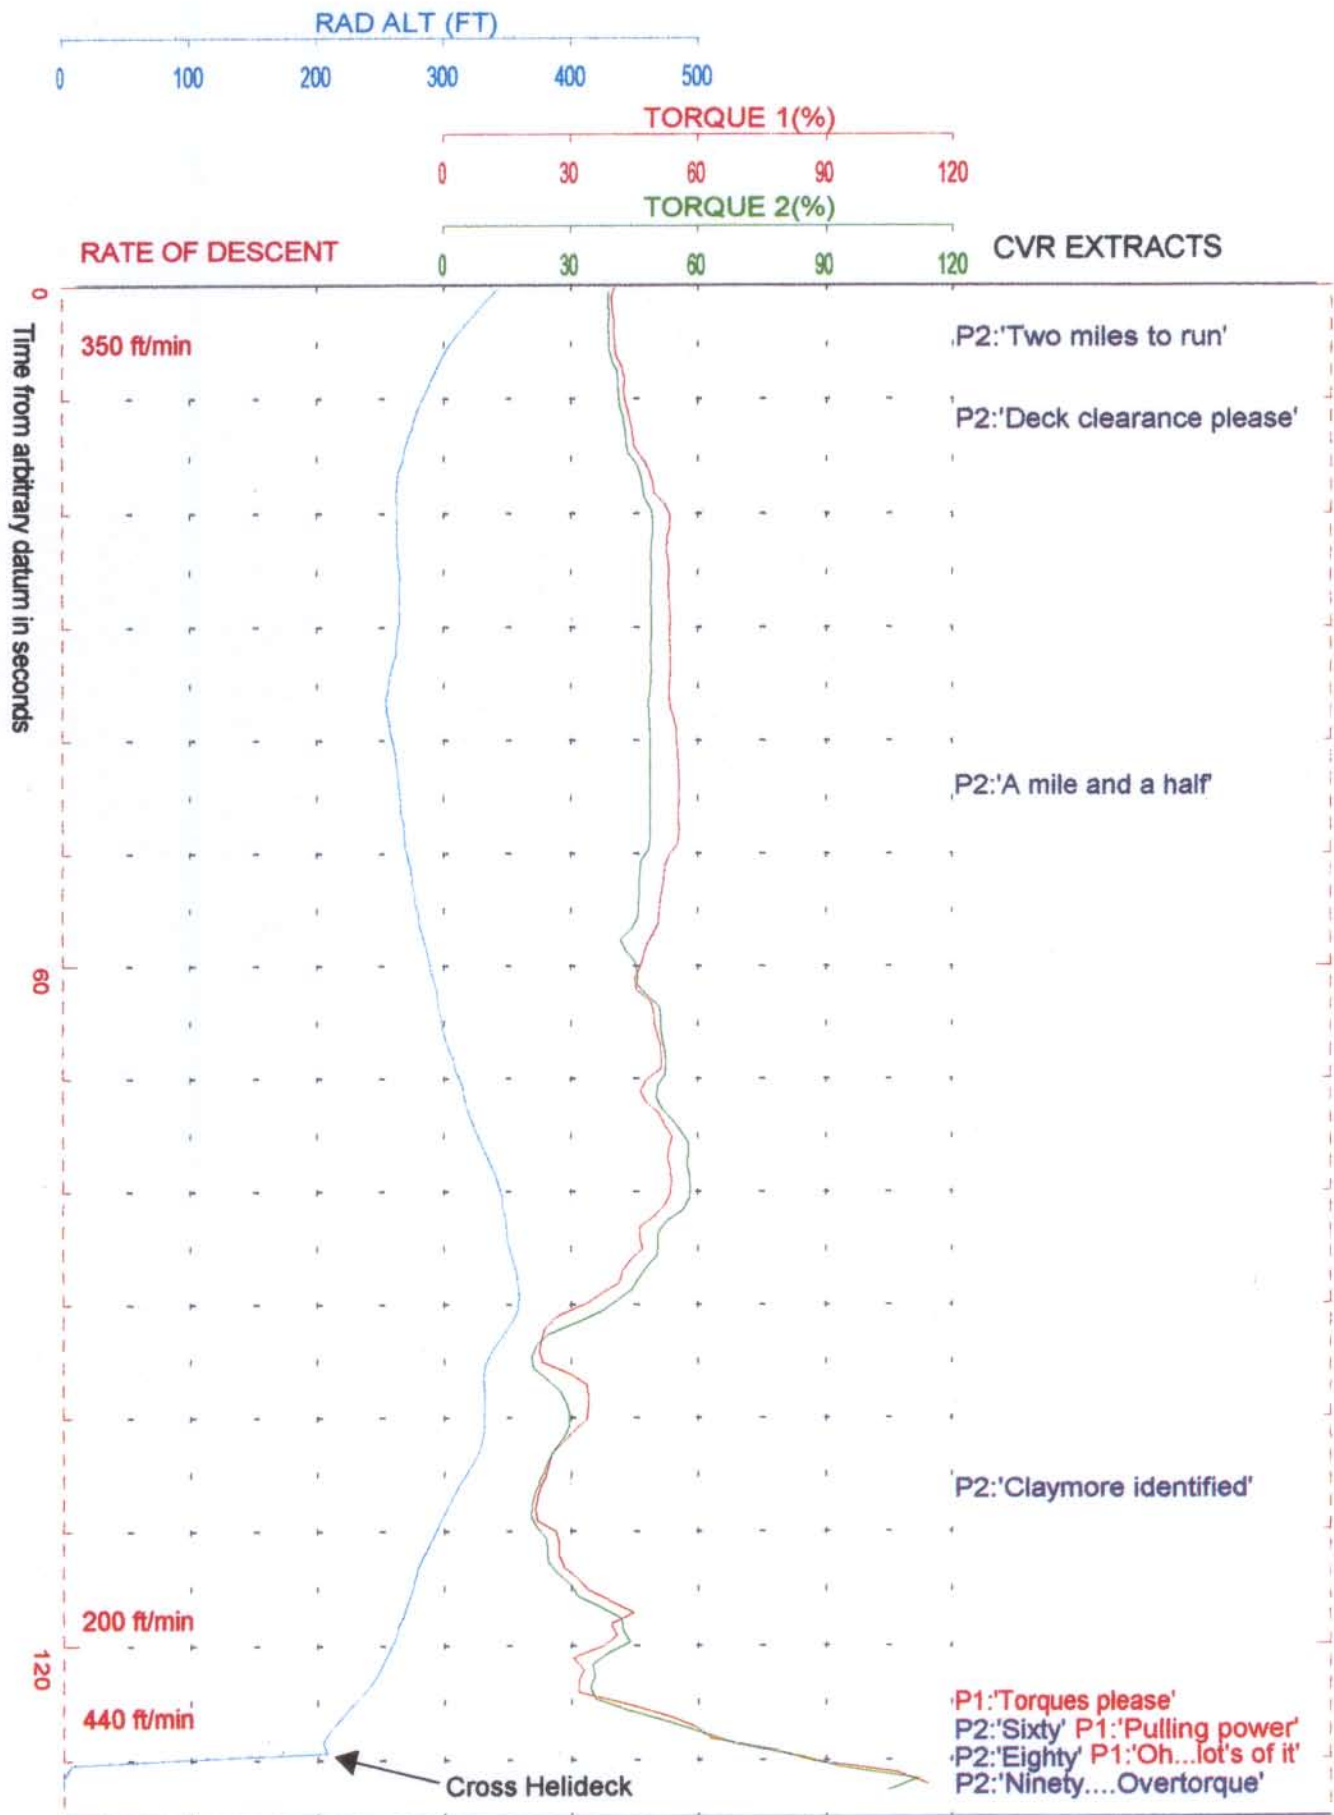
FIGURE 2. Rate of Descent and CVR annotation

Although the recorded weight-on-wheels signal did not register the final settling on the gear by changing state, the one second sampling period of this data means that the landing gear switch may have been made at any point on from the start of the last second of the recording. The time taken from the known airborne state (radio altitude 6.7 feet) to the when weight-on-wheels was likely to have

occurred, makes it apparent that the rapid descent was arrested at around the point that the helicopter came into contact with the deck. The absence of any 'holding up' of the power supply within the CVFDR meant that the recording of data and voice terminated immediately upon the operation of the tail boom mounted inertia switch.

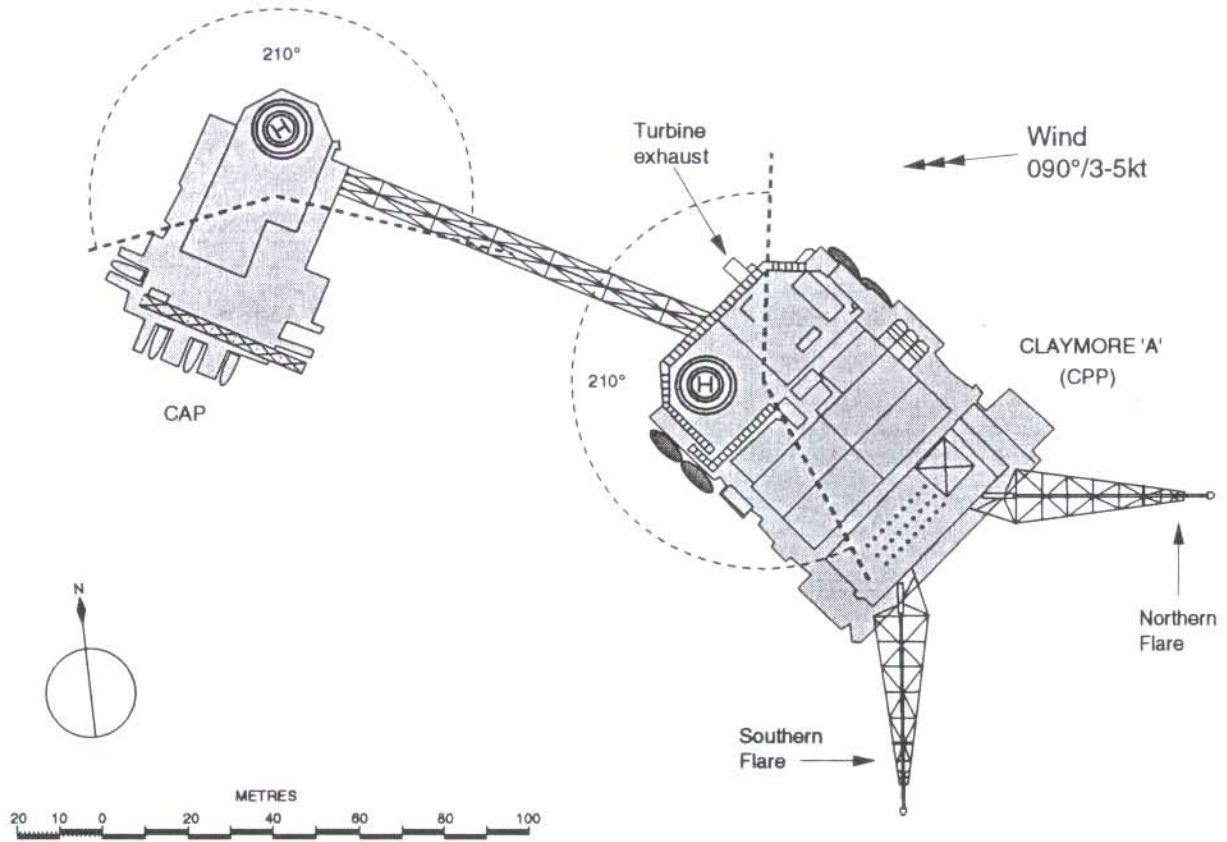
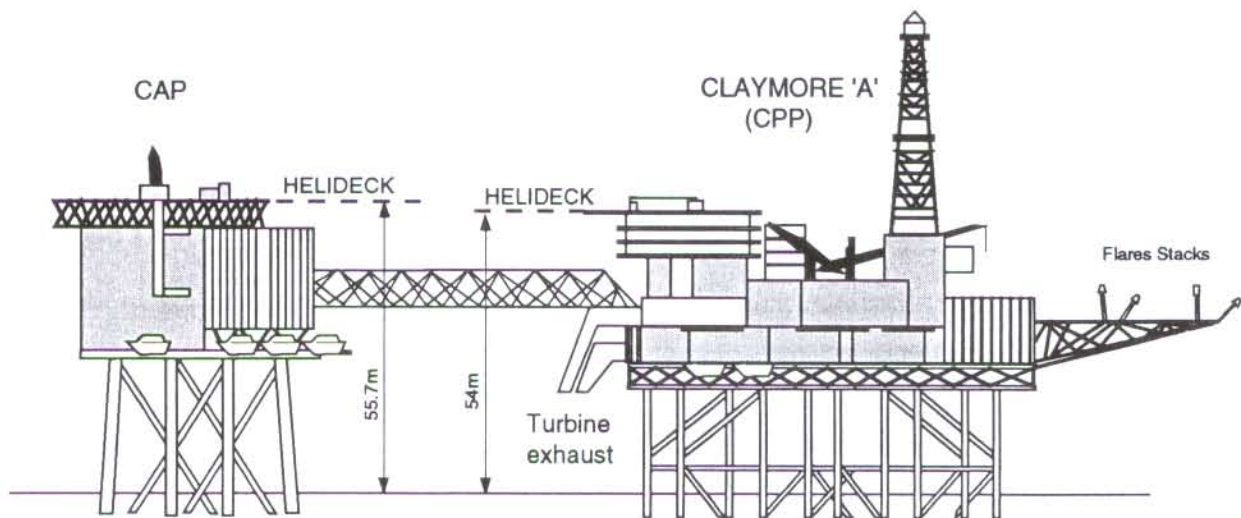
Figure 3

The CAP, a new permanent installation located approximately 95 nm on the 060° radial from Aberdeen, is positioned to the west alongside the Claymore Production Platform (CPP) and joined to it by a walkway 95 metres in length (Figure 3). The dual installation complex supports two helidecks. The CPP helideck was to be used for emergency landings only due to the proximity of the new walkway. The newly commissioned helideck on the CAP, however, had no such restrictions or limitations except that its 210° obstacle free sector had been reduced by 9° to 201°, again due to the presence of the adjoining walkway. This infringement of the 210° sector by the walkway, had been notified to the Civil Aviation Authority and was listed as a non-compliant item in the crew briefing material (Installation/Vessel Limitation List (IVLL)). The CPP, as well as being equipped with gas turbine engines to provide production power supplies, was fitted with two horizontally mounted flare stacks used for the 'burning off' of surplus gas products. These flare stacks, referred to as the 'northern' and 'southern' stacks, are approximately 50 metres in length and extend to the east and south from the production platform structure.
