**ACCIDENT**

<b>Aircraft Type and Registration:</b>	Pioneer 300, G-CEEG	
<b>No &amp; Type of Engines:</b>	1 Rotax 912ULS piston engine	
<b>Year of Manufacture:</b>	2006	
<b>Date &amp; Time (UTC):</b>	9 June 2007 at 1431 hrs	
<b>Location:</b>	Oban Airport, Strathclyde, Scotland	
<b>Type of Flight:</b>	Private	
<b>Persons on Board:</b>	Crew - 1	Passengers - 1
<b>Injuries:</b>	Crew - None	Passengers - None
<b>Nature of Damage:</b>	Broken propeller, slight damage to engine cowling, landing gear jacks buckled	
<b>Commander's Licence:</b>	Private Pilot's Licence	
<b>Commander's Age:</b>	56 years	
<b>Commander's Flying Experience:</b>	1,450 hours (of which 90 were on type) Last 90 days - 87 hours Last 28 days - 32 hours	
<b>Information Source:</b>	AAIB Field Investigation

**Synopsis**

The landing gear seized in the partially extended position and during the subsequent landing, the nose gear collapsed allowing the propeller to make contact with the runway.

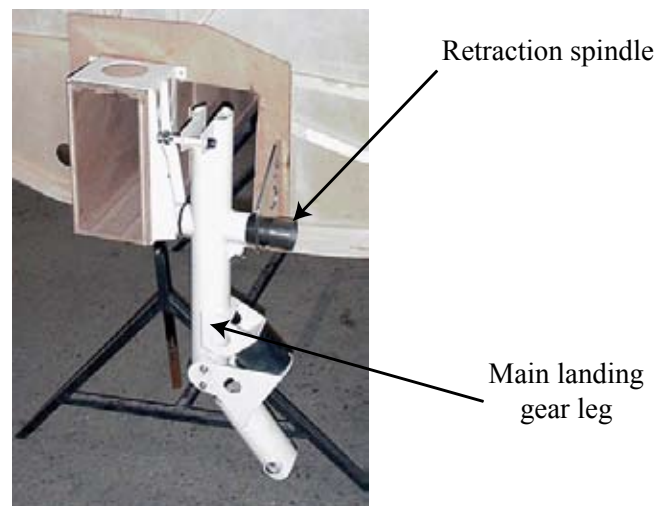
**Figure 1**

The owner of the aircraft, who was also the pilot on the incident flight, reported that the right main landing gear screw jack and nose leg locking rod had buckled, which had caused the nose and right landing gear to collapse. The owner removed the right landing gear screw jack and retraction mechanism and attempted to rotate the right main leg about the retraction spindle (see Figure 1). However the leg could not be easily rotated about the spindle and remained jammed at an angle of approximately 50°.

Main landing gear leg

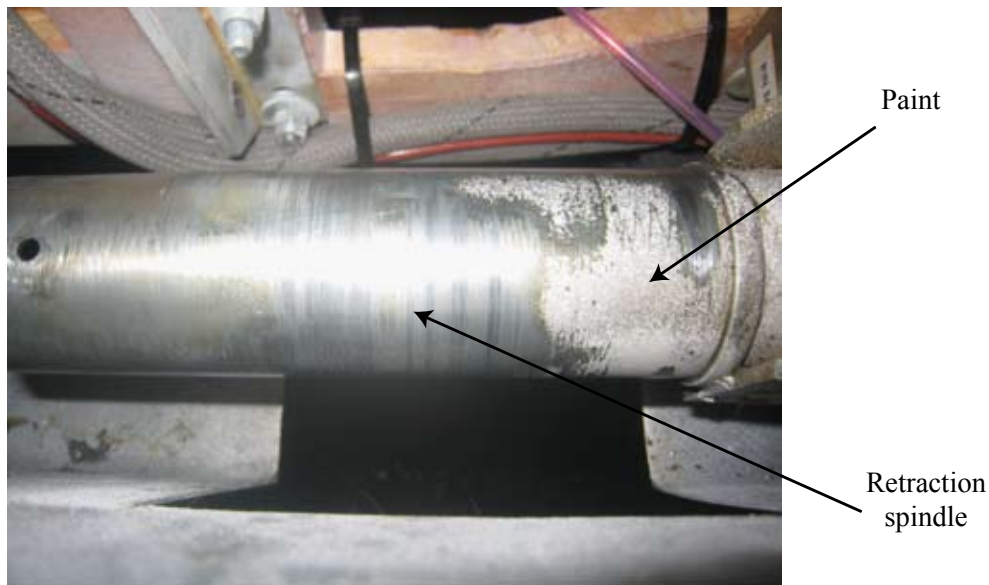
**Figure 2**

On removing the right leg from the retraction spindle, the owner noticed that there was paint on the inner portion of the spindle and that there did not appear to be much grease on the painted portion of the shaft (see Figure 2). There should not be any paint on the spindle.

Paint on right spindle

There was no paint on the spindle for the left leg. The owner was of the opinion that the paint might have left insufficient space to allow the grease, which is applied via a nipple on the landing gear leg, to flow along the full length of the right spindle. Consequently he believed that it was the accumulation of the paint debris, as it was rubbed off the spindle, and a partially dry bearing face that caused the leg to seize on the spindle. The owner reported that the leg rotated freely after the paint had been cleaned from the right spindle, though he did comment that when grease was applied through the grease nipple, surplus grease was only seen to come out of the outside edge of the spindle. Following the replacement of all three screw jacks and the nose leg locking rod, the landing gear was cycled satisfactorily using the original gearbox and electrical motor.
