No: 1/89

Ref: EW/C1092

Beechcraft B 76 Duchess, G-BNTT

Location: Glenrothes airport, Fife

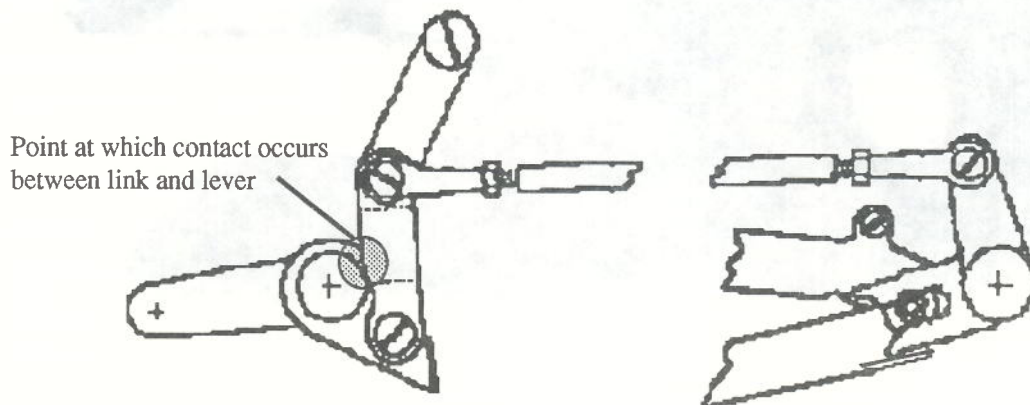
It was discovered that the tendency for the pin to pass the fork arose from higher than expected loads between the drive pin and the fork. These were caused by fouling between the lower scissor link and the arm on the door operating shaft at an intermediate position during the door operating sequence, (see Fig 2 of door operating mechanism) which prevented normal movement of the scissor link pair. These loads exploited lateral flexibility of the forked bellcrank support structure which, when combined with poor lateral engagement of the drive pin in the fork, allowed the fork to move sufficiently outboard to permit the pin to pass the fork.

Fig. 2 Gear nearly up - doors nearly closed Point at which door mechanism becomes stiff

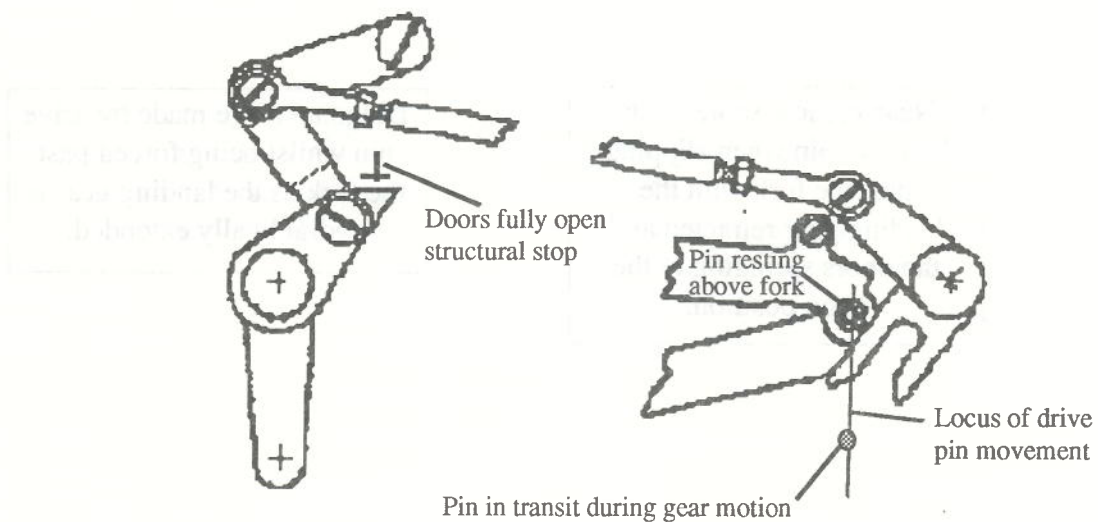
Although the Beechcraft Class 1 Service Instruction No. 1209 had been complied with and the rigging of the NLG door operating mechanism was correct, it was possible for a situation to arise where the nose gear was retracted but its doors and their operating mechanism were in the open position. Witness marks on the inboard face of the door operating forked bellcrank lever (see photograph) showed that the drive pin on the drag brace knee had slipped past the fork on several occasions and had subsequently been forced back past the fork during gear extension. If the gear door drive pin slips past the mechanism drive fork during the retraction cycle, it becomes lodged above it. Under these circumstances, the NLG doors are spring driven to the open position and the door operating mechanism then rests on the open limit stop. Thus when the pilot next attempts to lower the landing gear , the NLG door drive pin on the drag brace knee is forced against the top of the fork, which cannot move away in a normal pivoting movement. (see Fig 3 of door operating mechanism)

Fig. 3 Doors open In this position, the door linkage operating shaft cannot rotate anti-clockwise, any further

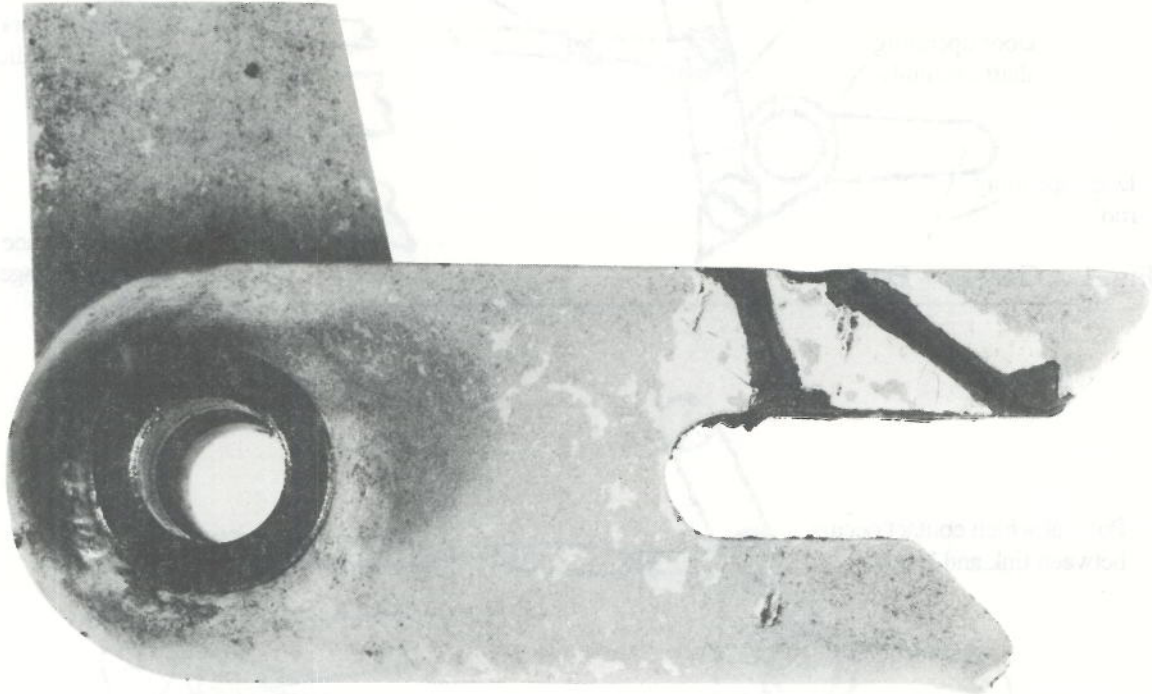
**Inboard face of nose landing gear door operating forked lever
from Beechcraft B76 Duchess**

Near vertical score made by drive pin when slipping past the fork with the landing gear retracted and the doors springing to the open position.

Diagonal score made by drive pin whilst being forced past the fork as the landing gear is hydraulically extended.
