**AAIB Bulletin No: 9/95**

**Ref: EW/G95/06/23**

- i) Jodel D117, G-ATIZ
- ii) Piper PA-28-180 Cherokee, G-ATLW

Leicester Airport

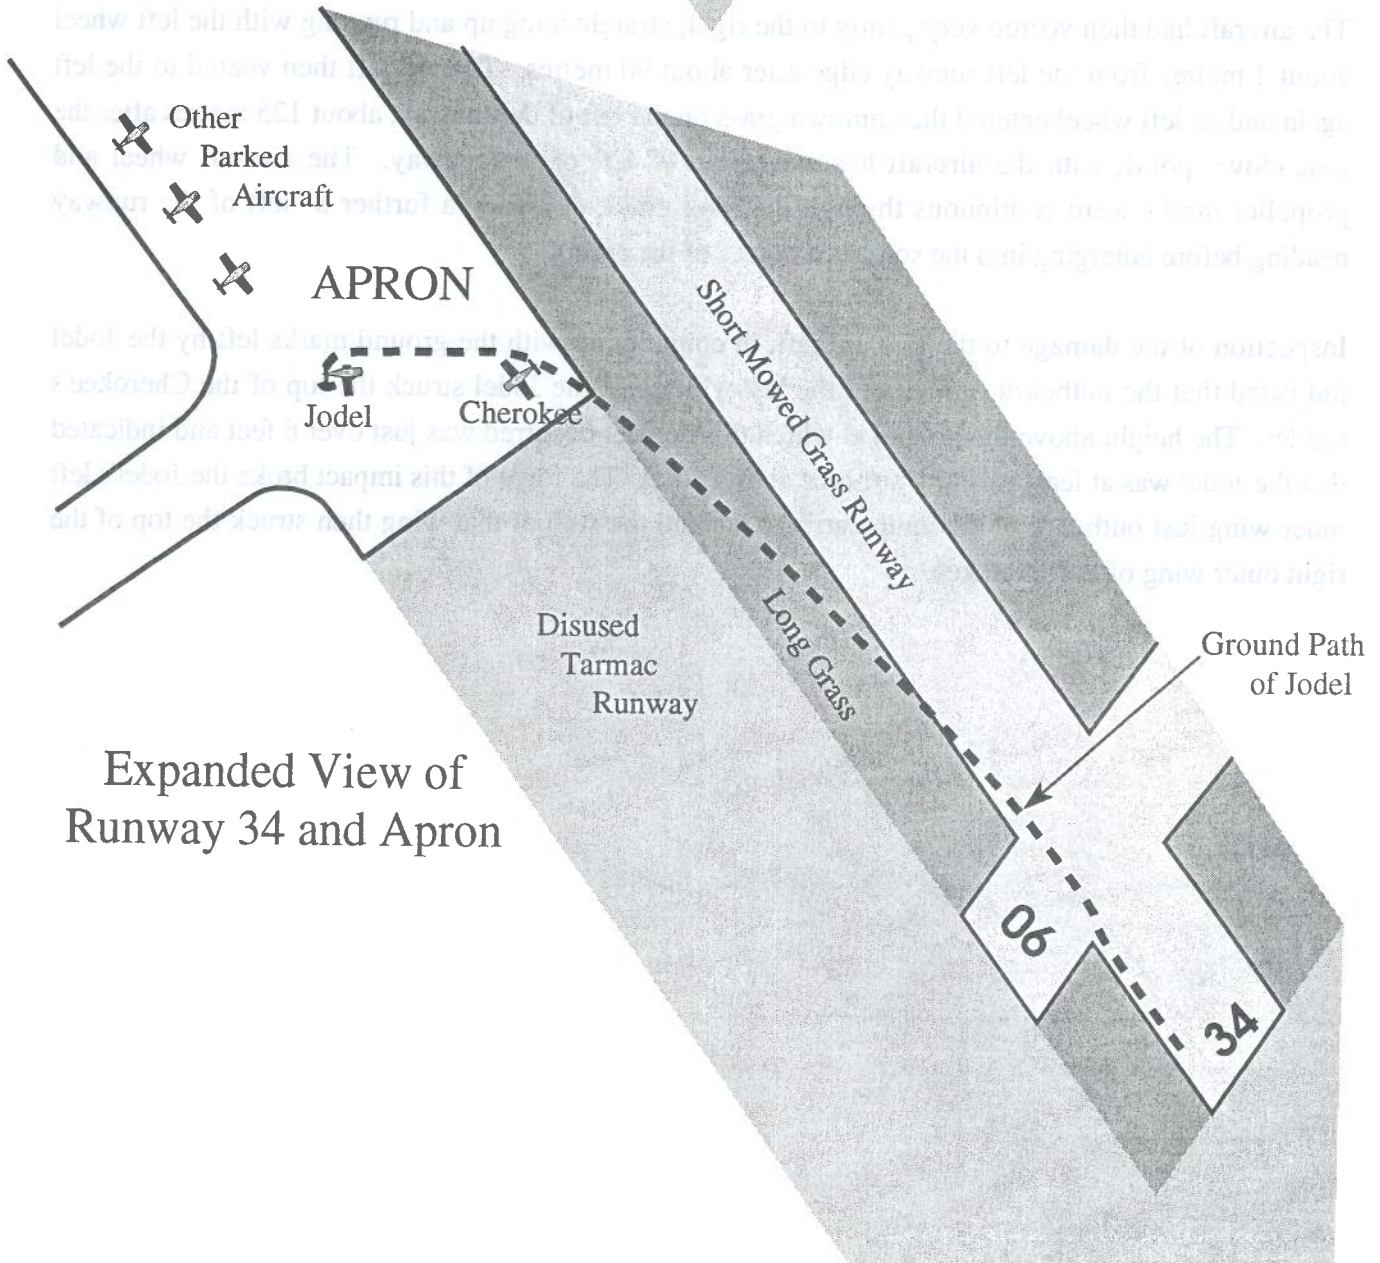
An inspection of the airfield was made and it was possible to trace a continuous wheel track back from the point of collision to the touchdown point on the runway. This showed that the Jodel landed with its left wheel within 2 metres of the left edge of the runway, level with the top of the runway numbers. The aircraft had then veered very gently to the right, straightening up and running with the left wheel about 4 metres from the left runway edge after about 90 metres. The aircraft then veered to the left again and its left wheel entered the unmown grass on the left of the runway, about 125 metres after the touchdown point, with the aircraft heading about 9° left of the runway. The aircraft wheel and propeller marks were continuous through the long grass, deviating a further 8° left of the runway heading before emerging into the southeast corner of the apron.

Expanded View of  
Runway 34 and Apron
