No: 4/91

Ref: EW/G89/08/12

Aircraft Type and Registration: Piper PA-34-200-2 Seneca, G-BACB

Location: Stansted Airport, Essex

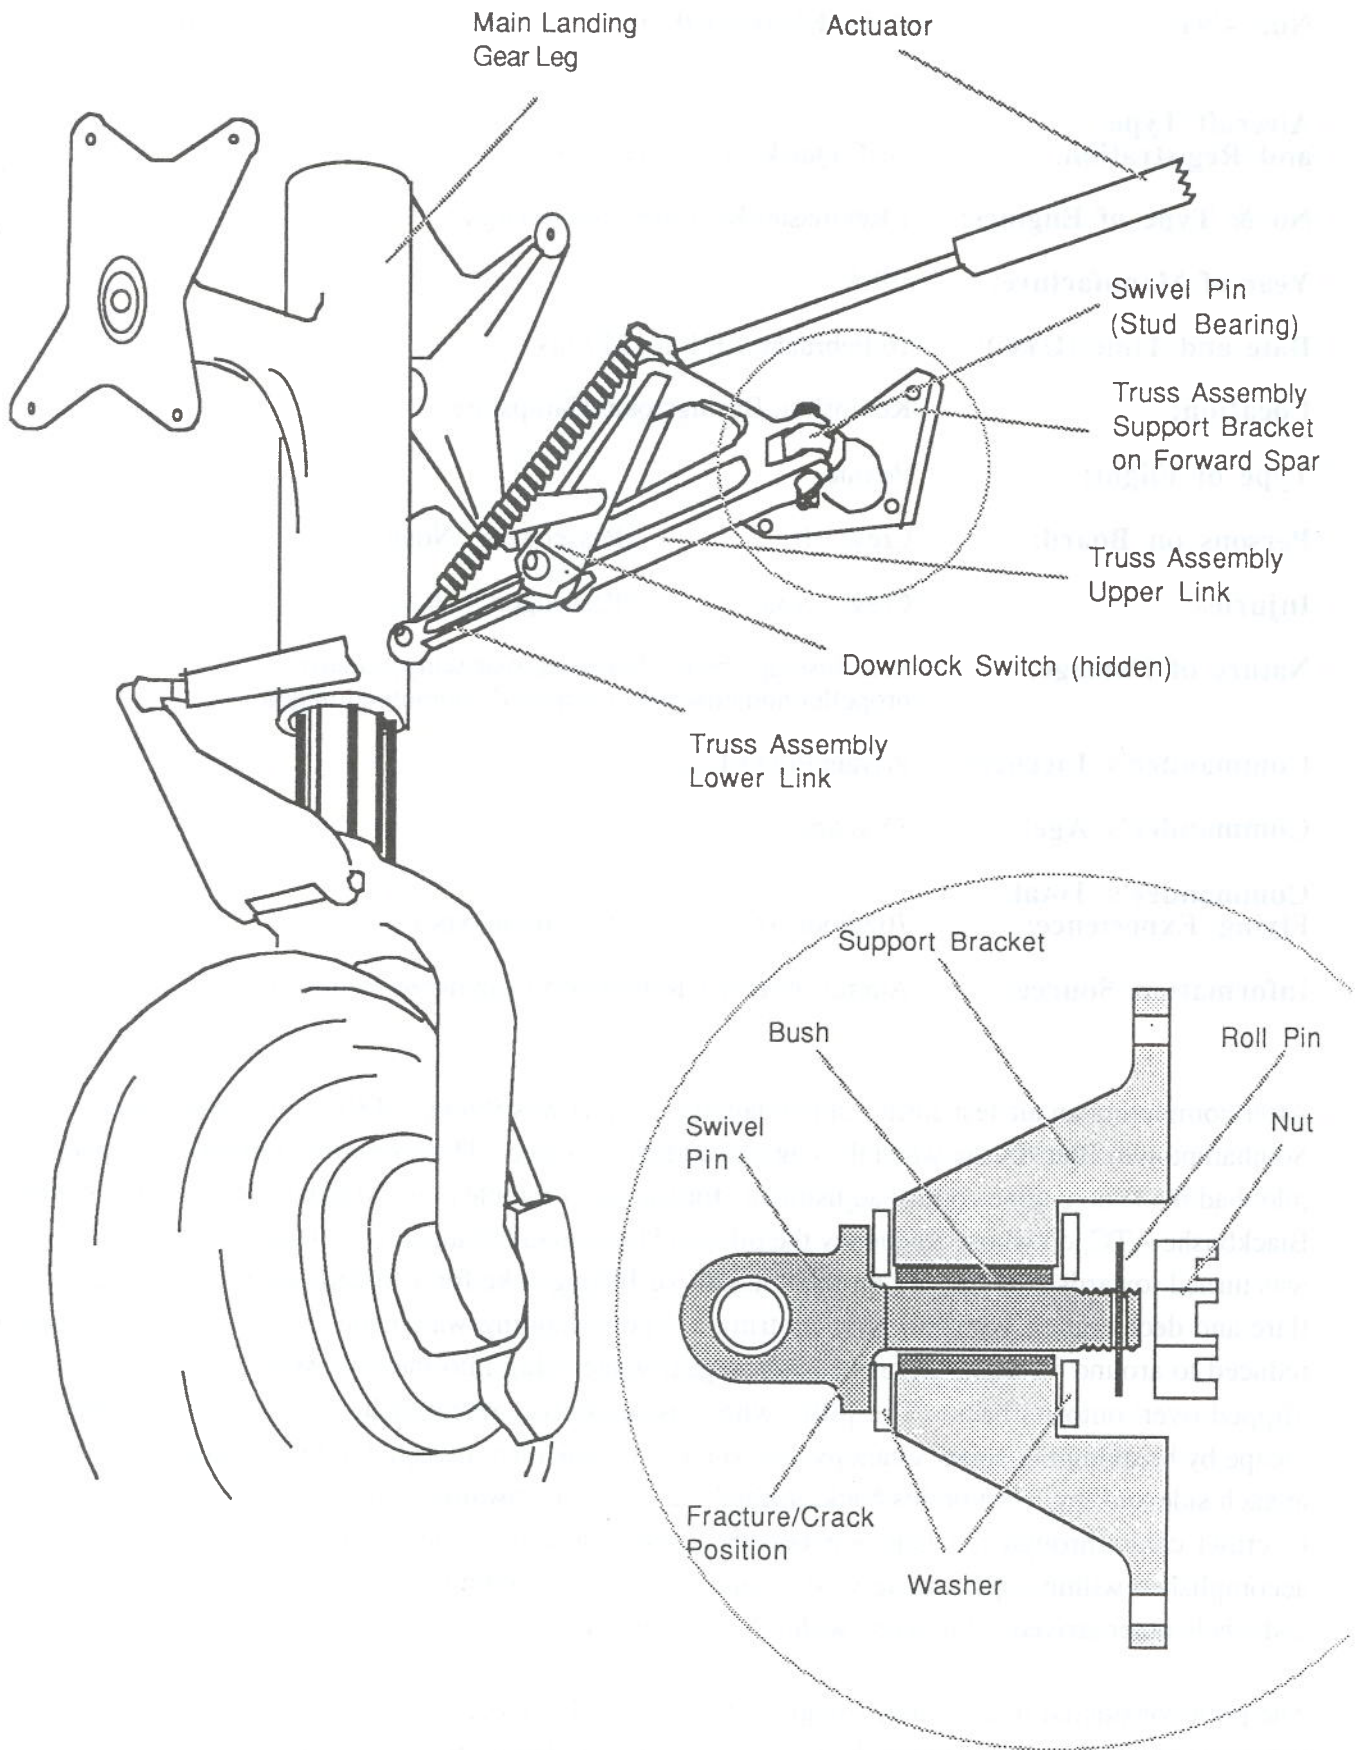
Inspection of the aircraft revealed that a swivel pin (or stud bearing) forming part of the left main landing gear truss assembly (or side stay) had failed (see fig. 1). The truss assembly, consisting of two overcentre links, was intended to hold the landing gear leg in the downlock position by bracing the leg to a truss assembly support bracket bolted to the forward spar. The swivel pin formed the attachment between the truss and the bracket. To cater for landing gear retraction, the swivel pin was allowed to pivot in a boss formed on the bracket and was retained by a castellated nut secured with a roll pin. A steel bush was fitted in the bore of the boss and a plain washer was fitted on either side. The boss incorporated a lubricator fitting (grease nipple). The bracket, with swivel pin fitted, was listed in the Piper Parts Catalogue as a single item, Part No. 95643-06 for the left main landing gear and Part No. 95643-07 for the right gear. Similar components are used on the Piper PA-28R and PA-32R models.

The swivel pin had fractured at the point where a blending radius under the head joined the shank, corresponding approximately to the assembled position of the edge of the bracket bush. The surface of the shank normally in contact with the bush was heavily pitted. Metallurgical examination indicated that the fracture had resulted from fatigue. A multi-origin fatigue crack had grown from the inboard and outboard edges of the shank (as installed) to form two crescent shaped cracks extending across approximately 25% of the cross-sectional area of the shank. The remaining 50% of the section had failed in fast fracture fatigue, over a few cycles. Markings indicated that the primary cracks had originated from corrosion pits in the surface of the shank, and had grown over a large number of cycles. Insufficient evidence was available to enable the number to be quantified, or to establish the events that had constituted a cycle.

The maintainer undertook an inspection of the swivel pin from the right main landing gear and assessed that this was cracked on both sides, in similar positions to the failed pin from the left gear. Detailed metallurgical examination confirmed the presence of two large cracks.

The aircraft had accumulated 3895 flying hours since new, and records did not indicate that either swivel pin or truss assembly support bracket had been replaced in this time. The number of landings made by the aircraft was not recorded. The Piper Service Manual schedules lubrication of the swivel fitting at 100 hour intervals, but the landing gear was maintained 'On Condition' and there is no requirement for inspection of the fitting. It has been recommended to the Civil Aviation Authority that consideration be given to requiring a periodic check of the swivel pin. It is estimated that such a check should require approximately 2 man-hours per aircraft.
