AAIB Bulletin No: 11/95

Ref: EW/G95/06/09

Aircraft Type and Registration: Beech B60 Duke, N1024L

Location: Liverpool Airport

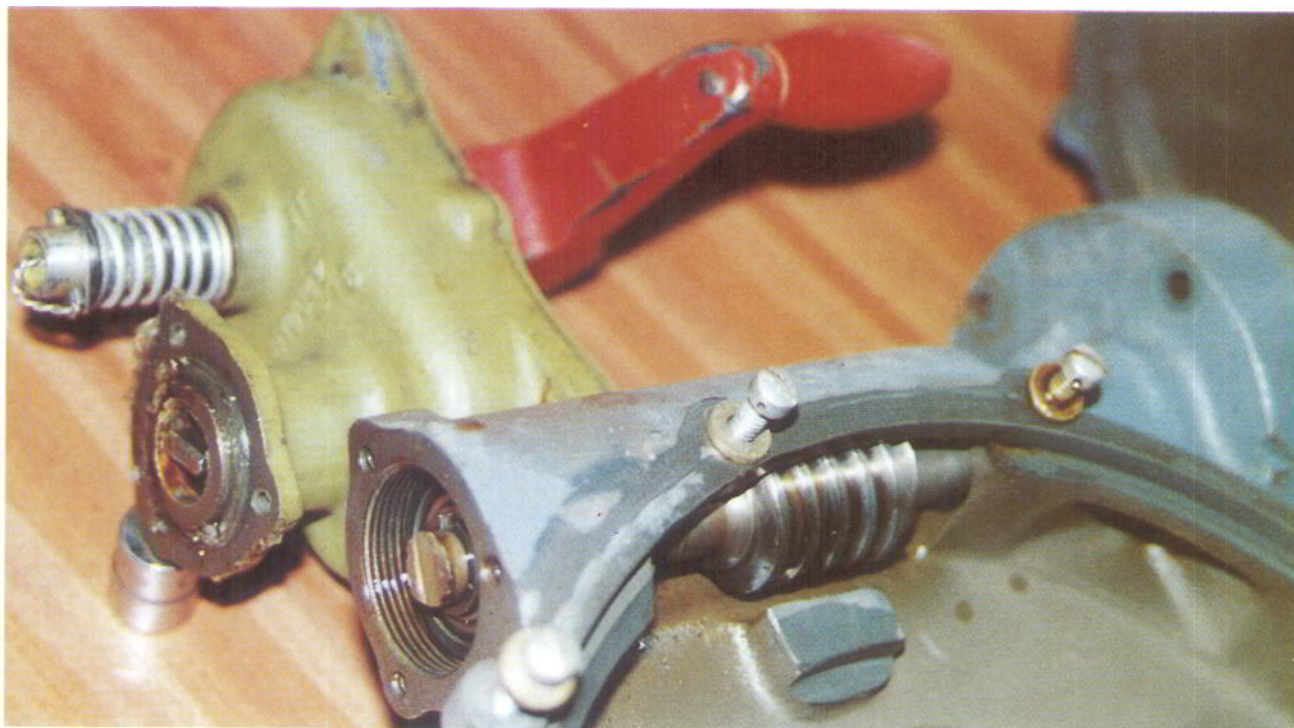
The landing gear had retracted on touchdown as landing loads buckled the actuating rods in the extension system. The downlocks were undamaged and it appeared that the gear had been almost fully deployed but without the downlocks engaged. A rigging check has not been possible because of the deformation in the system. Further investigation revealed that the electrical motor driving the retraction/extension system was unserviceable; one brush was severely worn, with less than 1 mm extension. (It was also found that the nose gear green indicating light had failed though it had been serviceable during the flight.) The manual extension system had failed to operate because the slot in the end of the worm gear shaft which was normally engaged by a key in the end of the manual drive output shaft had become so eroded by wear that the slot had ceased to exist (Photo). No other defect was found in the landing gear actuator that could have contributed to the deterioration of the slot end on the worm gear shaft. The Manufacturer's Maintenance Manual schedules overhaul or replacement at 4,000 hour for the actuator or "on condition". The aircraft had completed 4,354 operating hours.

**N1024L - Landing gear actuator worm gear shaft and manual drive gearbox
(Showing eroded end of worm gear shaft)**
