ACCIDENT

| Aircraft Type and Registration: | Zenair CH 601HD Zodiac, G-BVPL | |

Synopsis

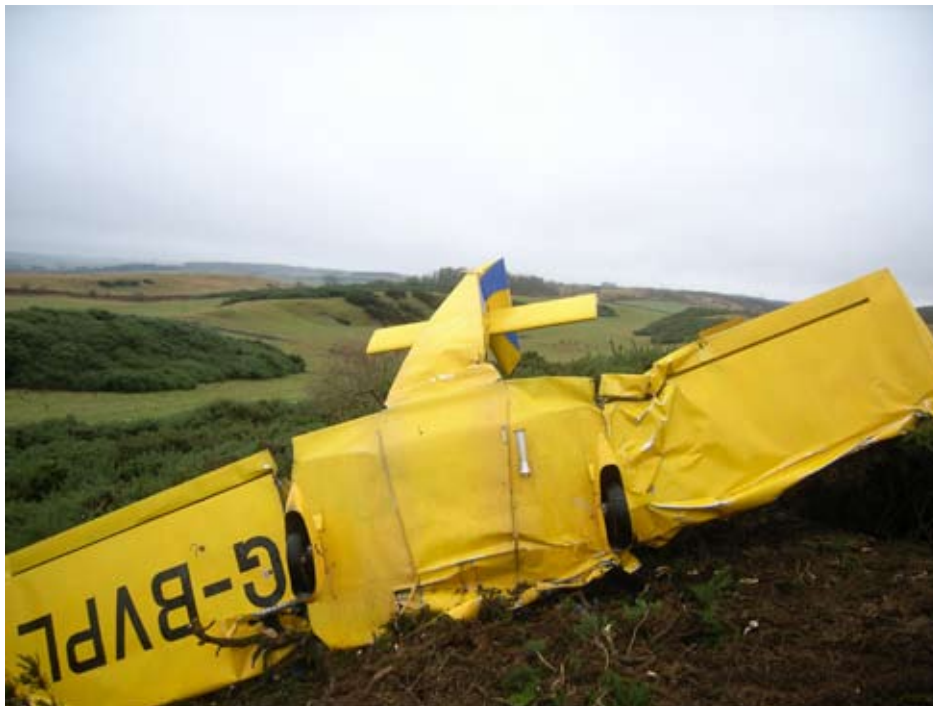
Figure 1

The aircraft had come to rest nose-down in a gorse thicket on the summit of a small hillock. There were no witness marks on the land surrounding the thicket to indicate that the aircraft had touched down prior to the thicket. The gorse bushes surrounding the aircraft were undamaged. After clearing the gorse to allow access, examination revealed that the right wing had been subject to a relatively uniform load which had crushed the leading edge, Figure 1; its inboard trailing edge section and aileron had been buckled under a compressive load. The left wing exhibited two areas of damage to the leading edge, one just outboard of the left main landing gear, caused by impact with a large gorse bush, the other the left wingtip, which had been subject to a significant impact. The rear section of the left wing, outboard of the landing gear, had been

Photograph illustrating impact damage to the wings and forward fuselage

pulled away from the inboard section of the wing and the rear fuselage and tail had been bent upwards and to the right. The main landing gear was undamaged and no evidence was found to indicate that they had made contact with either the gorse or the surrounding field prior to the impact. The engine had been pushed upwards and rearwards, causing severe damage to the bulkhead and the forward area of the cockpit.

The damage to the aircraft was consistent with it being in a nose-down attitude, and travelling at a relatively high speed, when it struck the ground. It appeared to have made contact initially with the gorse with its left wing tip, which resulted in it rotating about the left wing and causing the nose and the right wing leading edge to strike the ground heavily. The witness marks found on the artificial horizon gyroscope confirmed that it had been spinning and that the instrument was probably operating correctly when the aircraft struck the ground. The setting of 1008 hPa on the altimeter subscale would, given the atmospheric pressure in the region at the time of the accident, have been appropriate for operation from Midlem airstrip.

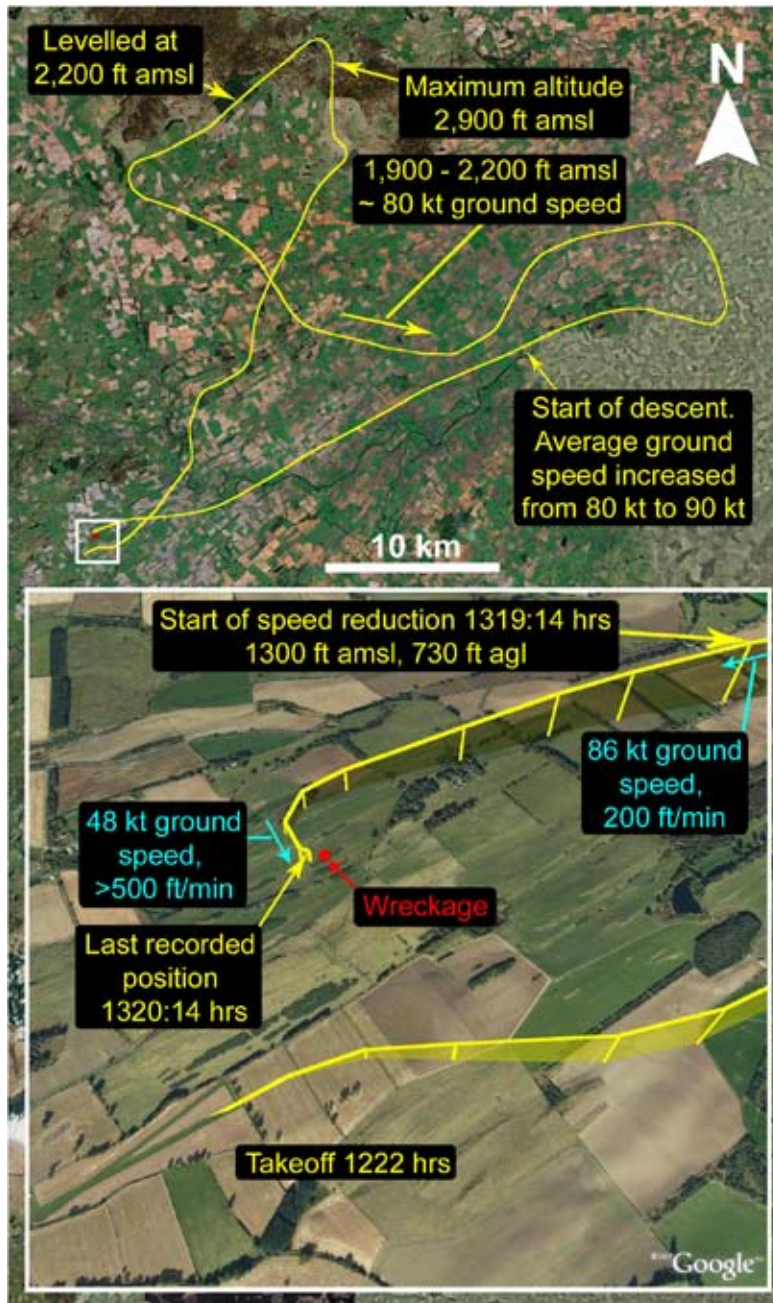
Figure 2

The aircraft departed from Midlem airstrip at 1222 hrs and carried out the flight as shown in Figure 2. As it returned to the airstrip, the recording showed a slow descent starting at 2,200 ft amsl, 28 km from the runway, which averaged around 100 ft/min. Approximately 2.5 km from the airstrip, on a track not in-line with

the runway, the descent rate started to increase and the ground speed, which had been steady at approximately 90 kt, started to reduce. Between 44 and 49 seconds later, a left turn was initiated during which the ground speed reduced to 48 kt. This was followed, during the last five seconds, by an increase in ground speed.

The recorded track ended just short of the wreckage site. The derived altitude rate indicated a steady descent rate of approximately 500 ft/min. However, whilst the lateral manoeuvre described by the last few points of the track were consistent with reaching the wreckage point before the next GPS track sample could be recorded, the derived altitude rate is inconsistent with this, requiring a doubling of the descent rate after the track finished and before impact. GPS vertical accuracy is not as good as its lateral accuracy under normal conditions. During the final turn, the GPS would have been losing and reacquiring use of satellites, as the right wing effectively blocked the signal path of satellites near to the horizon. These factors make the final trend in derived altitude rate unreliable. It is likely that the average descent rate was nearer to 1,000 ft/min during the final turn and that the GPS track terminated within approximately one second of the impact.

The GPS recorded flight path appears to show a descending turn as the final flight manoeuvre. This may have simply been, for example, the pilot's attempt to turn back into what little wind there was in order to carry out a forced landing. However, had significant reduction in the available power occurred, this would have removed an option for the pilot to fly to a landing area with better weather and escape from conditions that may have been unsuitable for visual flight.
