AAIB Bulletin No: 7/93

Ref: EW/G93/03/14

Aircraft Type and Registration: Taylor Monoplane, G-BDNC

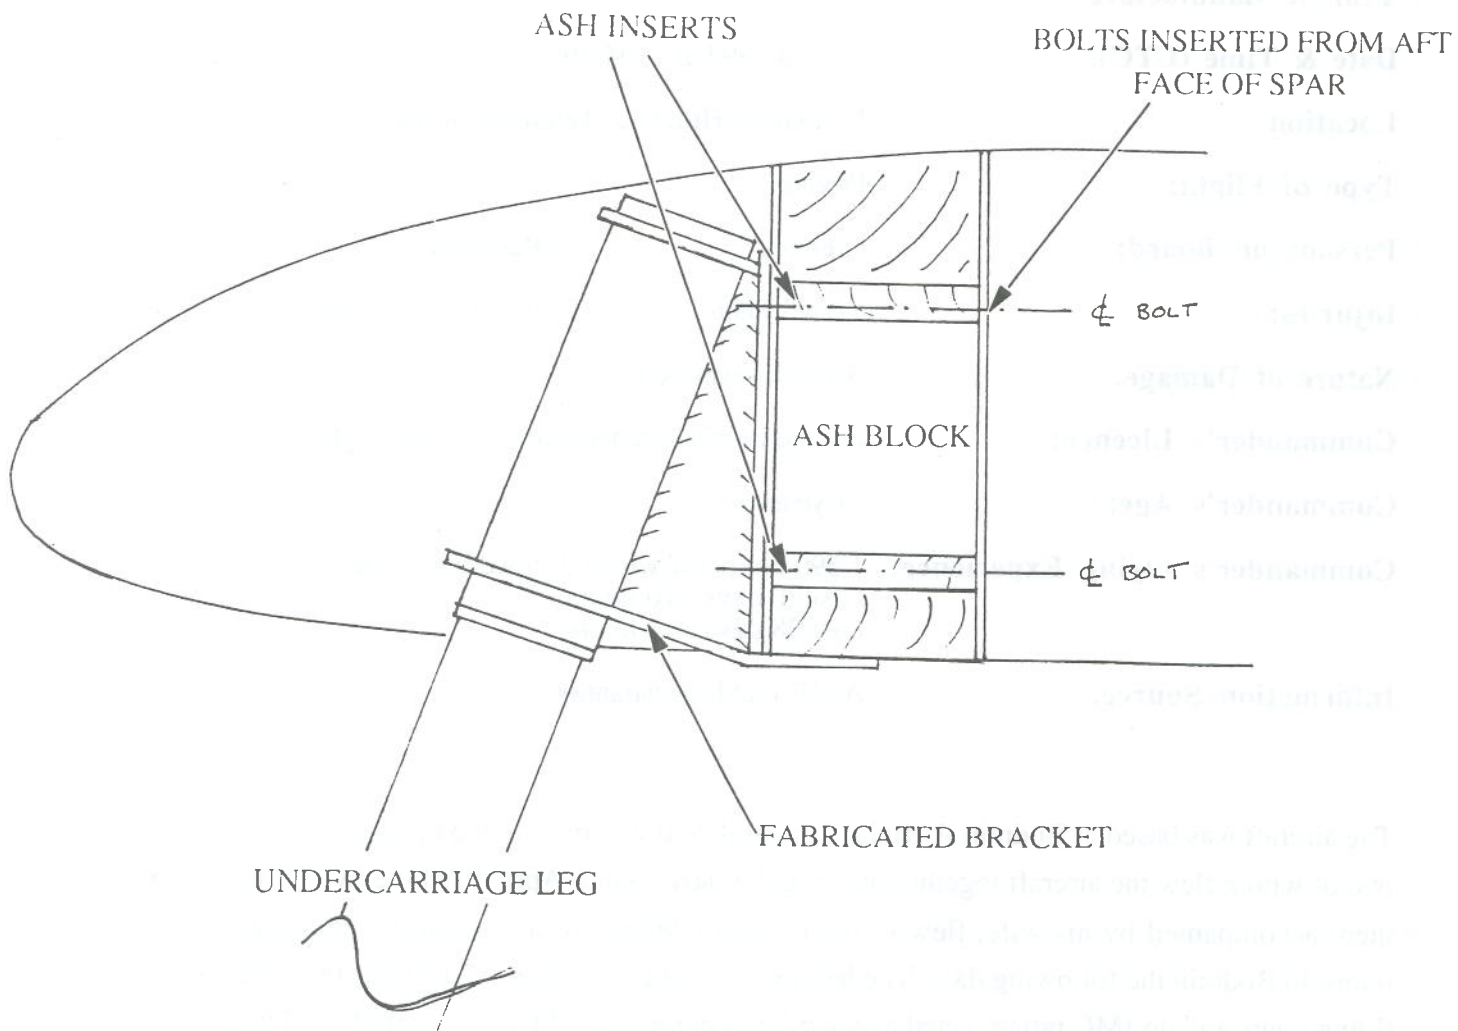
TAYLOR MONOPLANE G-BDNC, DIAGRAM SHOWING ATTACHMENT OF MAIN LANDING GEAR TO WING SPAR

The Taylor monoplane plans showed that the landing gear leg was attached to the front spar by a fabricated bracket bolted through the spar with four 5/16 inch diameter bolts and nuts (see diagram). Examination revealed that the lower pair of bolts had broken at the point where the bolt entered the nut, allowing the bracket to bend around the upper two bolts as the leg folded forwards.

Metallurgical examination showed that the failed bolts had evidence of fatigue damage both on the fracture surface and in the root of other threads. Fatigue had also initiated in one of the upper bolts. The nature of the fatigue showed that it arose primarily from plain bending loads with one or two static 'jumps' indicating heavy landings. It was also noted that the two plate washers from the failed bolts were dished, suggesting that the wooden structure had collapsed locally underneath. If this occurred

during initial tightening, then it could have allowed loosening of the assembly and movement of the bolts. Some thread wear was found to indicate that such movement had occurred.

Discussions with the organisation charged with repairing the aircraft revealed that the ash spar inserts called-up on the construction drawing appeared to be of soft wood on G-BDNC. It had also been flown relatively more intensely than is usual with this class of aircraft.

The metallurgist points out that thicker washers would have spread the load more evenly and that it would have been advantageous to have inserted the bolts from the front of the spar, given that the bolts were not loaded in pure tension.
