No: 9/90

Ref: EW/C1159

Aerospatale AS332L, G-PUMA

Fire damage to rotor brake, transmission bay and sliding cowling

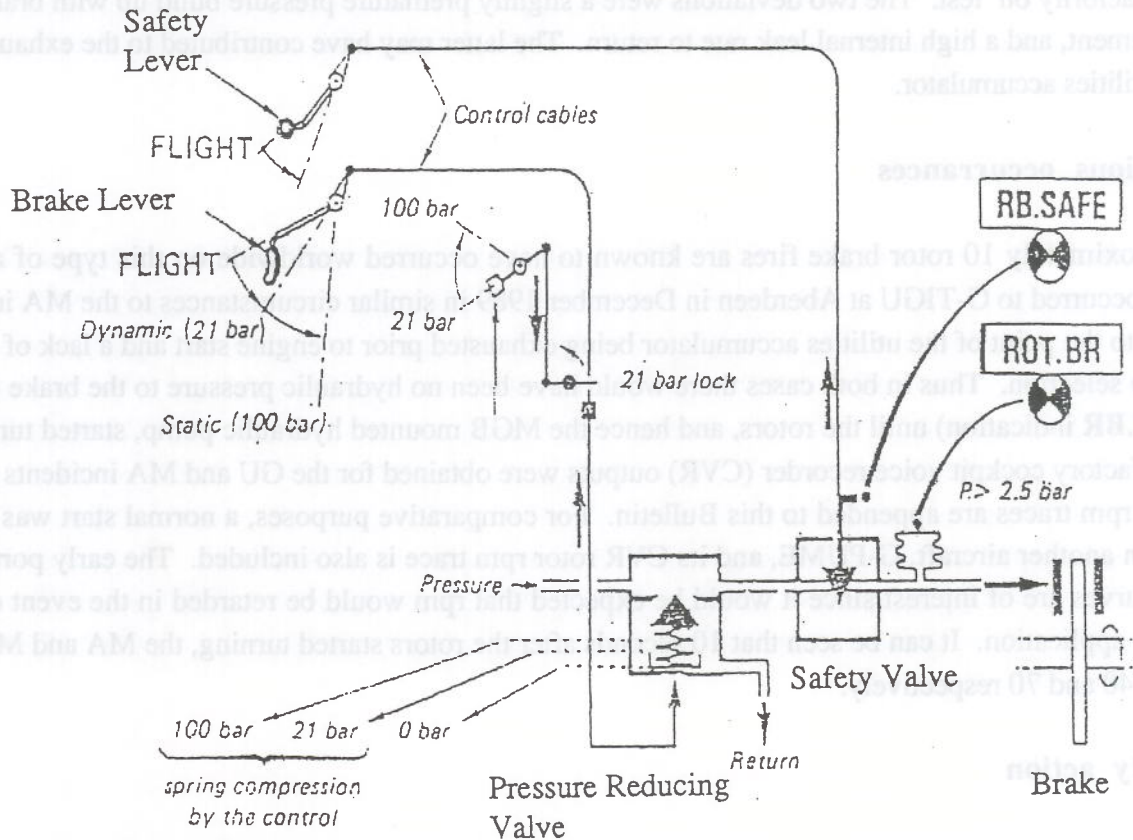
AS332 Brake System Schematic

A schematic of the operating system is shown in the attached Figure and it can be seen that it consists of two levers, mounted on the overhead panel close to the top of the windscreen, operating on a

pressure reducing valve and a safety valve respectively. When the Safety Lever is in the "Flight" (ie fully forward) position, the safety valve is closed which allows no pressure to the brake unit even if the Brake Lever should inadvertently be pulled. When the Safety Lever is in the "Ground" (ie fully back) position, the **RB.SAFE** caption is illuminated, meaning that the Brake Lever can now be applied. Brake pressure progressively increases with lever movement up to the 21 bar detent. Further movement to the 100 bar detent is inhibited by a baulk which can only be removed by operation of an additional lever on the bulkhead behind the pilot. The latter position is used to maintain the rotors stationary whilst both engines are started in high wind conditions; brake release then results in rapid rotor spin-up, reducing the possibility of blade sailing.

A pressure switch illuminates a **ROT.BR** caption when the pressure in the brake line exceeds 2.5 bar.
