# AAIB Bulletin S2/2011

### SERIOUS INCIDENT

<b>Aircraft Type and Registration:</b>	Britten-Norman BN2A-26, Islander, VP-MON
<b>No &amp; Type of Engines:</b>	2 Lycoming O540 piston engines
<b>Year of Manufacture:</b>	Not known
<b>Date &amp; Time (UTC):</b>	22 May 2011 at 2154 hrs
<b>Location:</b>	John A Osborne Airport, Montserrat
<b>Type of Flight:</b>	Commercial Air Transport (Passenger)
<b>Persons on Board:</b>	Crew - 1                      Passengers - 7
<b>Injuries:</b>	Crew - None                      Passengers - None
<b>Nature of Damage:</b>	None
<b>Commander's Licence:</b>	Commercial Pilot's Licence
<b>Commander's Age:</b>	34 years
<b>Commander's Flying Experience:</b>	3,600 hours (of which 2,000 were on type) Last 90 days - 13 hours Last 28 days - 13 hours
<b>Information Source:</b>	AAIB Field Investigation

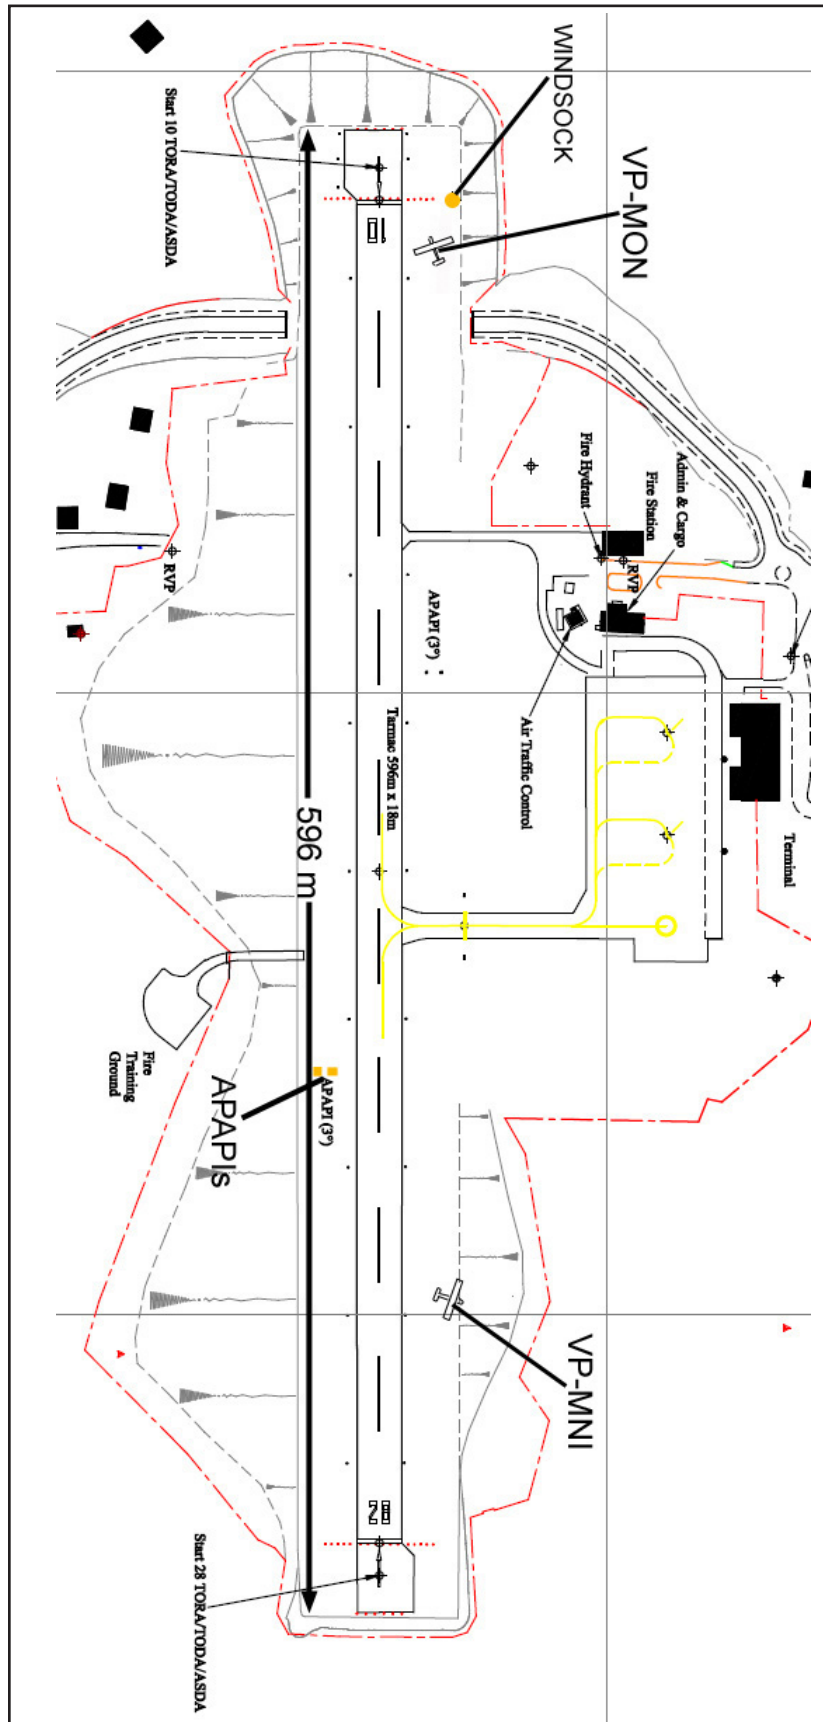
The runway was inspected by the AIM and latterly by the AAIB. They noted a skid mark approximately 24 m long made by the aircraft’s right main tyres that started approximately 191 m from the beginning of the paved area of Runway 28 (163 m from the threshold), 12 m before the Runway 28 APAPIs.

The aircraft’s tyre marks continued along the runway until the left and right tyre marks left the paved surface about 115 m and 148 m from the end of the paved surface respectively.

There are no overrun areas on either runway. At the end of each runway is a vertical drop in excess of 200 ft. See Figure 1 for a diagram of the airfield.

There is one windsock located to the north of the Runway 10 threshold.

The operator of John A Osborne Airport, Montserrat, should install a windsock and anemometer adjacent to the Runway 28 threshold.
