No: 4/92

Ref: EW/G92/01/01

Aircraft Type and Registration: Cessna 421, N41098

Nature of Damage: Right main landing gear, wing undersurface and propeller damaged, right engine shock loaded

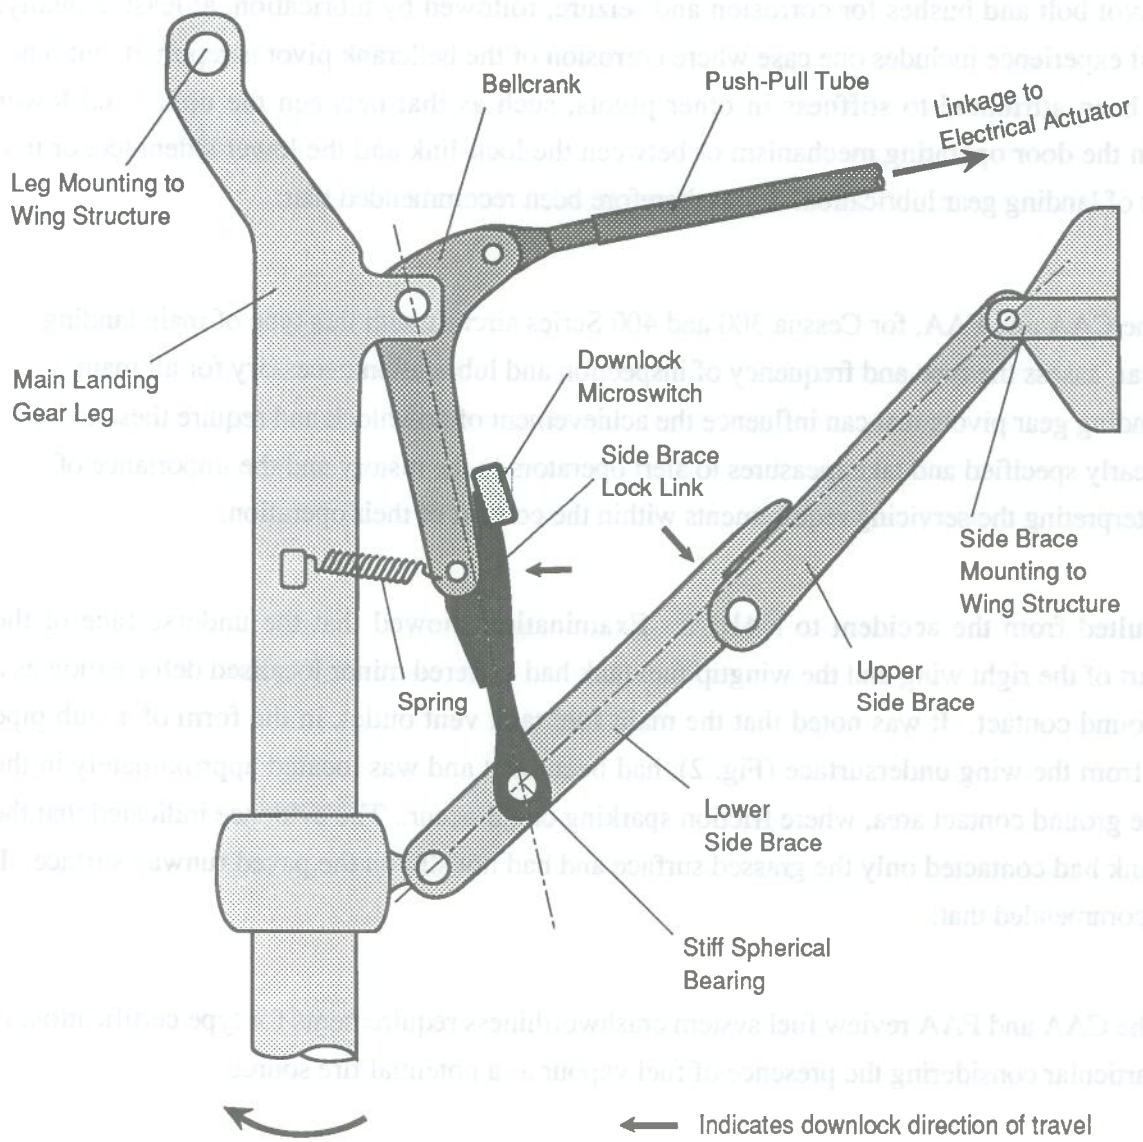
Fig 1

Each main landing gear leg of the Cessna 421 is mounted on trunnions carried on the forward and aft wing spars and retracts by pivoting inboard about a fore-aft axis. Lateral support for the leg on this earlier version of the aircraft is provided by a two piece sidebrace. In the locked down position (Fig. 1) upper and lower sidebraces are held overcentred by a lock-link that is driven by a bellcrank. The bellcrank pivots on a bolt located in a pair of lugs on the main leg, and is operated by an electric actuator via a mechanical drive system. When the gear is in the locked down condition, the linkage formed by the lock-link and bellcrank is itself held overcentred by forces applied by the actuator drive system and by a light spring.

Inspection of N41098 showed that fracture of the bellcrank, the bellcrank pivot bolt and one of the bellcrank pivot bolt lugs had occurred. The characteristics indicated that all of the failures had resulted from overload, and no evidence of any pre-existing defect was found. An appreciable amount of play was present in many of the downlock mechanism pivots. In addition, the spherical bearing in the rod end of the lock-link, forming the pivot between the lock-link and the lower side brace, was found to be dry and somewhat corroded and very stiff. The torque required to pivot the lock-link when orientated in the position that it assumes as the gear locks down was measured as 13 lbf-ft. The stiffness would have resisted the overcentring of the lock-link/bellcrank linkage that constituted the final part of the gear downlocking sequence. Failure of the linkage to overcentre would prevent the downlock microswitch from operating and would remove the normal sidebrace lock and could prevent the sidebrace itself from overcentring. In this condition, sideloads on the wheel would be reacted through the retraction mechanism. The failures were consistent with the effects of such a situation.

The lock-link rod end spherical bearing is not provided with means for pressure lubrication. A Lubrication Diagram in the Cessna 421 Service Manual (Section 2-60, Figure 2-37, Sheet 6) includes a note to 'lubricate all spherical rod ends with a mixture of low temperature aircraft lubricating grease and moly-kote', but does not specify a frequency for this operation. The frequencies of other operations called for on this Diagram are specified.

available evidence indicated that most of these accidents resulted from stiffness in various pivots in the landing gear mechanism that prevented the gear from entering downlock when extended. This was generally associated with corrosion and inadequate lubrication. Indication of the lack of downlock was given in many of the cases, but the problem was not resolved by use of the emergency manual lowering system.

CAA Airworthiness Directive 008-01-89, effective 1 February 1989, required inspection of the bellcrank pivot bolt and bushes for corrosion and seizure, followed by lubrication, at least annually. The accident experience includes one case where corrosion of the bellcrank pivot is reported, but other cases have been attributed to stiffness in other pivots, such as that between the upper and lower sidebrace, in the door operating mechanism or between the lock-link and the lower sidebrace, or to a general lack of landing gear lubrication. It has therefore been recommended that:

- 92-21** The CAA and FAA, for Cessna 300 and 400 Series aircraft with this type of main landing gear, assess the type and frequency of inspection and lubrication necessary for all main landing gear pivots that can influence the achievement of downlock and require these to be clearly specified and take measures to alert operators to the history and the importance of interpreting the servicing requirements within the context of their operation.

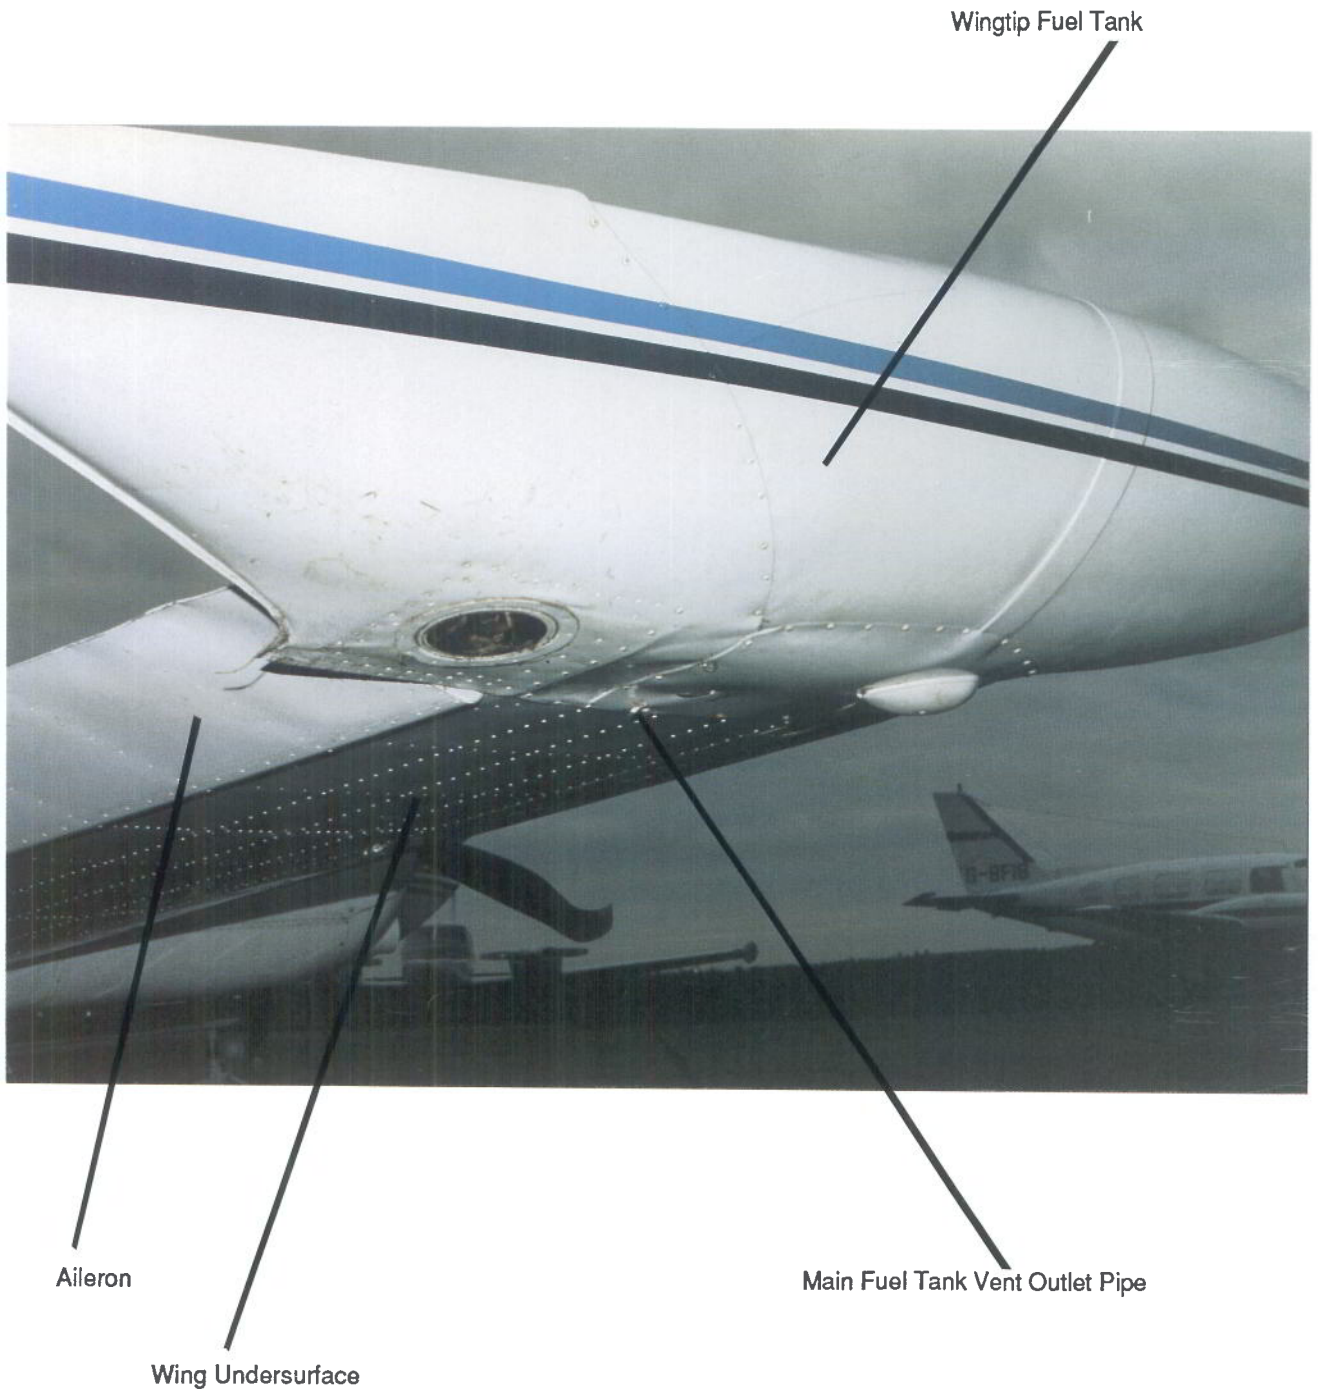
Fig 2

No fire resulted from the accident to N41098. Examination showed that the undersurface of the outboard part of the right wing and the wingtip fuel tank had suffered minor localised deformation as a result of ground contact. It was noted that the main fuel tank vent outlet, in the form of a stub pipe protruding from the wing undersurface (Fig. 2), had been bent and was located approximately in the centre of the ground contact area, where friction sparking could occur. The evidence indicated that the wing and tank had contacted only the grassed surface and had not slid on the paved runway surface. It has been recommended that:

- 92-22** The CAA and FAA review fuel system crashworthiness requirements for type certification, in particular considering the presence of fuel vapour as a potential fire source.
