**AAIB Bulletin No: 12/96**

**Ref: EW/G96/10/16**

**Aircraft Type and Registration:** Slingsby T67B Firefly, G-BLLS

**Nature of Damage:** Damage to nose landing gear and propeller

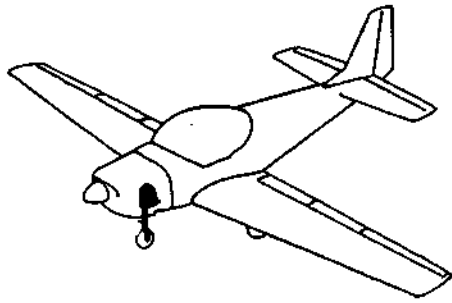
The nose gear components were forwarded to the AAIB for detailed examination. It was evident that the fracture surface at the end of the oleo strut had been ground away by the surface of the runway.

A colour photograph of the Fatigue failure can be seen in this Report on the Internet.

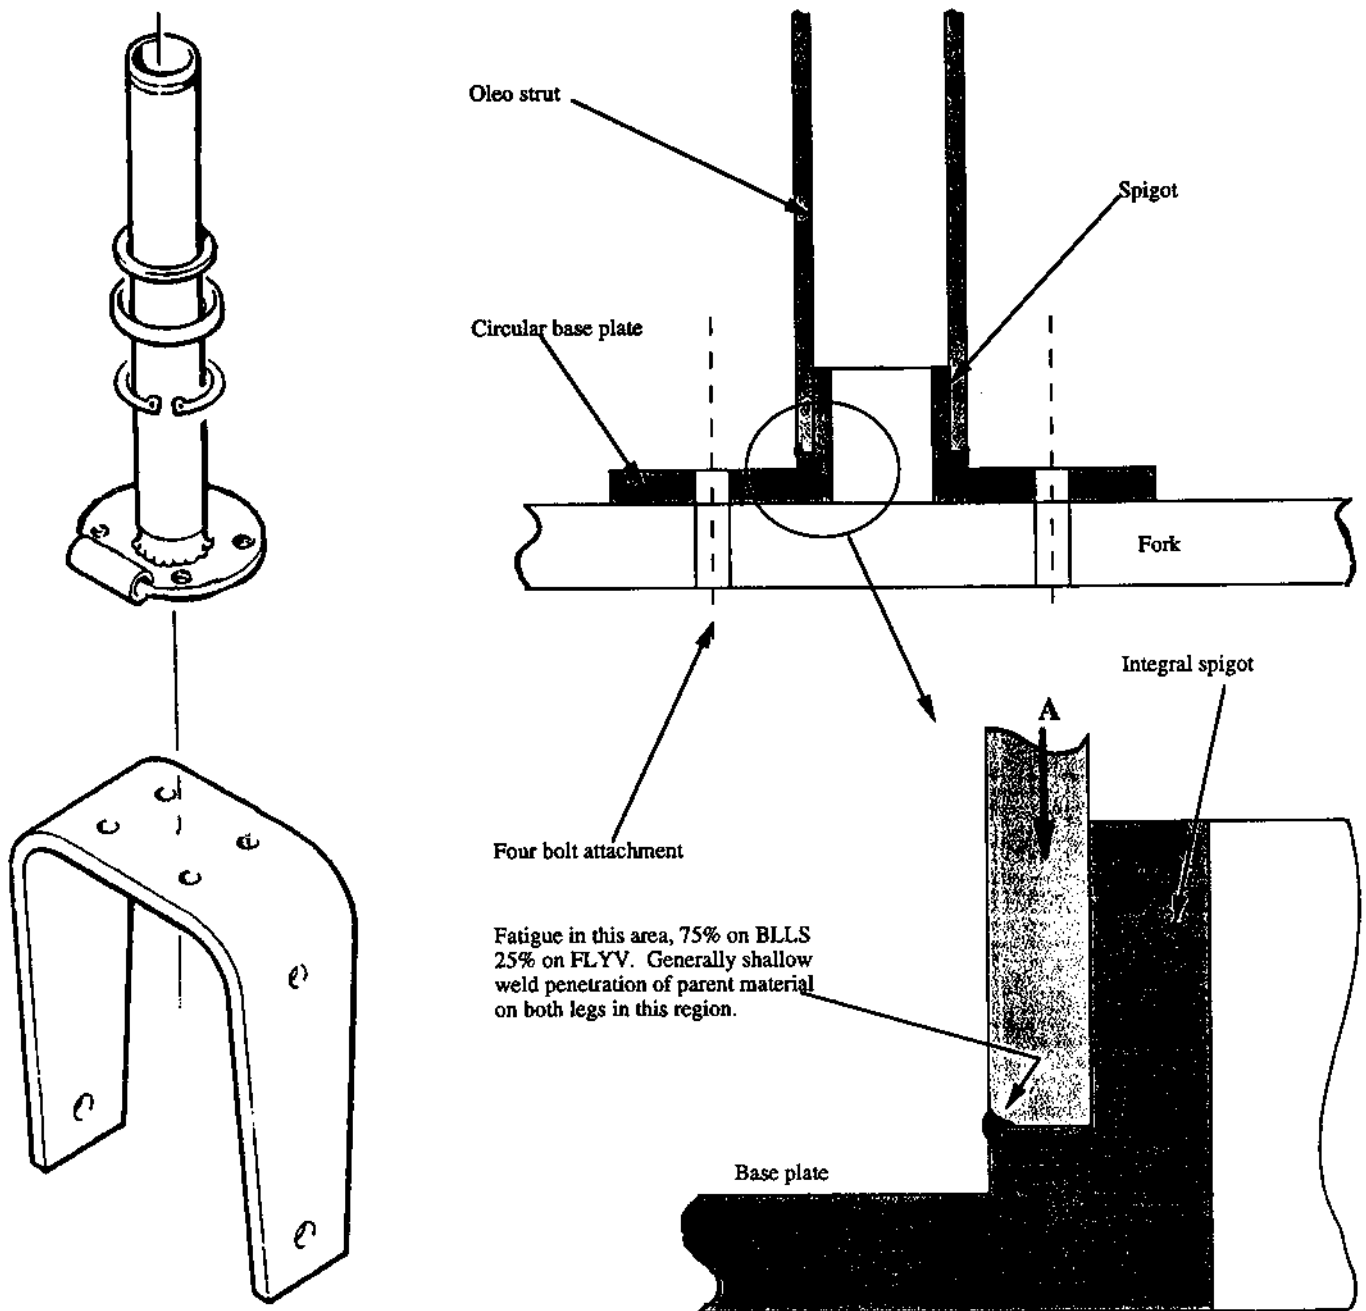
**Figure 1**

The mating fracture face, however, had survived without damage and was available for detailed examination. The nose wheel fork on this version of the T67 is attached to the lower end of the nose gear oleo strut by means of a bolted connection. As shown in Figure 1, the lower end of the strut is located over a steel spigot, which itself is part of a circular base plate, these two items being welded together in the manner indicated. Thus the plate forms a flange at right angles to the strut axis and the nose wheel fork is attached to this plate by four bolts. The failure had occurred in the area of the welded joint between the strut and spigot, metallurgical examination of the fracture face indicating that approximately 75% of the welded section had failed as a result of a tension fatigue cracking mechanism, the remainder through overload. It was noted that the fatigue cracks had originated from the inner boundary of the weld at multiple sites. It was also apparent that the weld penetration into the parent material of both strut and spigot was small in relation to the interface area. The hardness of the weld material was greatly in excess of the parent material. The parent steel material from which these items are made is welded in the 'softened' (annealed) condition. It requires heat treatment after welding to produce the required properties, in particular, within the heat affected zone adjacent to the weld. This zone can cool sufficiently quickly immediately after welding to produce untempered 'martensite', which has a hard and brittle microstructure containing high internal stresses.

**Nose Gear Lower Strut Configuration, G-BLLS**
