ACCIDENT

Aircraft Type and Registration:	Aerospatiale/Westland SA 341G Gazelle, YU-HEW	
No & Type of Engines:	1 Turbomeca Astazou IIIA turboshaft engine	
Year of Manufacture:	1977	
Date & Time (UTC):	26 January 2008 at 1625 hrs	
Location:	Rudding Park, Harrogate, North Yorkshire	
Type of Flight:	Private	
Persons on Board:	Crew - 1	Passengers - 1
Injuries:	Crew - 1 (Fatal)	Passengers - 1 (Fatal)
Nature of Damage:	Aircraft destroyed	
Commander's Licence:	Private Pilot's Licence (Helicopters)	
Commander's Age:	43 years	
Commander's Flying Experience:	853 hours (of which 56 were recorded as helicopter and 46 recorded on type - see text) Last 90 days - 46 hours Last 28 days - 1.5 hours (approx)	
Information Source:	AAIB Field Investigation

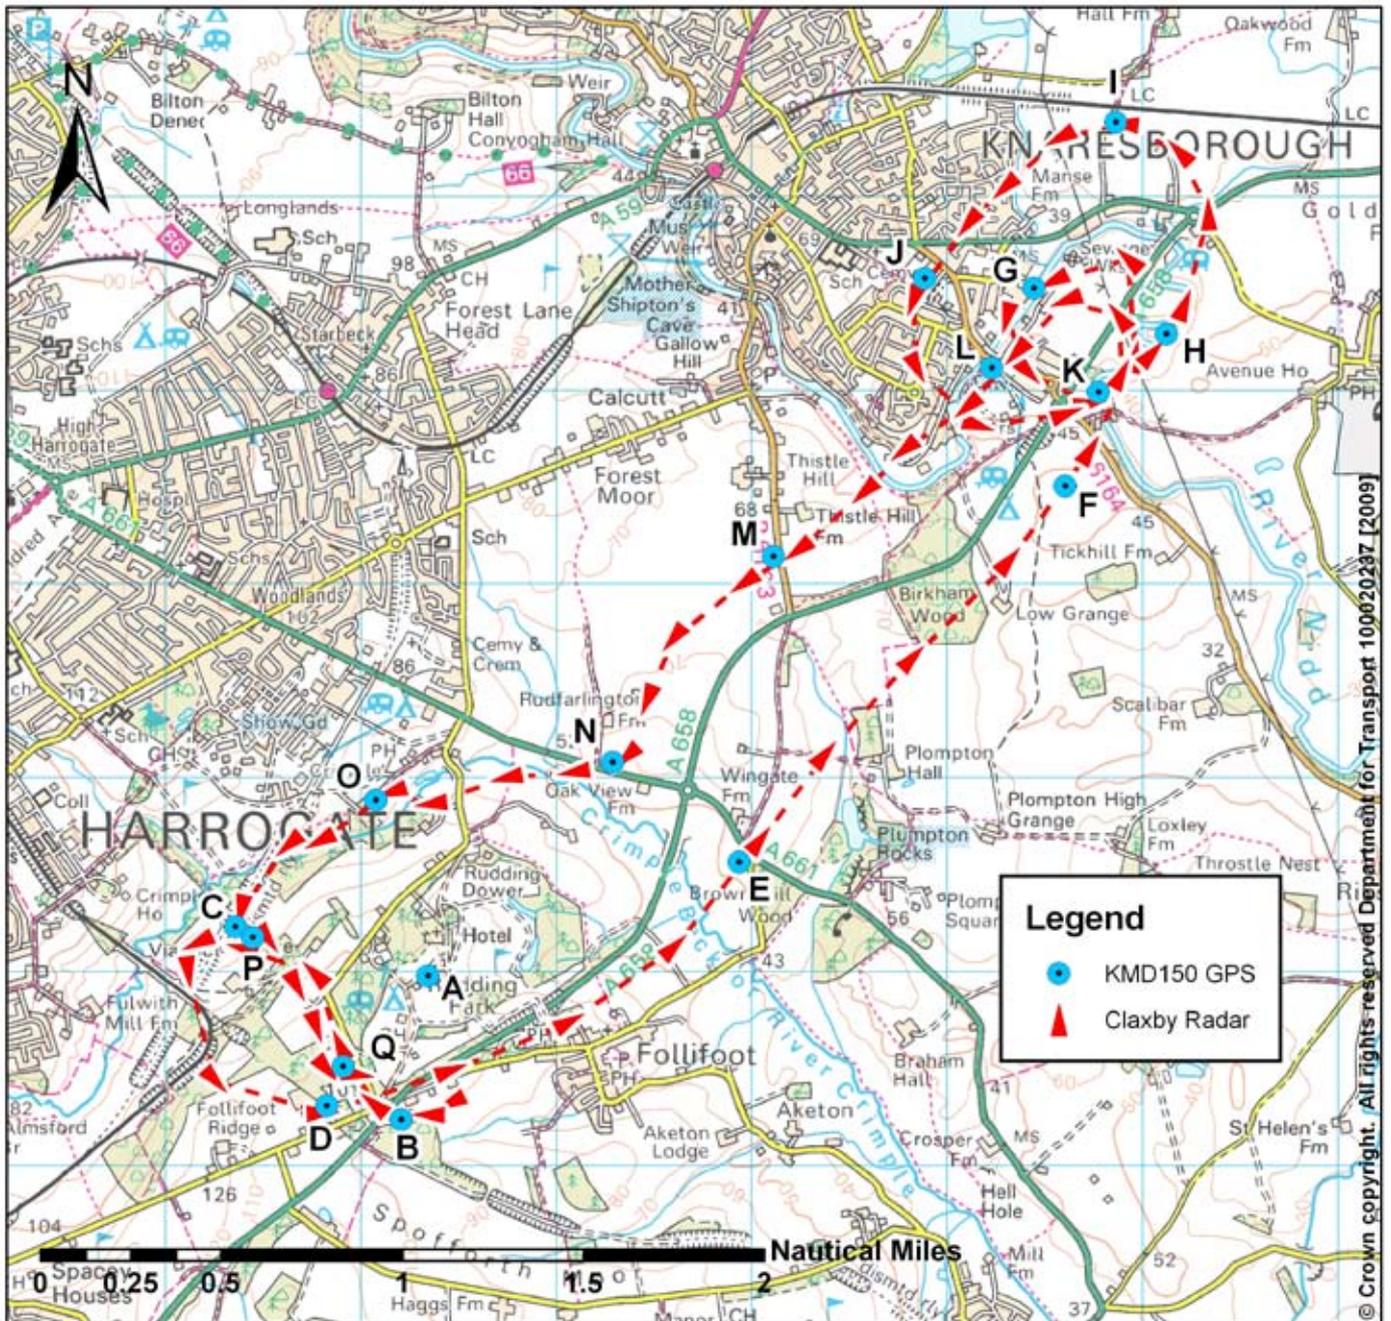
Figure 2
Radar and GPS tracks

Radar and GPS data show the aircraft's return to the hotel was from the north and that it flew along the hotel grounds' south-west boundary at between 539 and 278 feet agl, the latter being the last height recorded by the aircraft's GPS unit, on a track of 127°T. In this direction the path flown would have taken the aircraft close to some chalets situated in the hotel grounds, including the one owned by the pilot. Witness descriptions of the aircraft's final moments varied, but

recorded position, ground speed and ground track angle every 30 seconds, giving 17 points starting 16:17:54 hrs (just after takeoff) and ending 16:25:54 hrs. The radar track (in red) and GPS points (in blue and labelled A-Q) are illustrated in Figure 2.

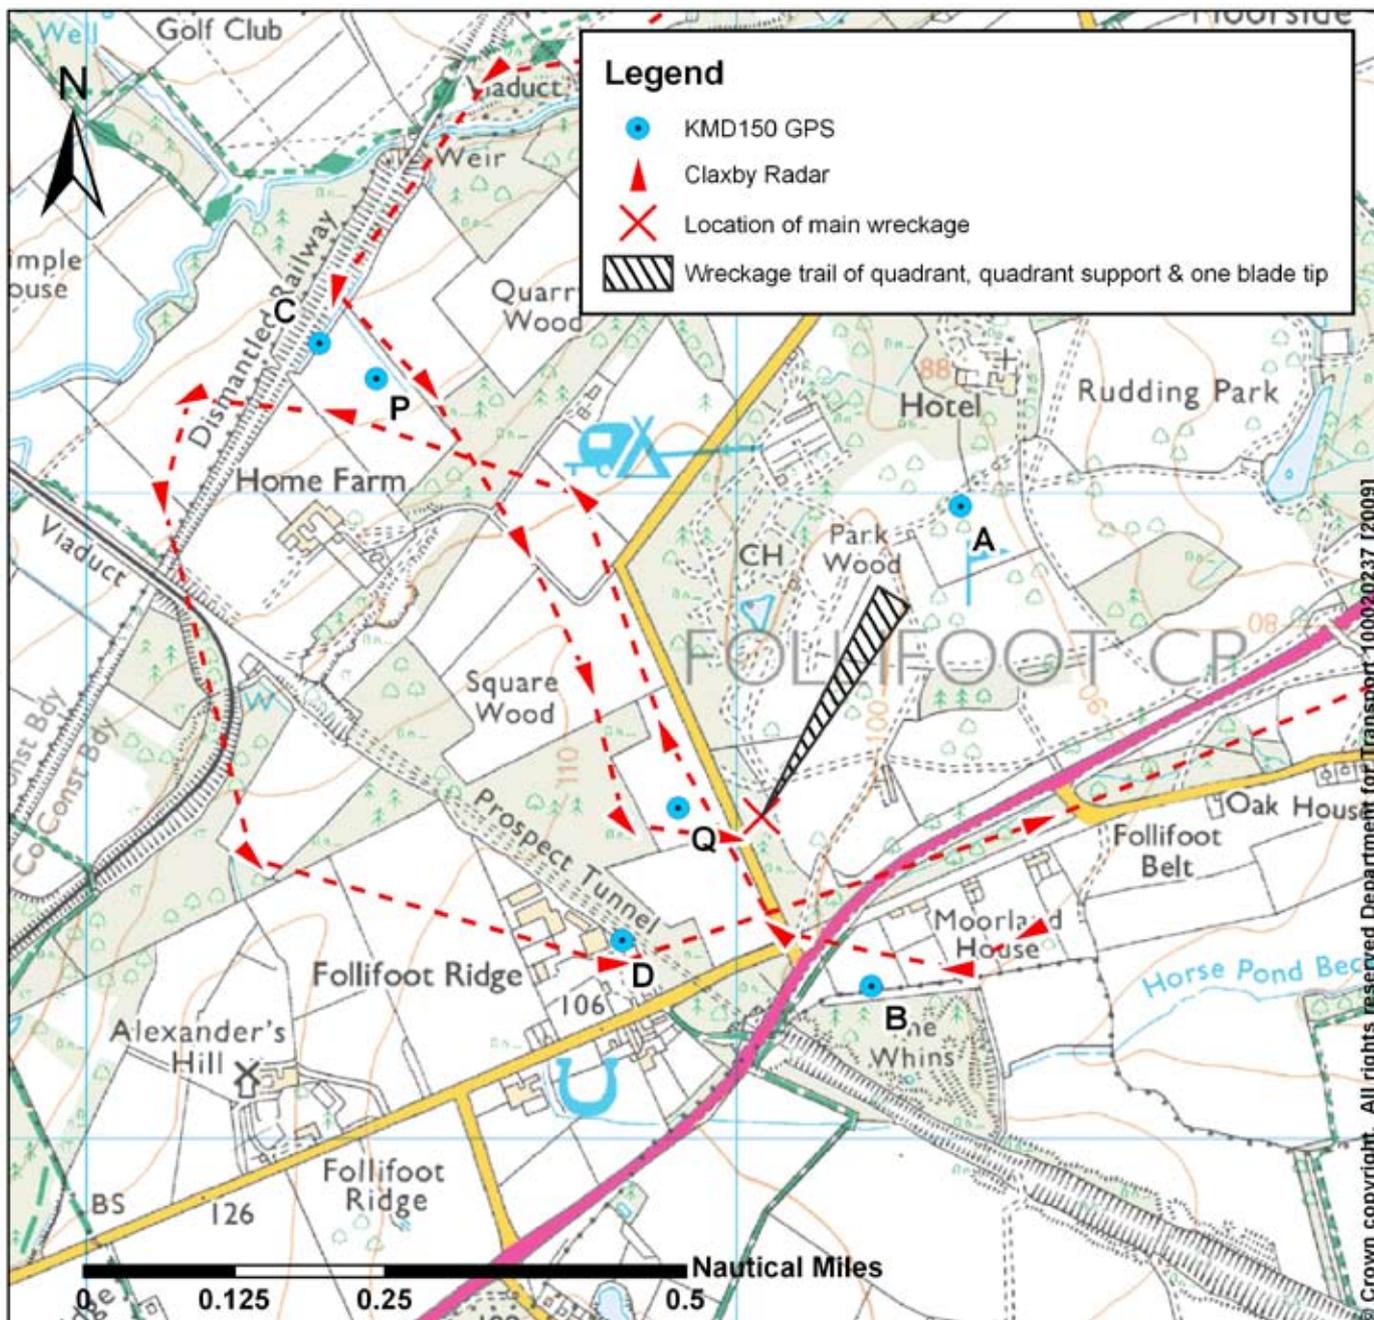
Figure 3

The wreckage was located in an area of deciduous trees 600 m south-west of the helicopter landing site from which it had taken off. The aircraft was significantly disrupted and was situated at the foot of a ring of six trees that were approximately 30 m high, the trunks of which formed a circle approximately 10 m in diameter. The engine was still inside its pod, although it had become detached from the fuselage. The jet pipe in the Gazelle faces rearward, and it appeared to have been damaged from the rear.

The tail rotor control quadrant (in several pieces), the quadrant support and the tip of a main rotor blade (mass 2.3 kg) were all found in a narrow wreckage path within 5° of a line north-east radially from the main wreckage. The rotor blade tip and the quadrant support

An expanded view of the start and end of the accident-flight track is given at Figure 3.

Expanded view of flight track, with wreckage locations
