## ACCIDENT

<b>Aircraft Type and Registration:</b>	Vickers Supermarine Spitfire Mk XIX, G-RRGN	
<b>No &amp; Type of Engines:</b>	1 Rolls-Royce Griffon RG 30 SM-S piston engine	
<b>Year of Manufacture:</b>	1945 (Serial no: 6S-594677)	
<b>Date &amp; Time (UTC):</b>	7 January 2013 at 1519 hrs	
<b>Location:</b>	East Midlands Airport	
<b>Type of Flight:</b>	Private	
<b>Persons on Board:</b>	Crew - 1	Passengers - None
<b>Injuries:</b>	Crew - None	Passengers - N/A
<b>Nature of Damage:</b>	Damage to propeller, lower engine cowling, both radiator fairings, left flap, left aileron, underside of left wing	
<b>Commander's Licence:</b>	Airline Transport Pilot's Licence	
<b>Commander's Age:</b>	46 years	
<b>Commander's Flying Experience:</b>	9,273 hours (of which 89 were on type) Last 90 days - 217 hours Last 28 days - 62 hours	
<b>Information Source:</b>	Aircraft Accident Report Form submitted by the pilot

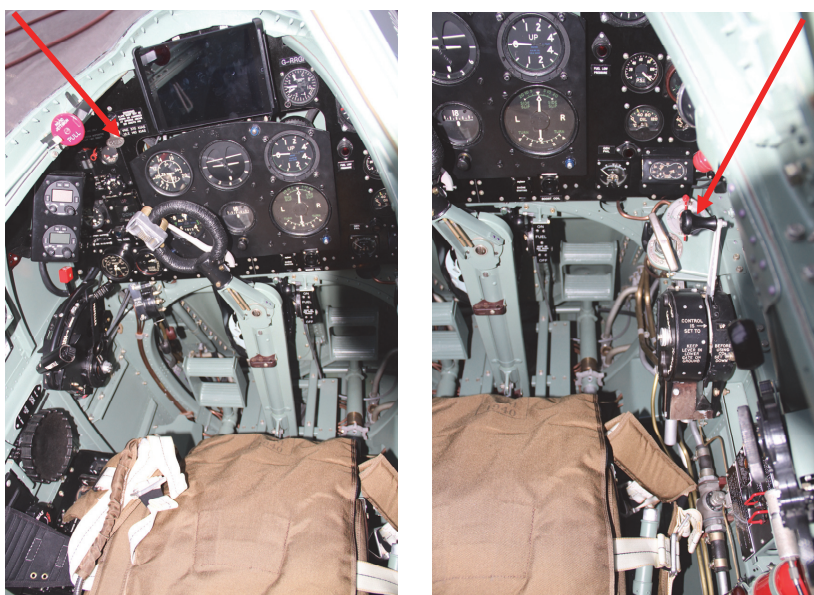
**Figure1**

The aircraft had landed on Runway 27 at East Midlands Airport and was taxiing to vacate the runway when the undercarriage retracted, causing the wooden propeller to strike the runway and shatter. The pilot stated that he had intended to retract the flaps but inadvertently selected the undercarriage to UP: the levers are on different sides of the cockpit (Figure 1). It is apparently a usual practice to retract the flaps as soon as possible after landing to minimise the effect they have on cooling radiator airflow. There is no weight-on-wheels protection circuit.

Spitfire Mk XIX cockpit showing flap lever (arrowed left) and undercarriage selector (arrowed right)
