Piper PA-34-200T Seneca II, G-ROLA

AAIB Bulletin No: 5/2004	Ref: EW/C2003/05/09	Category: 1.3
Aircraft Type and Registration:	Piper PA-34-200T Seneca II, G-ROLA	
No & Type of Engines:	2 Continental TSIO-360-EB piston engines	
Year of Manufacture:	1976	
Date & Time (UTC):	8 May 2003 at 1220 hrs	
Location:	Sherburn-in-Elmet Aerodrome, Yorkshire	
Type of Flight:	Private	
Persons on Board:	Crew - 2	Passengers - None
Injuries:	Crew - None	Passengers - N/A
Nature of Damage:	Both propellers bent, engines shock loaded, nose cone split, nose landing gear doors damaged	
Commander's Licence:	Airline Transport Pilot's Licence	
Commander's Age:	51 years	
Commander's Flying Experience:	6,355 hours (of which 750 were on type)	
	Last 90 days - 67 hours	
	Last 28 days - 14 hours	
Information Source:	Aircraft Accident Report Form submitted by the commander and further enquiries by the AAIB

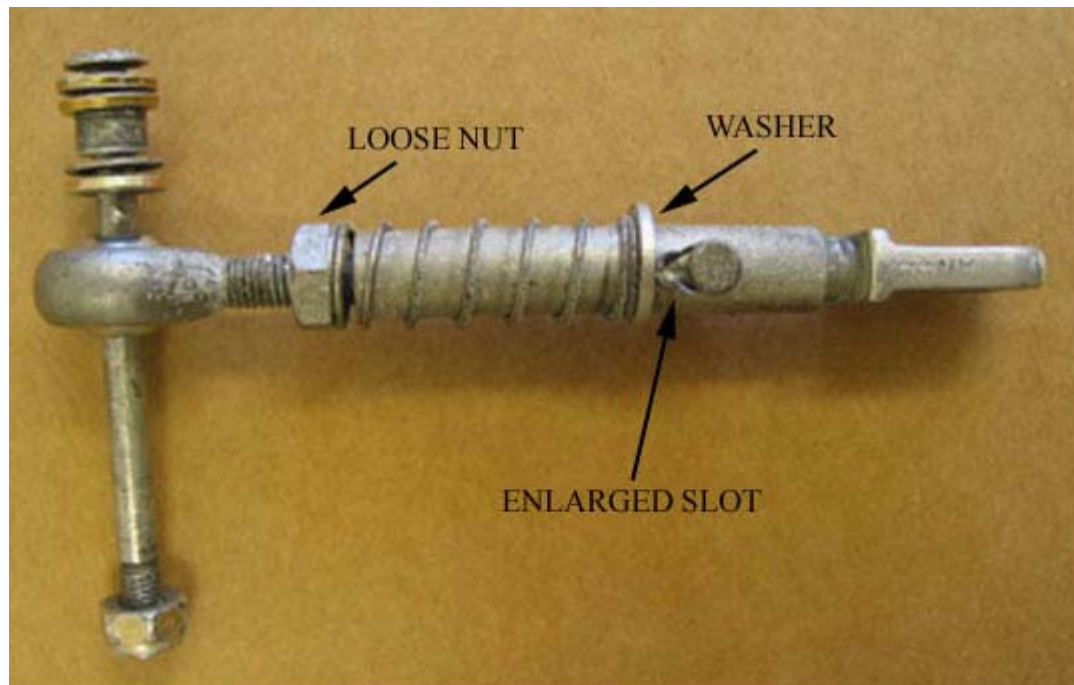
Figure 3: Downlock spring link from accident aircraft

The downlock spring link was slightly bent and the adjustment lock-nut was still loose as shown in Figure 3. The slot through which the cross-pin passed was enlarged which enabled an additional reduction in the length of the link. The enlargement of the slot had formed a lip which prevented the washer in Figure 3 from resting against the pin under the spring load (as it does in Figure 2). As a result the spring was no longer having any effect on the length of the link. The enlargement of the

slot appeared to be the result of overload crushing damage, probably sustained during the collapse. However, it is not uncommon to find enlargement of this slot due to wear. Any pre-existing wear of the slot would have been masked by the crushing damage.

The extra friction would have resisted movement of the drag link into the over-centre position and would also have hindered free fall of the nose gear - a problem that was reported during the flight tests. The aircraft manufacturer was consulted about the cause of the enlarged slot on the downlock spring link. In the manufacturer's opinion an excessive amount of play in the downlock spring link could allow the drag link to move out of the over-centre position before the downlock link had moved out of its own over-centre position, resulting in an excessive loading of the downlock link and collapse of the nose gear. It appears probable, therefore, that the downlock spring link was not adjusted to the correct length. The loose nut on the threaded portion of the downlock link further indicates that adjustment was not correctly carried out.

It is recommended that the Federal Aviation Administration, as the primary certifying authority for the Piper PA-34 Seneca aircraft series, should require the aircraft manufacturer to provide a clear and unambiguous description of the operation of the nose gear downlock spring link, its installation and its correct rigging by both narrative and pictorial means.
