# Bolkow BO 105DBS-4, G-DNLB

<b>AAIB Bulletin No:</b> 8/2003	<b>Ref:</b> EW/C2002/05/07	<b>Category:</b> 2.2
Aircraft Type and Registration:	Bolkow BO 105DBS-4, G-DNLB	
No & Type of Engines:	2 Allison 250-C20 turboshaft engines	
Year of Manufacture:	1992	
Date & Time (UTC):	24 May 2002 at 1020 hrs	
Location:	Brough of Birsay, Isle of Orkney	
Type of Flight:	External load transfer (aerial work)	
Persons on Board:	Crew - 1	Passengers - None
Injuries:	Crew - 1 (Fatal)	Passengers - None
Nature of Damage:	Aircraft destroyed	
Commander's Licence:	Airline Transport Pilot's Licence	
Commander's Age:	53 years	
Commander's Flying Experience:	12,399 hours (of which 5,000 were on type)	
	Last 90 days - 101 hours	
	Last 28 days - 35 hours	
<b>Information Source:</b>	AAIB Field Investigation

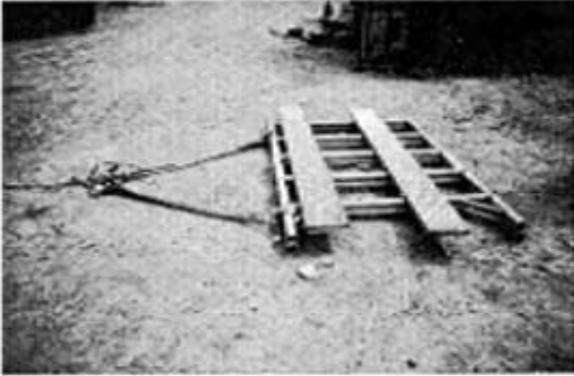
**Figure 1 - Photograph of replica load**

Having returned to the Brough to lift the penultimate load, the aircraft was marshalled over the load by the maintenance engineer. The load consisted of two scaffolding frames bound together with wire and a number of 16 cm x 1 cm metal electrical conduit sections approximately two metres long tied across the scaffolding in two groups with wire wrapped around the items and twisted together to secure them. Figure 1 shows a replica load.

The external load being carried at the time of the accident was not recovered. The persons who had constructed the original load assembled an identical load, (as shown in at Figure 1). The scaffolding sections were attached to the end of the lower wire strop with canvas straps joined at a swivel connector. The total distance from the load hook connection to the bottom of the load was 6.95 metres. The total width of the load was 2.4 metres and it weighed 68 kg.

The replica load was taken to the Ministry of Defence (MOD) Joint Air Transport Evaluation Unit (JATEU) at Brize Norton in Oxfordshire. The role of JATEU is to assess loads, which may be required to be flown beneath MOD helicopters and stipulate the method of carriage. Their assessment of the replica load was that it would not be flown as an external load beneath a military helicopter due to the flat profile and lack of mass, which in combination, would cause the load to be highly unstable. If for operational reasons it was imperative to transport the scaffolding sections and electrical conduit, it would probably have been carried as internal freight. If it was not possible to carry it as internal freight, the items would either have been placed in a net with some heavy ballast or the scaffolding sections would have been suspended from each corner and ballast placed on the platform made by the load to give it stability. JATEU considered that the load as prepared would not only be unstable both longitudinally and laterally, but also tend to twist around the swivels.

A static assessment of the replica load when attached to the aircraft load hook and then laid out to the rear as if trailing behind the helicopter, showed that when trailing, the load could be directly below the tail rotor.

From the external load trial it was noted that the replica load became very unstable at about 60 kt. During the accident flight, through encountering turbulence from the cliff edge or surrounding terrain, the onset of instability may have occurred at a lower airspeed if the load acceleration was rapid.

Knowledge of good practice for load construction was evident to JATEU staff and the client's HLOs had sufficient training and experience to know that the large slab sided sections of shed and the Portaloo were unsuitable for external carriage in the windy conditions. However, all the loads had been assembled by the building contractor's staff. They were sufficiently remote from the actual transfer task as not to be specifically trained in relation to helicopter lifting operations and consequently, little guidance was provided to them. The HLOs and the pilot had been extensively trained and had acquired practical experience of external load transfer but from his position hovering overhead the load, the pilot, who had the ultimate right to refuse to carry it, was poorly placed to observe and reject the load.

improving the stability of loads that have poor or unpredictable flight characteristics. (Safety Recommendation 2003-37.)
