AAIB Bulletin No: 10/94 **Ref:** EW/C94/7/6 **Category:** 1.1

Aircraft Type and Registration: Boeing 747-238, N160UA

Nature of Damage: Vertical stabiliser top cap fairing missing, ILS localiser aerials destroyed

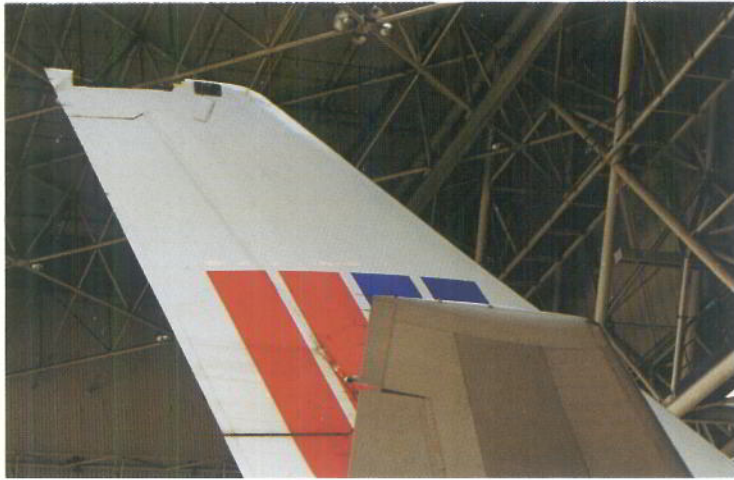
Examination of the aircraft showed that the majority of the GRP fin cap had been lost and the VOR/Localiser aerial located within it had been totally destroyed, together with the fusible connection links to the aircraft aerial system. The fin trailing edge box immediately above the rudder had also been damaged. There was no other externally visible damage to the aircraft.

Photo 1 Damage to top of fin as seen from the ground

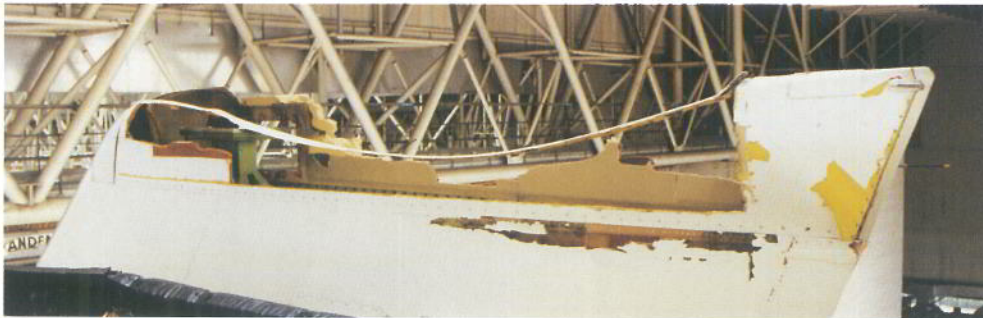
Photo 2 Closer view of damage to top of fin
(note damage to trailing edge section below the fin cap)

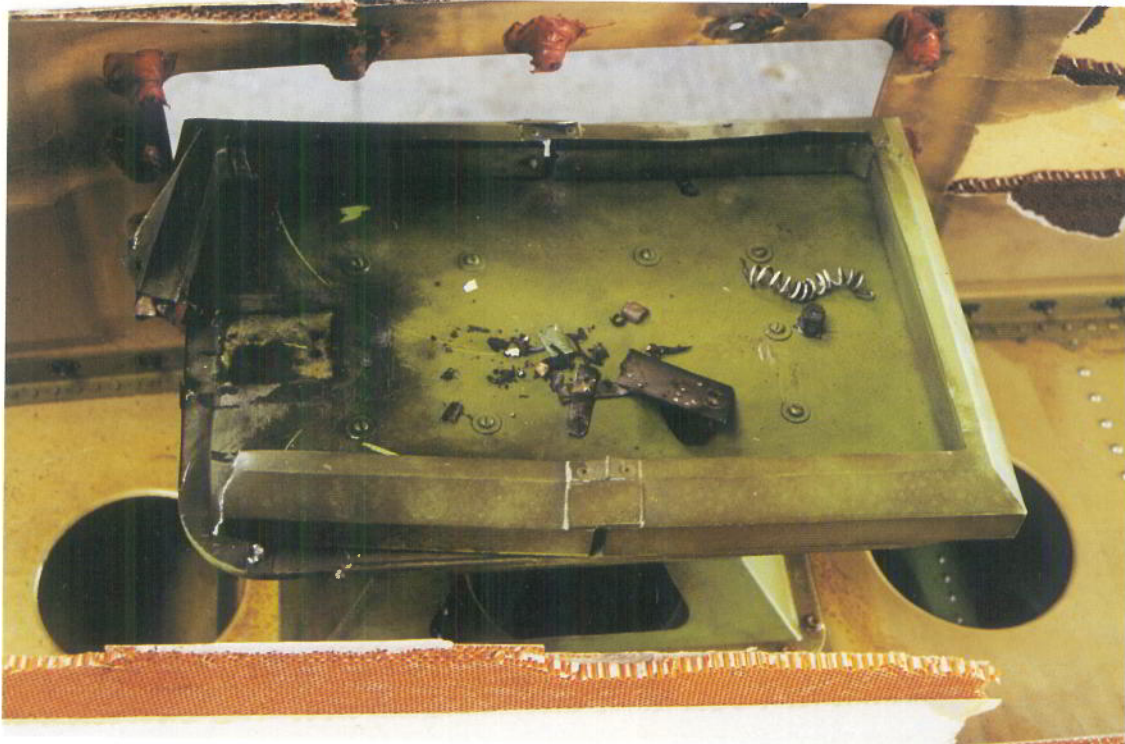
Electrical checks of the affected aerial system initially showed a conductive path between the aerial and screen elements in the aircraft. However, after disconnecting the aerial section connectors, the conductive path no longer existed. A self test of the two VOR/Localiser receivers indicated that they were still serviceable, however, before returning the aircraft to service both receivers were changed and the aerial connections cleaned.

Photo 3 Damage to antenna assembly.
(Small debris retrieved from inside fin top structure)
