No: 6/92

Ref: EW/C92/3/1

Aircraft Type and Registration: Lockheed 1011 Tristar, 9Y-TGJ

Nature of Damage: Major portion of No. 1 engine thrust reverser translating cowl detached, scoring of adjacent wing top and bottom surfaces and severe damage to No. 3 segment of the left horizontal stabiliser leading edge.

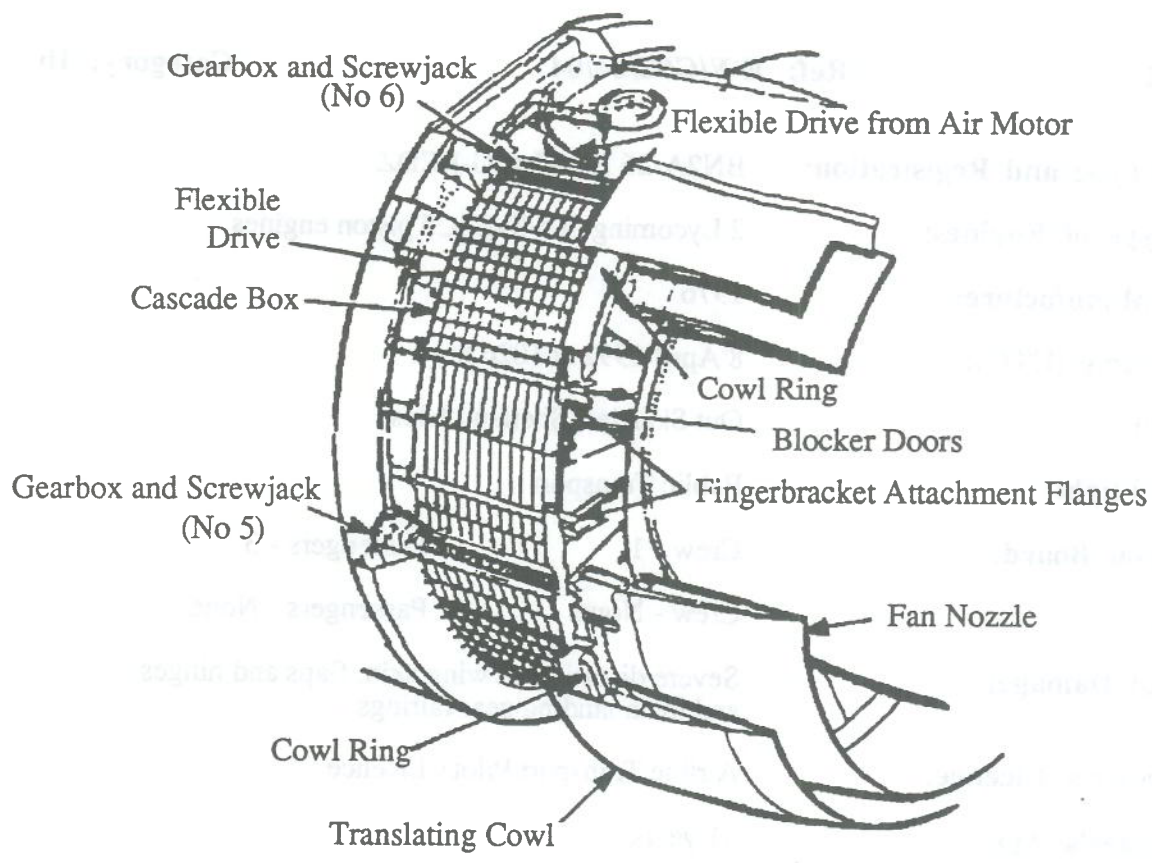
Rolls-Royce RB211 Standard Thrust Reverser

The thrust reverser was of the Rolls-Royce 'standard weight' type, driven by an air motor through a closed loop flexible drive system the connecting six gearboxes and screwjacks (see attached Figs.). In the process of investigating and manipulating the cowl the team disconnected the dual flexible drives from the air motor and found that the drive from the left hand output of the air motor was broken. Attempting to move the cowl through its manual drives at jacks Nos 2 and 5 they observed that jacks Nos 4 and 6 appeared to be jammed. They disconnected the drive into No. 6 gearbox and found that it had failed (the failure was later found to be at the air motor end of the drive). They also isolated No. 4 gearbox by disconnecting its associated drives on either side at Nos 5 and 3 gearboxes. At Nos 4 and 6 screwjacks they detached the ball nuts, which translate along the screws, from the cowl itself whereupon the distortion in the cowl straightened out and they were able to wind the cowl manually to the fully deployed position. The ball nut on No. 6 jack was still not free to move on the screw and so a cascade vane box was removed to give access and the flexible drive on the inboard side of No. 6 gearbox was disconnected (where the drive was later found to have failed). It then proved possible to wind No. 6 ball nut and also No. 4 ball nut to their fully forward positions and the vane box was refitted. When an attempt was made to wind the cowl forward for stowing and locking its movement became stiff and it again jammed. A cascade vane box was again removed for access and the drive into No. 1 gearbox disconnected. The cascade vane box was re-installed and the reverser was successfully wound to the fully forward position where both latches engaged.

The structure of the translating cowl comprises a leading edge ring (interrupted by the pylon) which is attached through the ball nuts to the screwjacks which themselves transfer cowl loads to the engine. A double skin structure is attached to the ring and provides the sealing of the bypass duct. The blocker doors do not seal the periphery of the bypass duct when the reverser is stowed and it is the cowl which sustains the duct pressure loads. Finger brackets attach the front, translating, end of the blocker doors to the cowl ring. When reverse thrust is selected the screwjacks open the cowl which, in turn, folds the blocker doors rearwards to block the cold nozzle.

Examination of the engine and the recovered cowl parts showed that the failure and separation of the cowl had begun with the loss of structural support from the No. 6 ball nut attachment when it was disconnected on 7 March. As the unsupported end of the cowl deflected under bypass pressure the next point of support was the attachment finger bracket of No. 15 blocker door; the blocker door itself would have been pulled outwards until it contacted the cascade vanes. It was this finger bracket which was found failed (in overload) at Frankfurt. The cowl was then restrained by the next blocker door finger bracket, No. 14, which separated from the cowl through failure of its attachment flanges during take-off or climb from Frankfurt. During the progressive bracket failures the maximum bending

moment in the unsupported end of the cowl would have been rapidly increasing (by a factor of, roughly, 6 with the failure of the first finger bracket and 16 with the failure of the second). The cowl structure finally collapsed in outward bending at the point of the next finger bracket just short of No. 5 jack whose gearbox contained one of the reverser's two stowing locks. This collapse resulted in the rest of the ring structure remaining in place and the other blocker doors remaining locked stowed; the one blocker door which had been liberated in the cowl separation sequence was free to slide to any position between its normal stowed position and its bypass blocking position. Though the cowl's main structural ring separated at the point of collapse the double skin assembly attached to it continued to detach around the reverser's whole periphery. The skin assembly had also broken part way around the periphery and had probably left the aircraft as two main pieces together with the smaller fragments found on the ground. At either end of the cowl outer skin some heavy abrasion and distortion was found which probably corresponded to the impacts with the wing and stabiliser.

Rolls-Royce have circulated two notices to operators describing the circumstances of the cowl detachment and are reviewing the engine Maintenance Manual to determine what changes in instructions and in the supporting descriptive material are appropriate to support the requirements of relevant MMEL's and Dispatch Deviations Procedures Manuals.

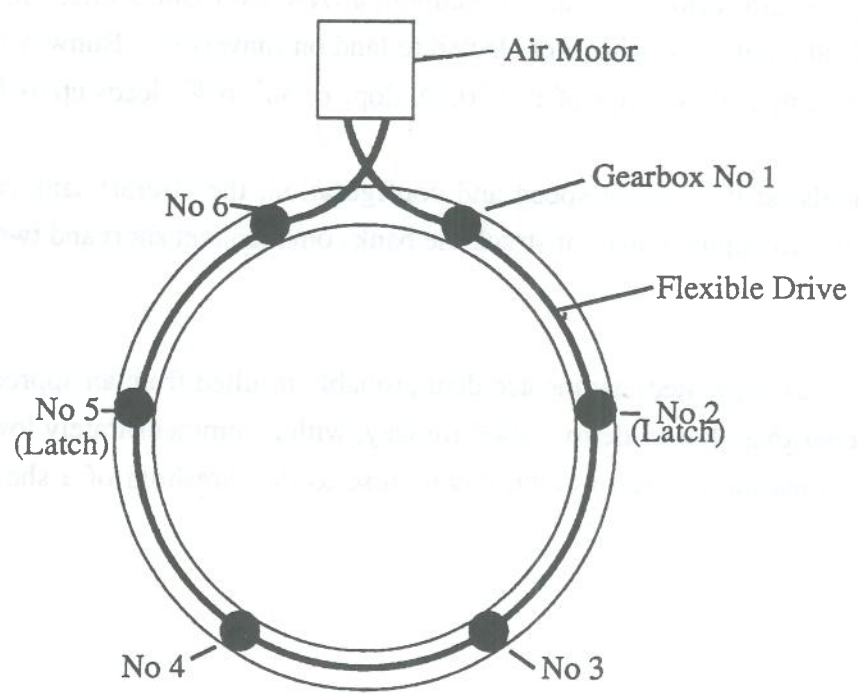
Translating Cowl Gearbox and Screwjack Positions Viewed from Rear

If the inoperative reverser is the result of a malfunctioning cowl screwjack then the MMEL Procedures Manual permits one screwjack, only No. 3 or No. 4, to be removed and it is not permitted therefore that No. 6 be removed. If the translating ball nut on a jack is detached from the cowl then, even if the jack is not removed one of its functions, structural support of the cowl, is eliminated.
