ACCIDENT

Aircraft Type and Registration:	Beech B58 Baron, G-OSDI	
No & Type of Engines:	2 Continental Motors Corp IO-520-CB piston engines	
Year of Manufacture:	1980	
Date & Time (UTC):	5 April 2008 at 1220 hrs	
Location:	Leicester Airport, Runway 28	
Type of Flight:	Private	
Persons on Board:	Crew - 1	Passengers - None
Injuries:	Crew - None	Passengers - None
Nature of Damage:	Right propeller blades bent, engine shock-loaded, scraping on right wing tip, passenger step displaced	
Commander's Licence:	Private Pilot's Licence	
Commander's Age:	54 years	
Commander's Flying Experience:	682 hours (of which 64 were on type) Last 90 days - 1 hour Last 28 days - 0 hours	
Information Source:	AAIB Field Investigation

Synopsis

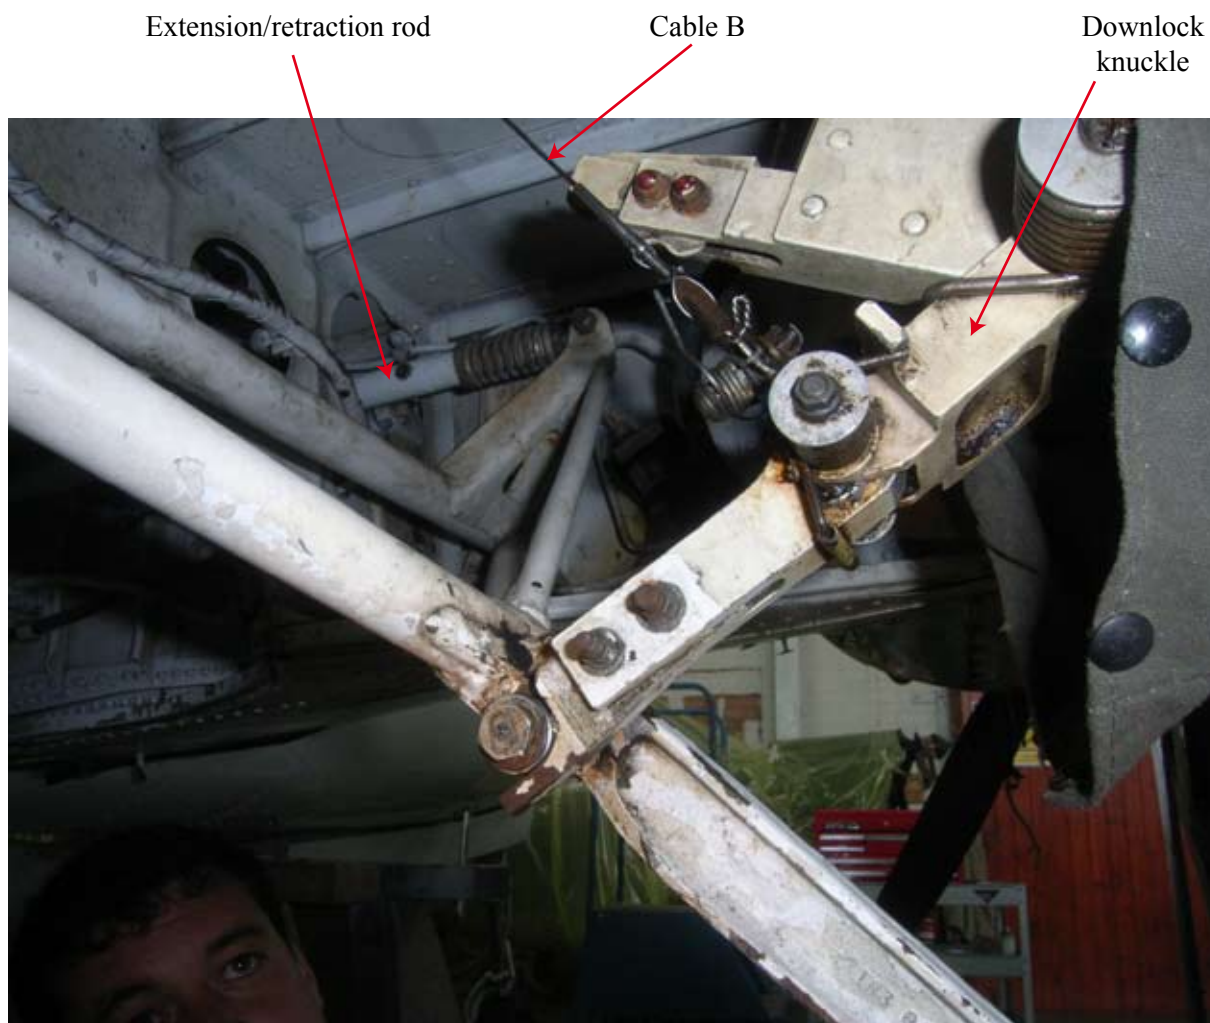
Figure 1
Gear down and locked

condition, the rod overtravels and compresses a spring, which forms part of the rod: the downlock is thus held overcentre by this spring pressure (see Figure 1). As this occurs, cable 'B' tensions and pulls the secondary downlock into place underneath a roller on the sidebrace; this is to prevent the gear from being forced out of lock by cornering forces or yawed landings. The green indication in the cockpit is not an indication that the gear is fully locked DOWN with the secondary lock in place, but, because it is activated by a striker plate on the sidebrace, it is an indication that the leg is in a position where the sidebrace is overcentre.

Maintenance Manual (MM) requires this gap to be only 0.010 – 0.020 inches. In Figure 1 it can be seen that the secondary lock is hard up against the roller, whereas the MM specifies the same clearance. Both left and right gear rollers were found to have seized solid and could not be freed. A third roller of the same type in the nose landing gear mechanism was also seized.

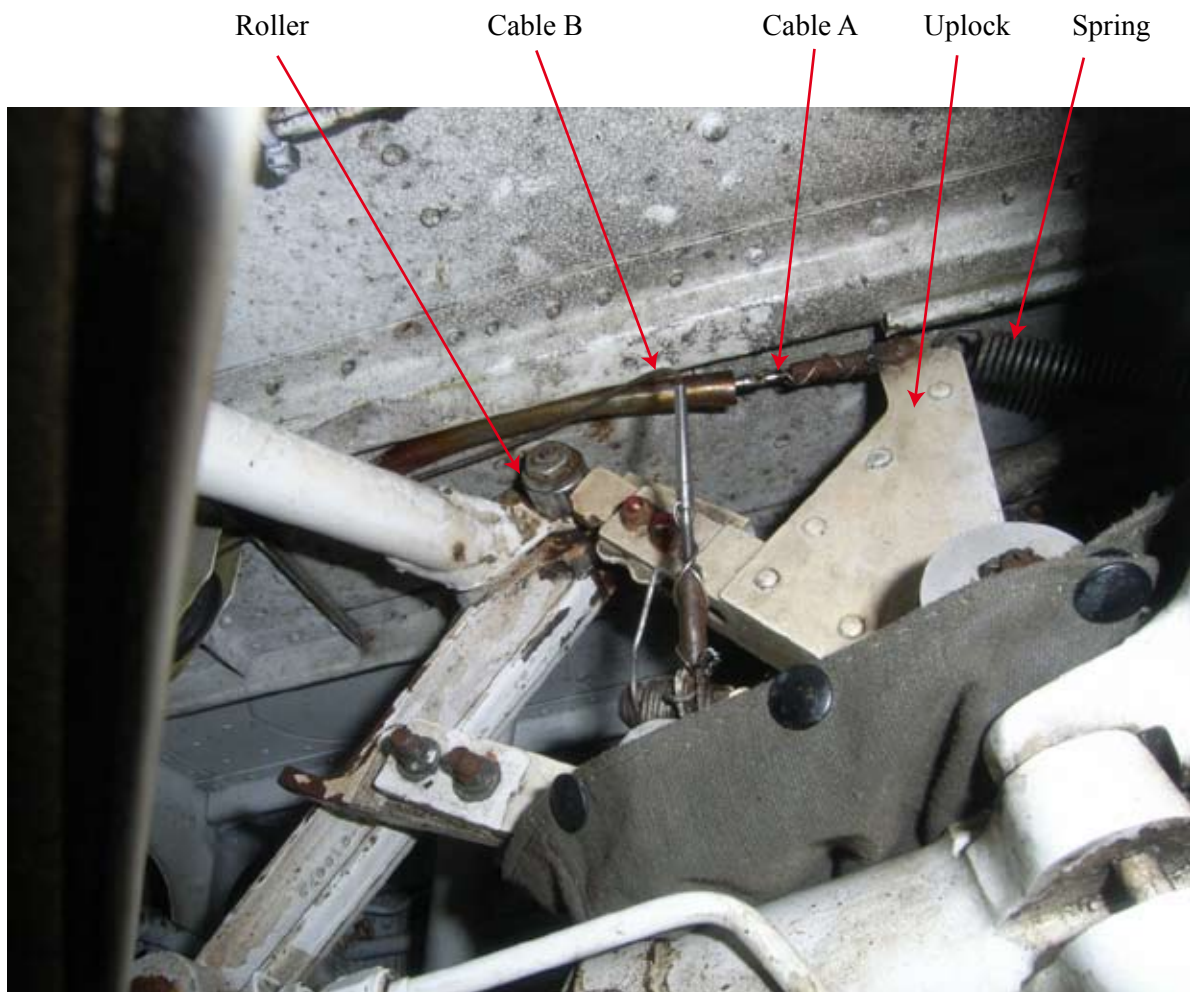
Figure 2
Gear up and locked

Figure 2 shows the right main landing gear of G-OSDI in the up-and-locked condition (doors removed for access): cable 'A' is tensioned and pulling the uplock against its spring under the roller. Although not apparent in the photograph, there was a clearance of about 0.25 inches between the uplock and the roller. The
