No: 8/91

**Aircraft Type and Registration:** Boeing 707, JY-AJK

**Date & Time (UTC):** 12 December 1990 at 1507 hrs

**Location:** Cargo stand 310, London Heathrow Airport

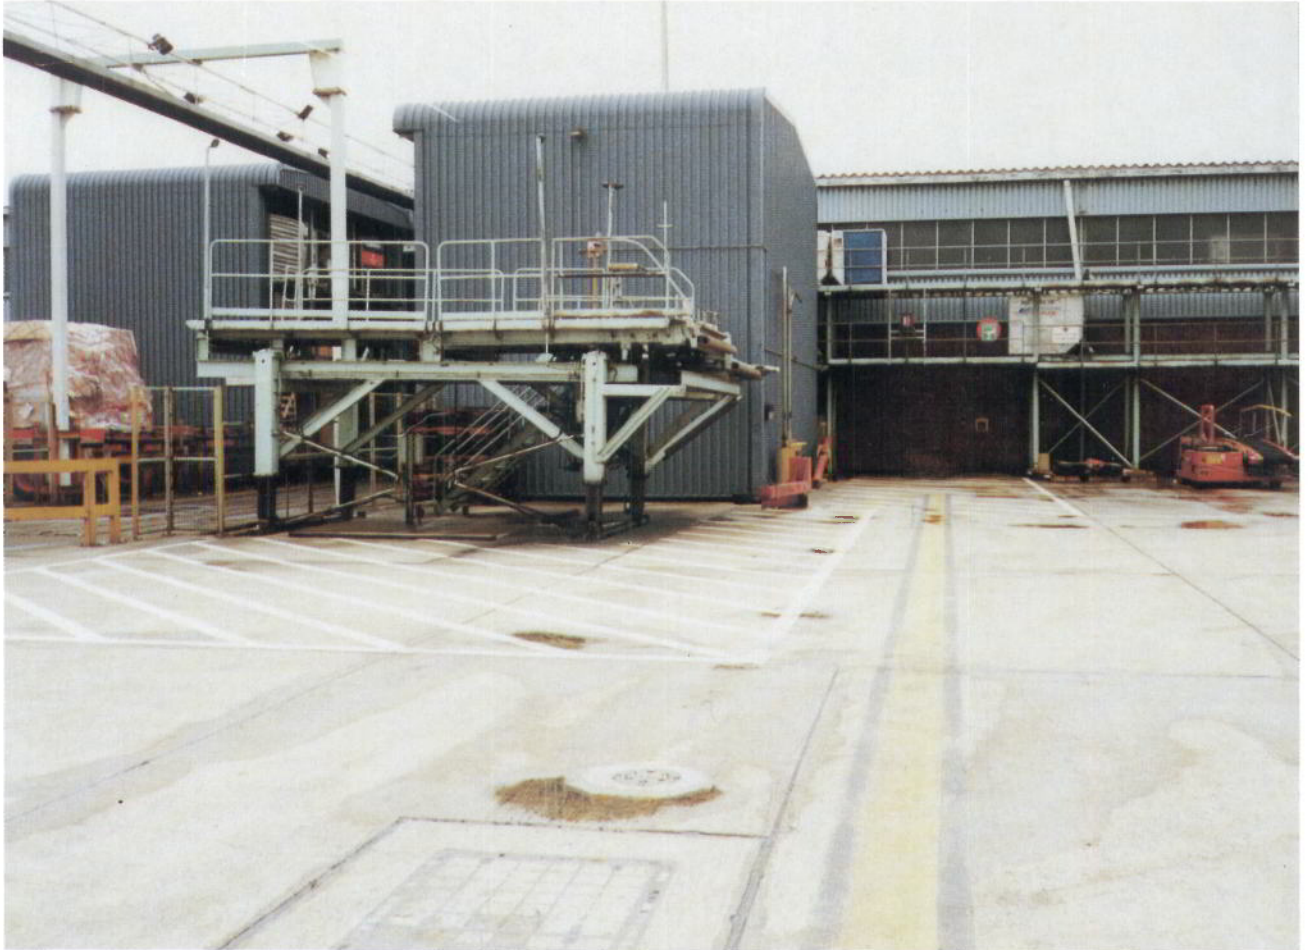
**Cargo Stand 310**  
**LONDON HEATHROW AIRPORT**

At 1115 hours Royal Jordanian Airways flight RJA 051 parked on stand 310 to unload and then reload with cargo ready for a 1330 departure to Brussels. This stand has a fixed cargo handling system and is designed for the use of B707 and DC8 aircraft. The aircraft was positioned on the stand by the commander using the AGNIS/Stop Bar system. (The acronym AGNIS is derived from Azimuth Guidance for Nose In Stands. It is a red/green light system which provides guidance along the stand centreline to the aircraft commander and is intended as a "back-up" to the stand painted centreline marking. The stop bar is a metal bar across the centreline at windscreen level). On the stand, ground vehicle manoeuvring space around the nose of the aircraft was very much restricted by the cargo platform to its left, the cargo building in front of it, and walkway supporting structure to its right. The lack of space makes accurate taxiing and parking very desirable but the painted centreline markings cannot be seen from the flightdeck during the final part of the approach to the stand. (see photograph).

The push back commenced without the full crew and without any attempt to control vehicle traffic on service roads immediately behind and to the side of the aircraft. After about 5 feet of rearward travel the commander perceived that all was not well and instructed the ground engineer to stop the pushback. After so doing he went to inspect the fuselage and saw that the aircraft had struck the cargo handling platform, part of which was protruding. The police were summoned and photographs were taken before the aircraft was removed for repairs. The photographs showed both nosewheels to the right of the centreline. The aircraft was out of service for 19 days.
