ACCIDENT

Aircraft Type and Registration:	Rotorsport UK MTOSport, G-LZED	
No & Type of Engines:	1 Rotax 912 ULS piston engine	
Year of Manufacture:	2010	
Date & Time (UTC):	27 June 2011 at 1120 hrs	
Location:	Shell Island Campsite, Llanbedr, Gwynedd, North Wales	
Type of Flight:	Private	
Persons on Board:	Crew - 1	Passengers - 1
Injuries:	Crew - None	Passengers - None
Nature of Damage:	Pod, right main and nose landing gear, rotor blades, propeller, tail fin and rudder pedals damaged	
Commander's Licence:	Private Pilot's Licence	
Commander's Age:	47 years	
Commander's Flying Experience:	380 hours (of which 88 were on type) Last 90 days - 38 hours Last 28 days - 7 hours	
Information Source:	AAIB Field Investigation

Synopsis

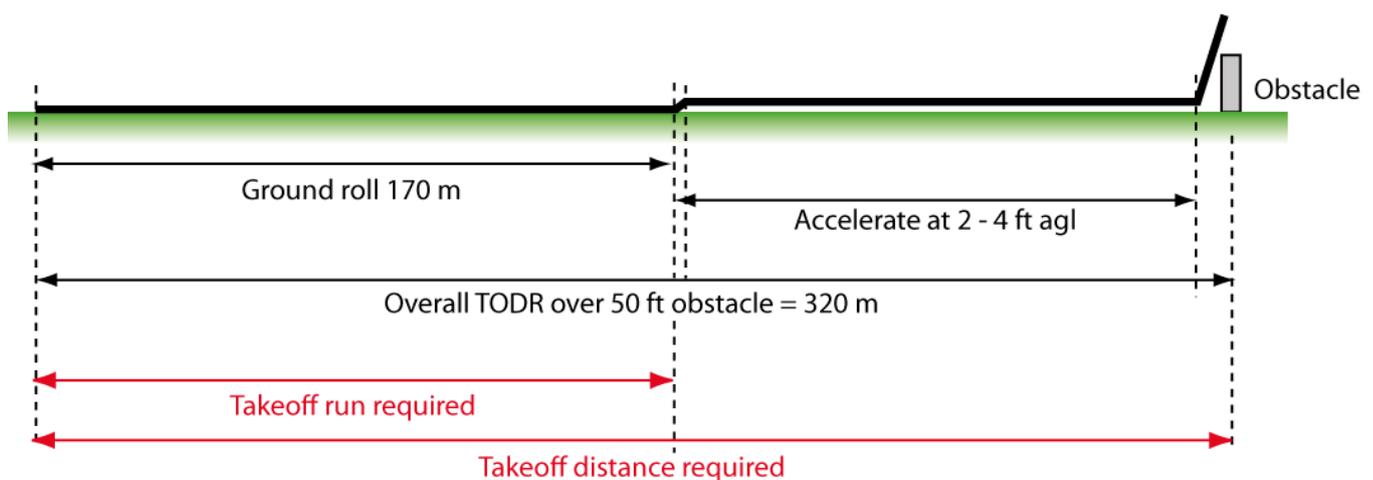
Figure 1 gives a pictorial description of the elements of the MTOSport's takeoff to a height of 50 ft, clearing a nominal obstacle.

MTOSport gyroplane's takeoff performance at MTOW in still air

The MTOSport Pilot's Handbook reports a takeoff run of up to 170 m, in still air. Applying the CAA factor of 20% for a tailwind, G-LZED required about 204 m to become airborne. This does not include the 1.33 safety factor which would increase the TORR to 271 m. However, once airborne the gyroplane would still need to accelerate, in ground effect, at a height of between two and four feet before climbing away. As such, even if the pilot's estimate of the field as 250 m long had been correct, the field did not appear to have been of sufficient length to depart safely.
