No: 6/92

Aircraft Type and Registration: Boeing 757-236, G-BMRE

Location: London (Heathrow) Airport

Nature of Damage: Gouge and hole in the fuselage beneath the left hand pilot's seat

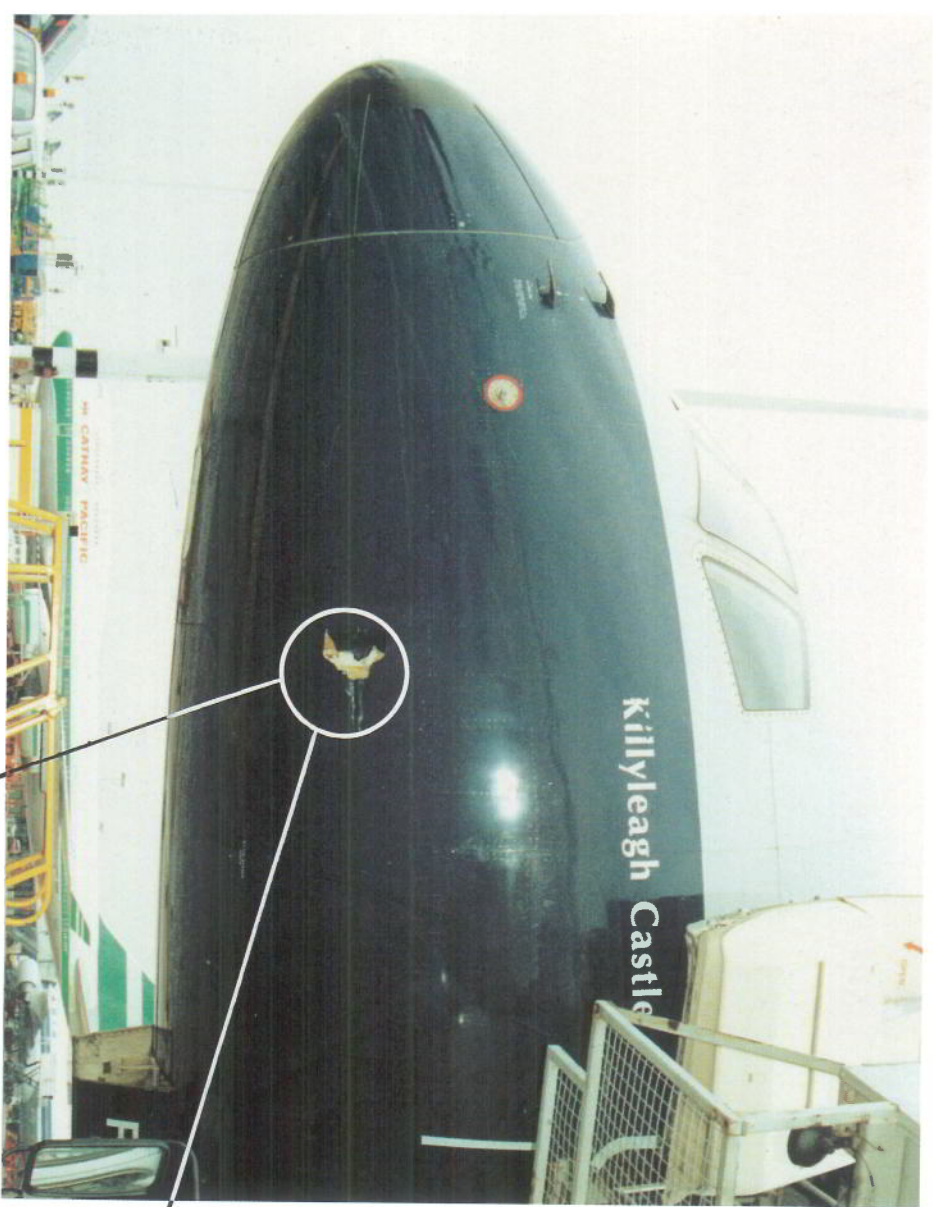
PHOTOGRAPH No. 1 DAMAGE TO THE AIRCRAFT

Examination of the damage revealed a rupture to the pressure hull which measured 11 inches by 13 inches and was located in the lower side fuselage three feet below the first pilot's side window (photograph No.1). A more detailed examination of the damage indicated that it had occurred on the ground prior to take-off and that either the aircraft had been reversed into an object, or an object had been driven forward into the aircraft. The section of the object that had caused the damage had been 9 feet 11 inches from the ground, was painted grey and had struck the aircraft from the rear, approximately seven degrees from the aircraft's fore/aft axis, parallel with the ground and travelling at about 12 mph. No damage had been reported to any ground equipment or vehicle except the passenger jetway at the stand from which the aircraft had departed. Examination of the passenger jetway and interviews with the jetway operator and independent observers established positively that the jetway had not caused the damage to this aircraft. An extensive search and examination of the ground equipment and vehicles in the areas of Terminal 1, Terminal 2 the central and northern motor transport and ground equipment servicing and repair workshops and the cargo vehicle parking area revealed a Luton cargo vehicle that had recently received damage to the upper forward right corner of its box body which was painted grey (photograph No.2). Examination of this damaged area showed excellent evidence of the aircraft's paintwork embossed upon it and that it was 9 feet 11 inches from the ground. When the the damaged area of the aircraft, which had been cut away from the aircraft was offered up to the damaged area of the Luton cargo vehicle, the markings on the piece of the aircraft matched perfectly with the structure of the vehicle. The task sheet for this vehicle on the morning of the accident was for it to deliver fast freight to this aircraft on stand C30.
