INCIDENT

Aircraft Type and Registration:	Boeing 757-225, G-OOOM	
No & Type of Engines:	2 Rolls-Royce RB211-535E4 turbofan engines	
Year of Manufacture:	1986	
Date & Time (UTC):	13 October 1995 at approximately 1250 hrs	
Location:	On approach to Birmingham Airport	
Type of Flight:	Public Transport	
Persons on Board:	Crew - 9	Passengers - 233
Injuries:	Crew - None	Passengers - None
Nature of Damage:	Loss of fairing panel on right-hand side of fuselage	
Commander's Licence:	Not known	
Commander's Age:	Not known	
Commander's Flying Experience:	Not known Last 90 days - N/A Last 28 days - N/A	
Information Source:	AAIB Field Investigation

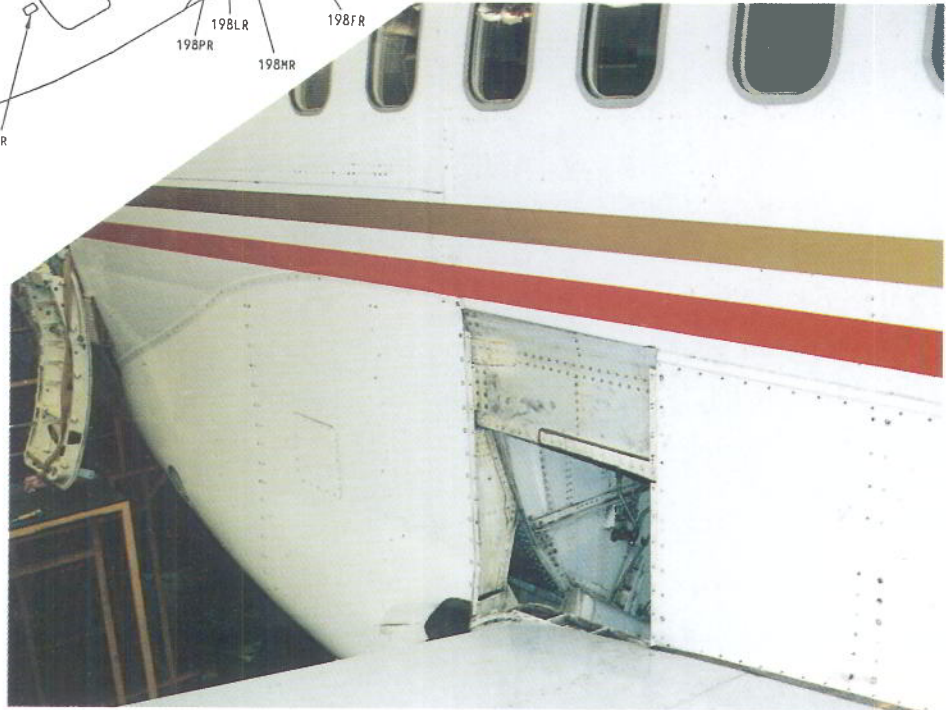
View of similar aircraft with Panel 198BR removed

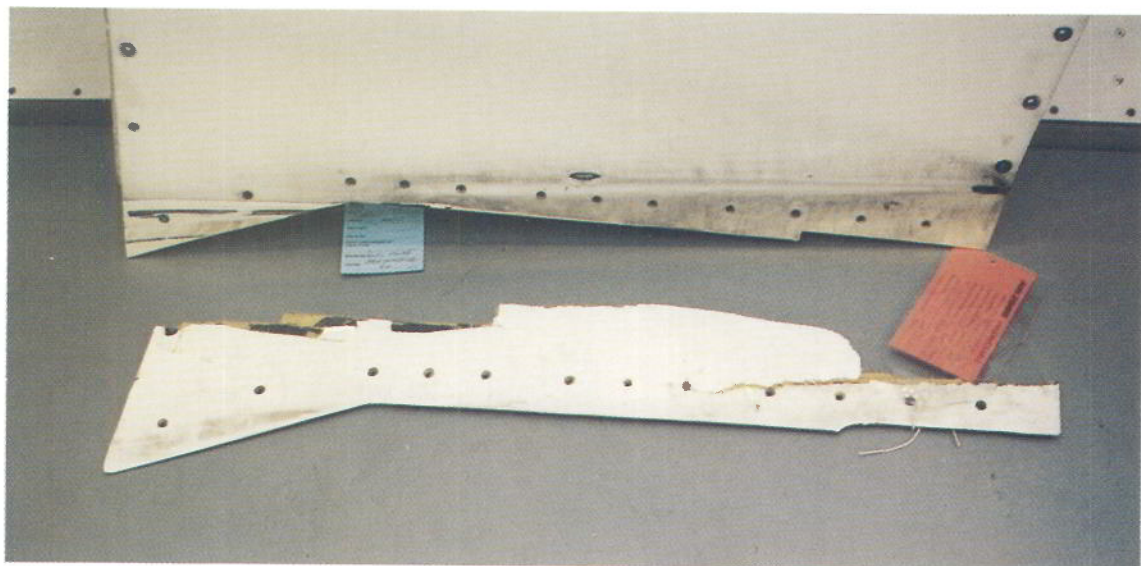
The panel, which was of composite construction, was identified as 196BR, as shown on the appended diagram. It was attached to the structure (typically 'T' section flanges) by means of screw type fasteners which located into floating nut-plates, or anchor nuts. The upper portion of the 'T' flange under the panel trailing edge had been torn off, which had caused damage to the leading edge of the panel located immediately aft. The section of the affected panel that had remained with the aircraft bore no evidence of disbonding, moisture ingress or any other visible material defect. It was despatched to

Following the incident, a maintenance organisation was contracted to fabricate a temporary panel out of sheet alloy. Due to pressure to return the aircraft to service, there was no organised documentation of evidence prior to repair. However, personnel did recall that one or two fasteners from the leading edge may have been missing. The fact that most were still in position suggested that the panel had departed by means of the fastener heads pulling through the holes in the panel.

Remaining portion of panel from G-OOOM
