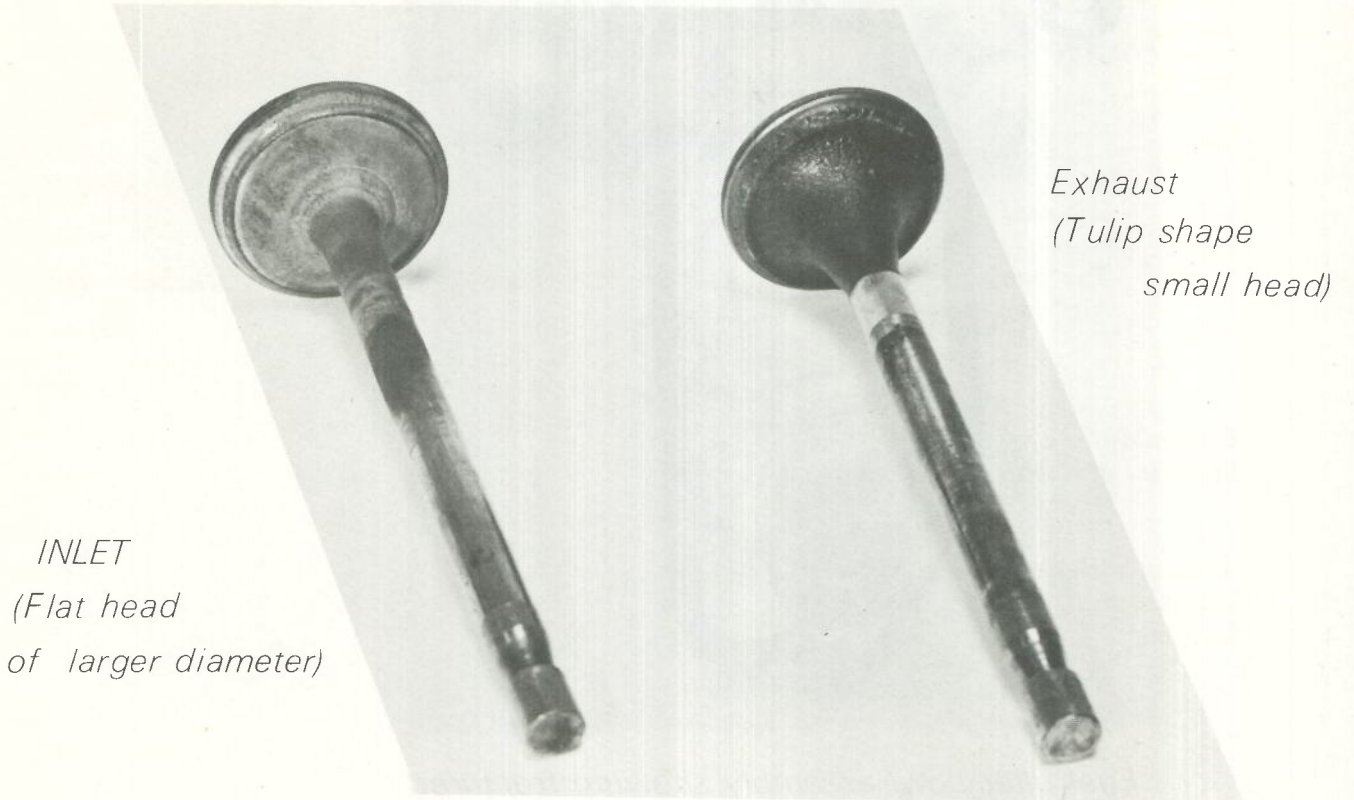
Fig. 1

Showing differences in heads of valves

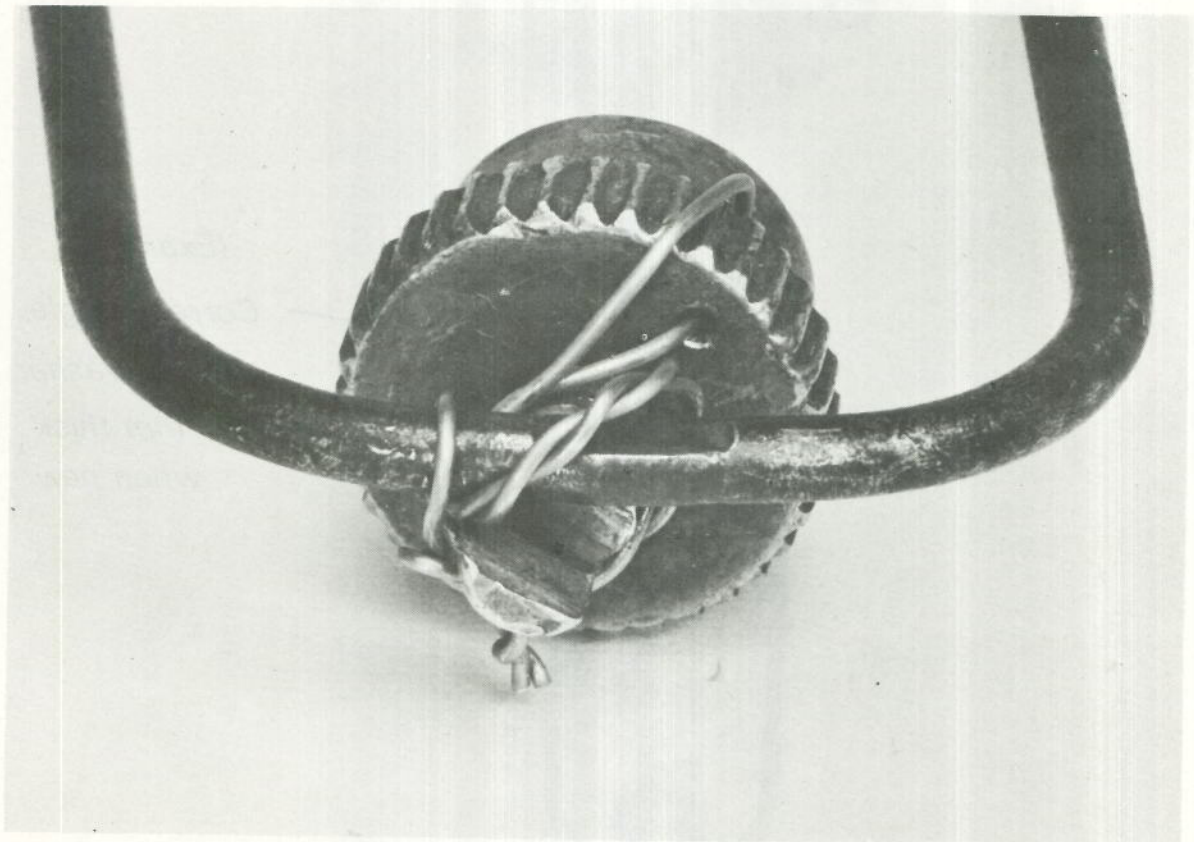
Fig 2.

Showing fractured anchorage lug and incorrect routing of locking wire

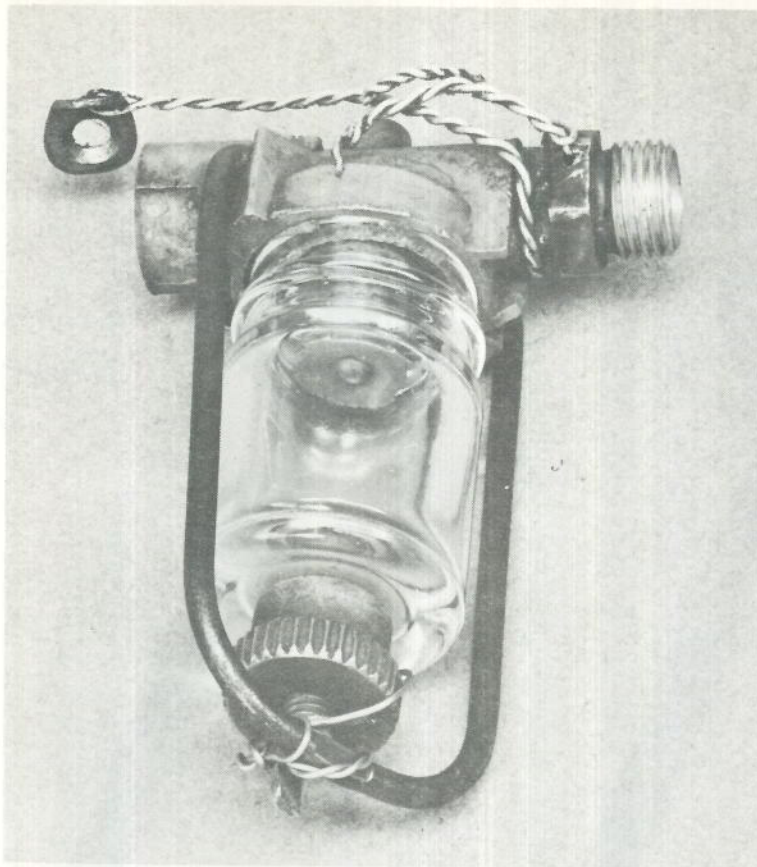
Fig 3.

Fuel filter bowl assembly showing fractured anchorage lug and incorrect wire locking

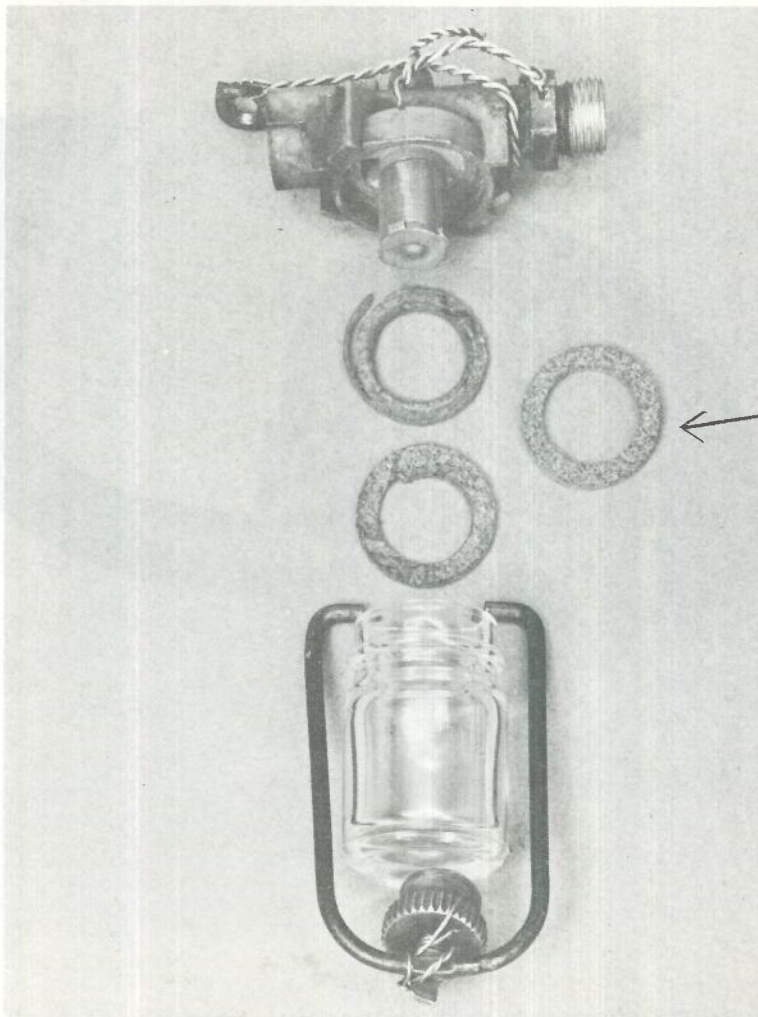
Fig 4.

(Example)  
Correct single  
sealing washer  
2 mm thick  
when new

Disassembled filter bowl showing two thin and damaged cork sealing washers
