ACCIDENT

Aircraft Type and Registration:	i) Cessna 152, G-BNXC ii) Aerotechnik EV-97 Eurostar, G-GHEE
No & Type of Engines:	i) 1 Lycoming O-235-L2C piston engine ii) 1 Rotax 912-UL piston engine
Year of Manufacture:	i) 1981 ii) 2001
Date & Time (UTC):	18 December 2005 at 1218 hrs
Location:	Moreton in Marsh, Gloucestershire
Type of Flight:	i) Training ii) Private
Persons on Board:	i) Crew - 1 Passengers - None ii) Crew - 1 Passengers - 1
Injuries:	i) Crew - 1 (Fatal) Passengers - N/A ii) Crew - None Passengers - None
Nature of Damage:	i) Aircraft destroyed ii) Substantial damage to engine and forward fuselage, left wing and landing gear
Commander's Licence:	i) Student Pilot (JAA Class 2 medical certificate) ii) Private Pilots Licence
Commander's Age:	i) 34 years ii) 62 years
Commander's Flying Experience:	i) 52 hours (of which 10 were on type) Last 90 days - 7 hours Last 28 days - Nil hours ii) 265 hours (of which 92 were on type) Last 90 days - 4 hours Last 28 days - 2 hours

Information Source:	AAIB Field Investigation

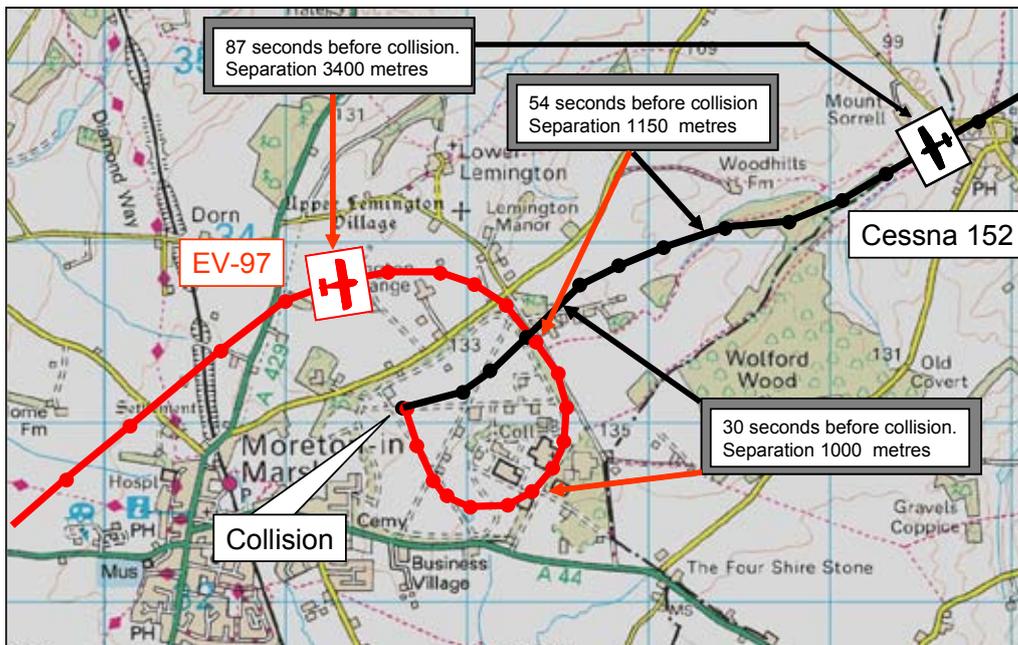
Figure 1
Tracks of the two aircraft, derived from GPS and radar information

At 2 minutes 20 seconds before the collision the aircraft were approaching the accident area from opposite directions, being approximately head-on to each other at a range of 7.6 km. As the Eurostar started its right turn in the accident area, 87 seconds before collision, the two aircraft were 3,400 m apart. The Cessna was directly ahead of the Eurostar at this stage, which would have been just to the right of the Cessna's nose. Shortly after, some 54 seconds before collision and just as the Eurostar crossed its intended track, the Cessna was seen to have altered course to the right by 20° to 25°. At this point the two aircraft were 1,150 m apart. The Eurostar then continued its right-hand turn while the Cessna turned back to parallel its original track for a short while before turning again to track directly for the centre of the disused airfield. The Cessna then resumed its original track whilst the Eurostar continued to turn right until it rolled out on a track of about 350°(M). At this point the aircraft were some six seconds from collision, the crossing angle was about 100° and the aircraft were between 300 and 350 metres apart.

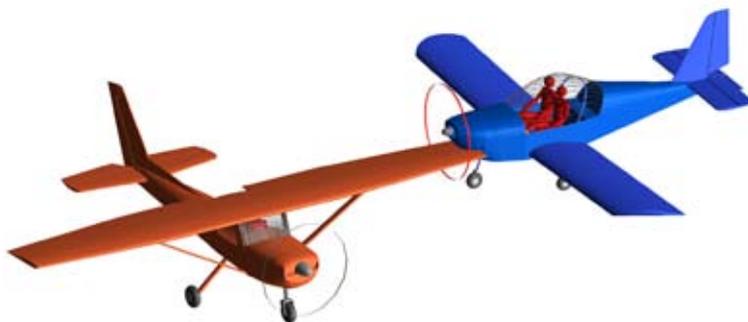
Figure 2

Simple 3D CAD models were created for both aircraft involved, in sufficient detail to allow the relationship between the patterns of damage sustained by each aircraft to be explored; in particular, the character and orientation of scrapes and paint smears observed on the Cessna's left outer wing and the distribution damage to the Eurostar's nose and engine. The analysis confirmed that the Eurostar had been tracking approximately at right angles to the Cessna, approaching the Cessna's left side, and that the lower segment of its propeller arc, lower engine cowl, and the upper part of the nose landing gear strut had impacted the Cessna's left wing end-on, approximately as illustrated in Figure 2. The precise attitude of the Eurostar in roll and pitch could not be determined, but neither was extreme.

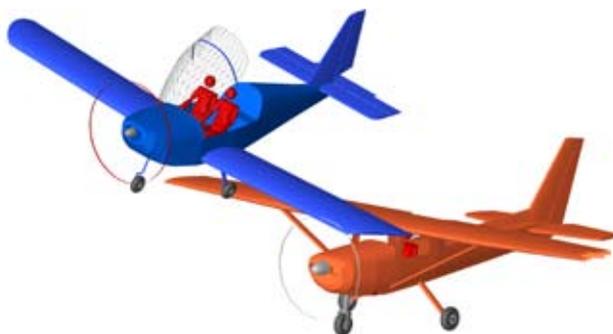
Figure 3

The propeller damage on the outer leading edge of the Eurostar's left wing was consistent with it having made a glancing contact with the rear face of the Cessna's propeller disc. In order for this to occur, the aircraft must have yawed rapidly relative to one another during the collision sequence so that their flight paths were approximately parallel. The Eurostar's occupants report that during the collision sequence the canopy burst open. The absence of any collision damage to the Eurostar's (open) canopy or fin, together with the absence of any contact between its right wing and the Cessna's fin and rudder, suggest that the Eurostar had rolled to the left

somewhat (relative to the Cessna) and *climbed over* the top of it before contacting its propeller, in the manner illustrated in Figure 3.

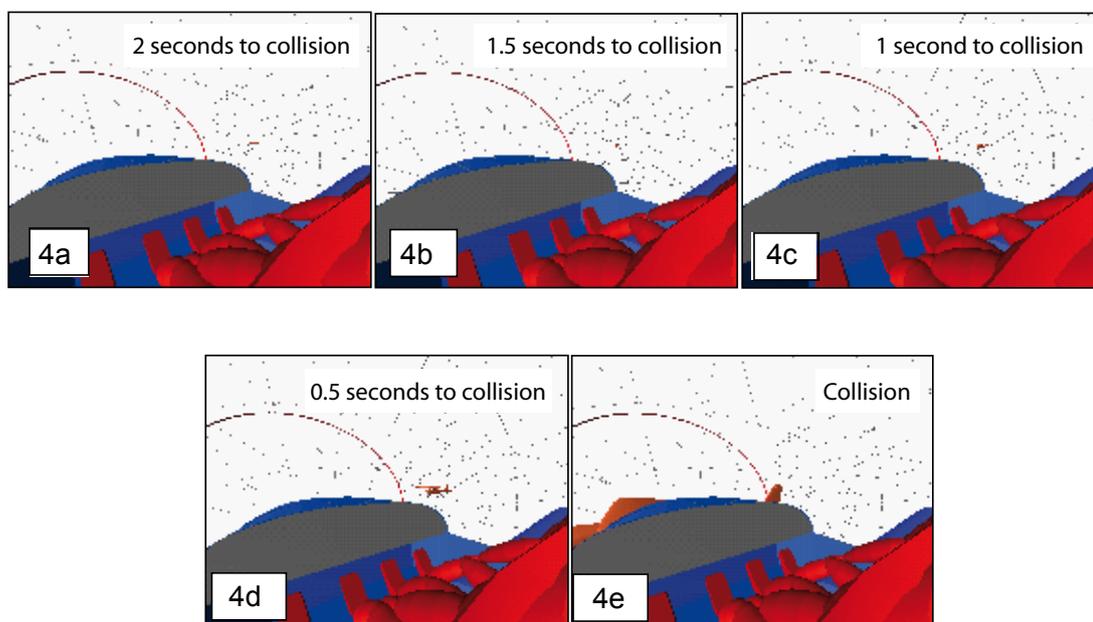
Figures 4a to 4e

This analysis suggested that, unless the Eurostar had been banked to the left, its pilot would have had a direct line of sight to the Cessna and that it would not have been obstructed by the instrument panel, cockpit surround or any other part of the aircraft. However, the angle subtended at his eye by the Cessna (ie the size of image formed on his retina), would have been very small and would have changed very little until the final second or so before the collision. If the Cessna had been in the Eurostar pilot's peripheral field of view, where visual acuity is poor and *rate of change* (movement across, or growth of image size on, the retina) is the primary factor in triggering a response, it is unlikely that he would have registered its presence in time to take effective avoiding action. Figures 4a through 4e mimic the images that would have been produced if a camera with a standard lens was positioned at the Eurostar pilot's eye position, pointed towards the Cessna, and the shutter triggered at half-second intervals during the final 2 seconds prior to the collision. The small size of the Cessna in relation to

Simulated view from the Eurostar, G-GHEE

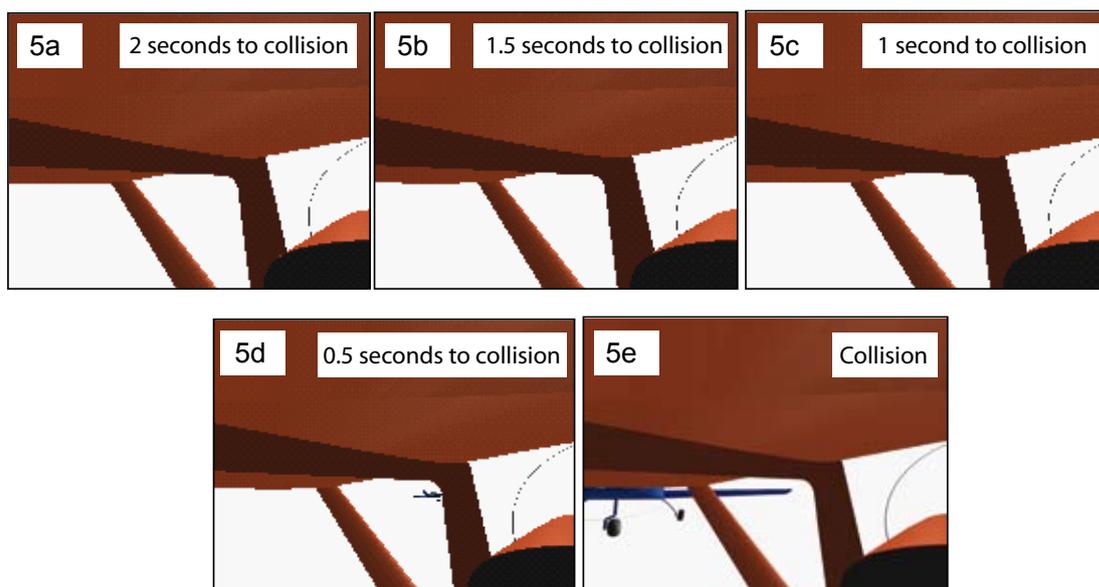
Figures 5a to 5e

A similar analysis to assess the Cessna pilot's probable field of view suggested that the Eurostar was likely to have been hidden behind the left screen pillar until about half a second prior to the collision, as shown in the sequence of *photo images* in Figures 5a through 5e. Had this been the case, then no effective avoiding action could have been taken by him in the time available.

Simulated view from the Cessna 152, G-BNXC
