**INCIDENT**

| <b>Aircraft Type and Registration:</b> | Embraer E120 Brazilia, F-GFEO | |
| <b>Date &amp; Time (UTC):</b> | 31 March 2005 at 0848 hrs | |
| <b>Location:</b> | Seven miles to the west of Isle of Man Airport, on approach to Runway 08 | |

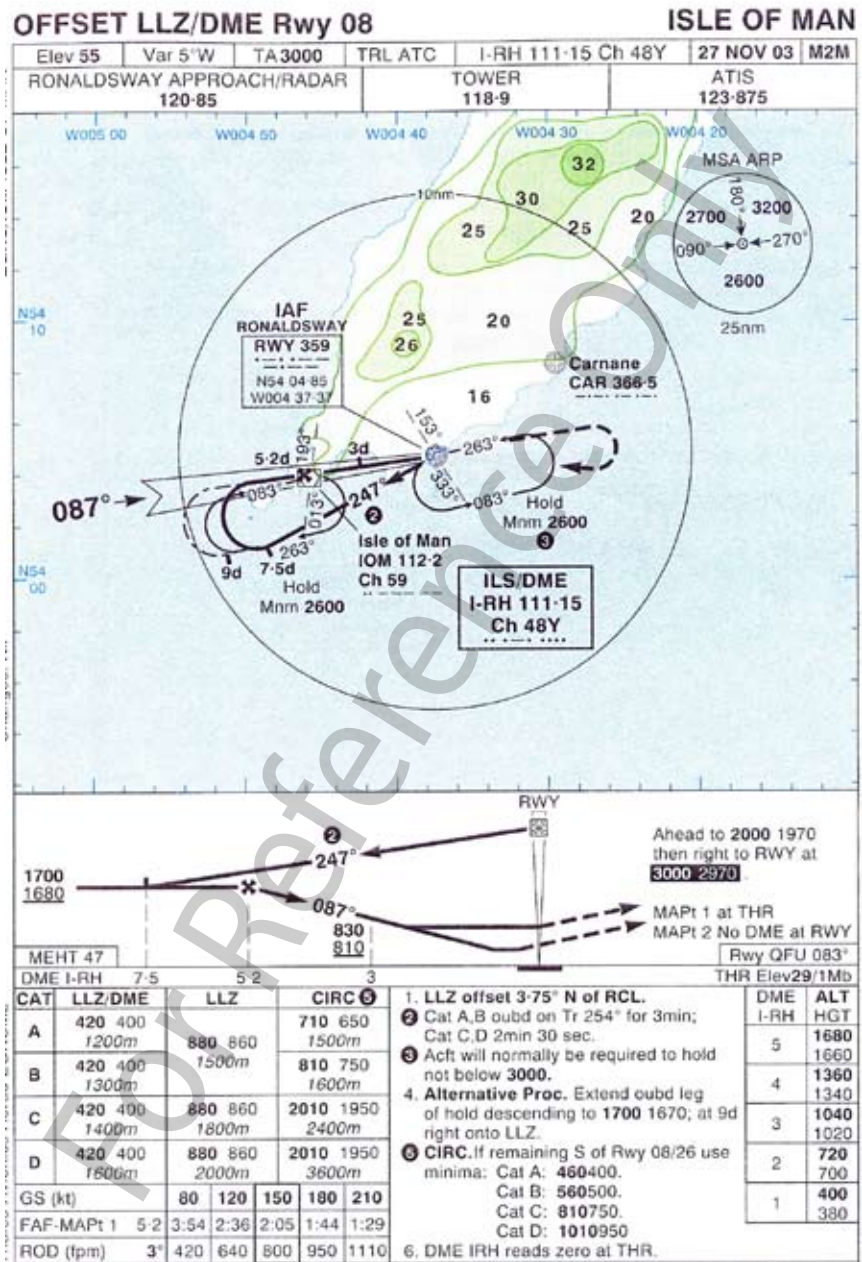
Figure 1

The aircraft took off from Manchester Airport at 0817 hrs with the commander acting as the handling pilot. During the cruise the commander briefed for a localiser/DME approach to Runway 08 at the Isle of Man, Figure 1. He recalled selecting the ILS frequency on his instruments for the approach whilst the first officer retained the Isle of Man (IOM) VOR. The crew were given radar vectors by ATC, to position the aircraft onto an intercept heading for the final approach and were cleared for the localiser/DME approach. The commander stated that, at about this time, and for reasons he cannot recall, either he or the first officer changed the ILS frequency previously selected on the commander's instruments to the IOM VOR frequency. The aircraft was fully configured for landing and the first officer reported to ATC that they were established on the localiser. The Approach controller then instructed the crew to transfer to the Tower frequency. The commander later stated that when he established the aircraft on the final approach track, by reference to the IOM VOR, he believed he was in fact establishing on the localiser. The IOM VOR antenna is positioned 5.2 nm to the west of the I-RH Localiser/DME antenna on the final approach track to the airfield, Figure 1<sup>1</sup>.

The commander was familiar with this particular approach and noticed that the DME reading was less than he was expecting when initially establishing on the final inbound track. On checking, he realised that he had the IOM VOR frequency selected instead of that for the ILS. The commander considered that this would make a good training point for the first officer

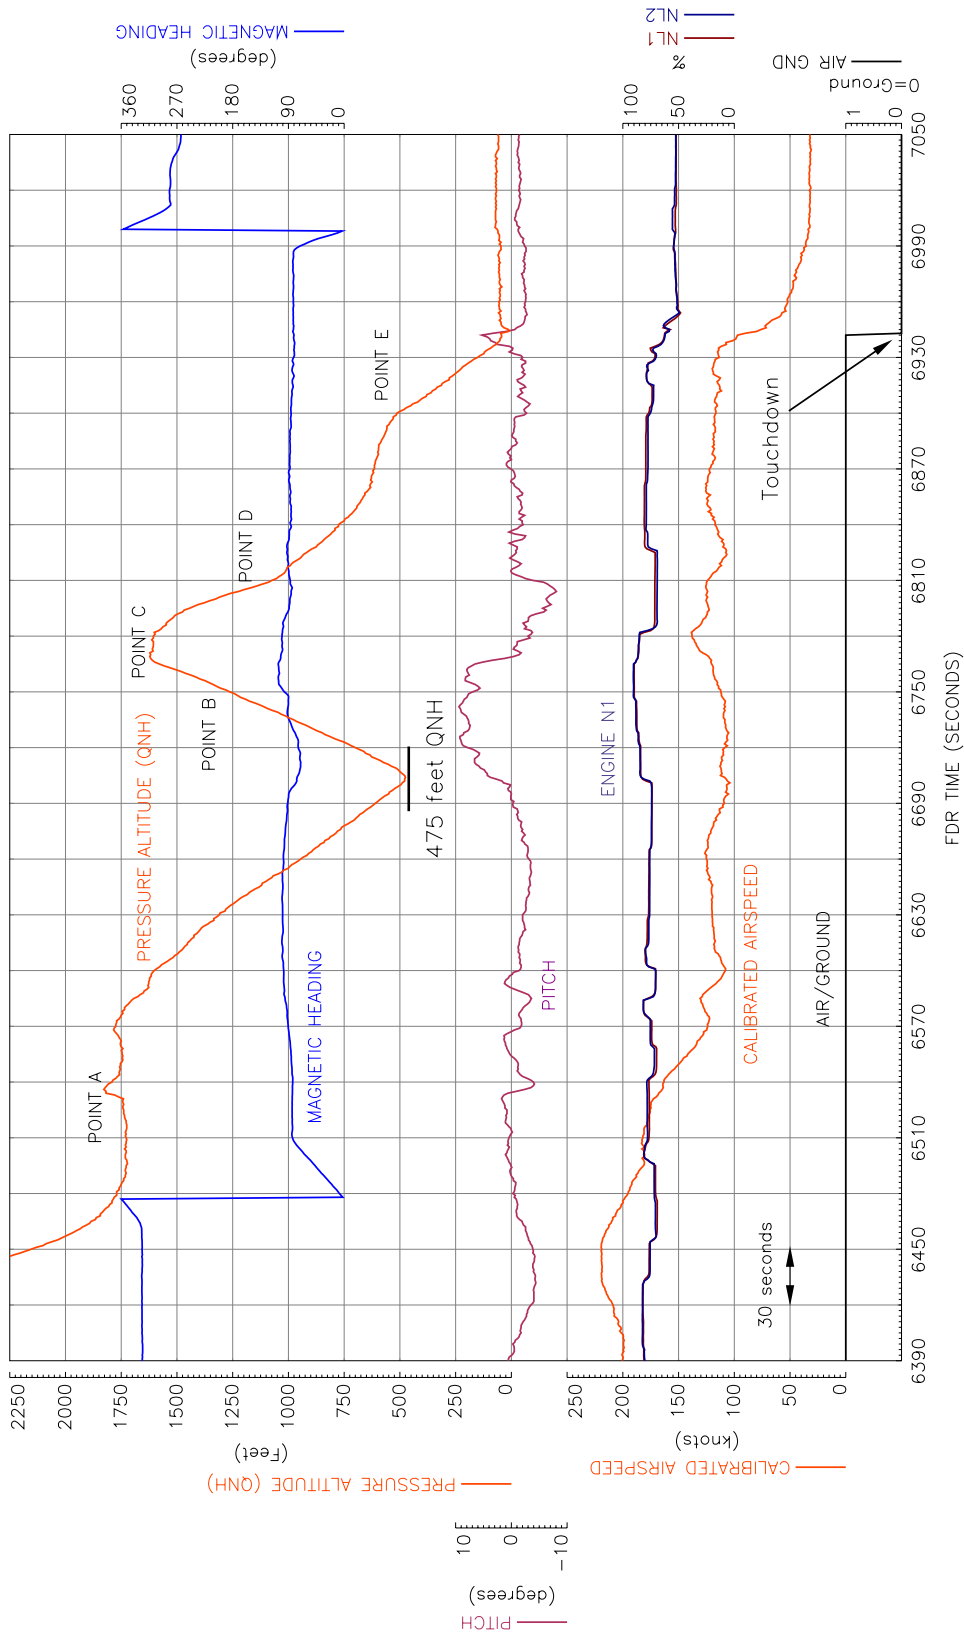
**Figure 2**  
Salient FDR Parameters  
(Incident to F-GFEO on 31 March 2005)

Figure 2 represents data covering the approach and landing phase of the flight. At 0846 hrs, the aircraft had descended to about 1,700 ft QNH (Point A) and had turned onto a magnetic heading of about 080°, with Flap 25 set. At 0847 hrs, the aircraft was approximately 12 nm from the airfield, at which time it started to descend at approximately 600 fpm on a

glide path of about 3°. The descent continued until, at approximately 475 ft QNH, engine power increased, the aircraft pitched up and started to climb. The climb rate was stabilised at about 1,000 fpm (Point B) until it levelled off at 1,600 ft QNH. The aircraft remained at this level until, at approximately 5 nm from the airfield (Point C), it began its final descent. Initially, the average descent rate was about 800 fpm, (Point D), but this was then reduced as an altitude of 650 ft was approached (Point E). Subsequently, it increased again to about 600 fpm following which the aircraft flew down a glide path of approximately 3° to touchdown, which occurred at 0853:21 hrs. The aircraft taxied clear of the runway and the FDR stopped recording at 0858:32 hrs, when the anti-collision beacon was turned off.
