INCIDENT

Aircraft Type and Registration:	Embraer E120 Brazilia, F-GFEO	
No & Type of Engines:	2 Pratt and Whitney PW-118 turboprop engines	
Year of Manufacture:	1987	
Date & Time (UTC):	31 March 2005 at 0848 hrs	
Location:	Seven miles to the west of Isle of Man Airport, on approach to Runway 08	
Type of Flight:	Public Transport (Passenger)	
Persons on Board:	Crew - 3	Passengers - 7
Injuries:	Crew - None	Passengers - None
Nature of Damage:	None	
Commander's Licence:	Airline Transport Pilot's Licence	
Commander's Age:	50 years	
Commander's Flying Experience:	11,750 hours (of which 2,210 hours were on type) Last 90 days - 117 hours Last 28 days - 37 hours	
Information Source:	AAIB Field Investigation

Synopsis

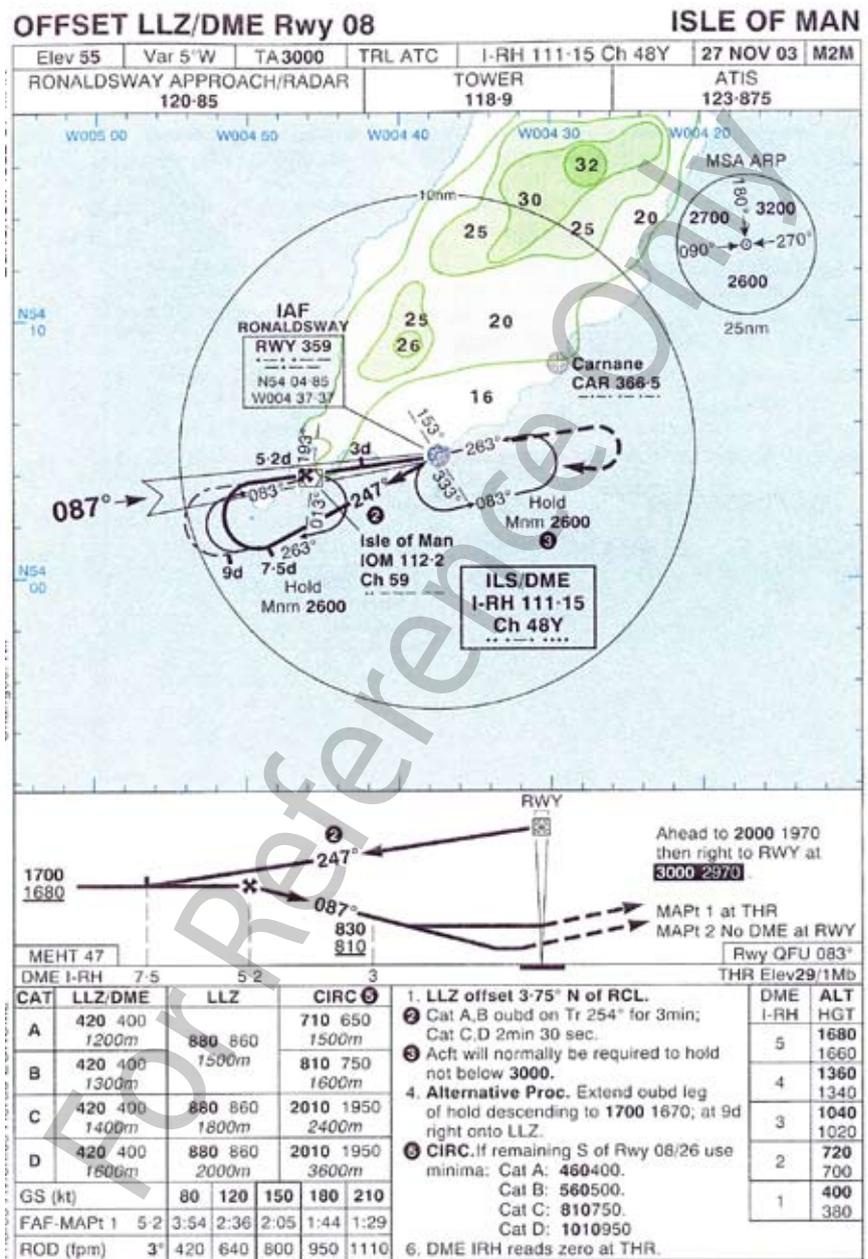
Figure 1

The aircraft took off from Manchester Airport at 0817 hrs with the commander acting as the handling pilot. During the cruise the commander briefed for a localiser/DME approach to Runway 08 at the Isle of Man, Figure 1. He recalled selecting the ILS frequency on his instruments for the approach whilst the first officer retained the Isle of Man (IOM) VOR. The crew were given radar vectors by ATC, to position the aircraft onto an intercept heading for the final approach and were cleared for the localiser/DME approach. The commander stated that, at about this time, and for reasons he cannot recall, either he or the first officer changed the ILS frequency previously selected on the commander's instruments to the IOM VOR frequency. The aircraft was fully configured for landing and the first officer reported to ATC that they were established on the localiser. The Approach controller then instructed the crew to transfer to the Tower frequency. The commander later stated that when he established the aircraft on the final approach track, by reference to the IOM VOR, he believed he was in fact establishing on the localiser. The IOM VOR antenna is positioned 5.2 nm to the west of the I-RH Localiser/DME antenna on the final approach track to the airfield, Figure 1¹.

The commander was familiar with this particular approach and noticed that the DME reading was less than he was expecting when initially establishing on the final inbound track. On checking, he realised that he had the IOM VOR frequency selected instead of that for the ILS. The commander considered that this would make a good training point for the first officer

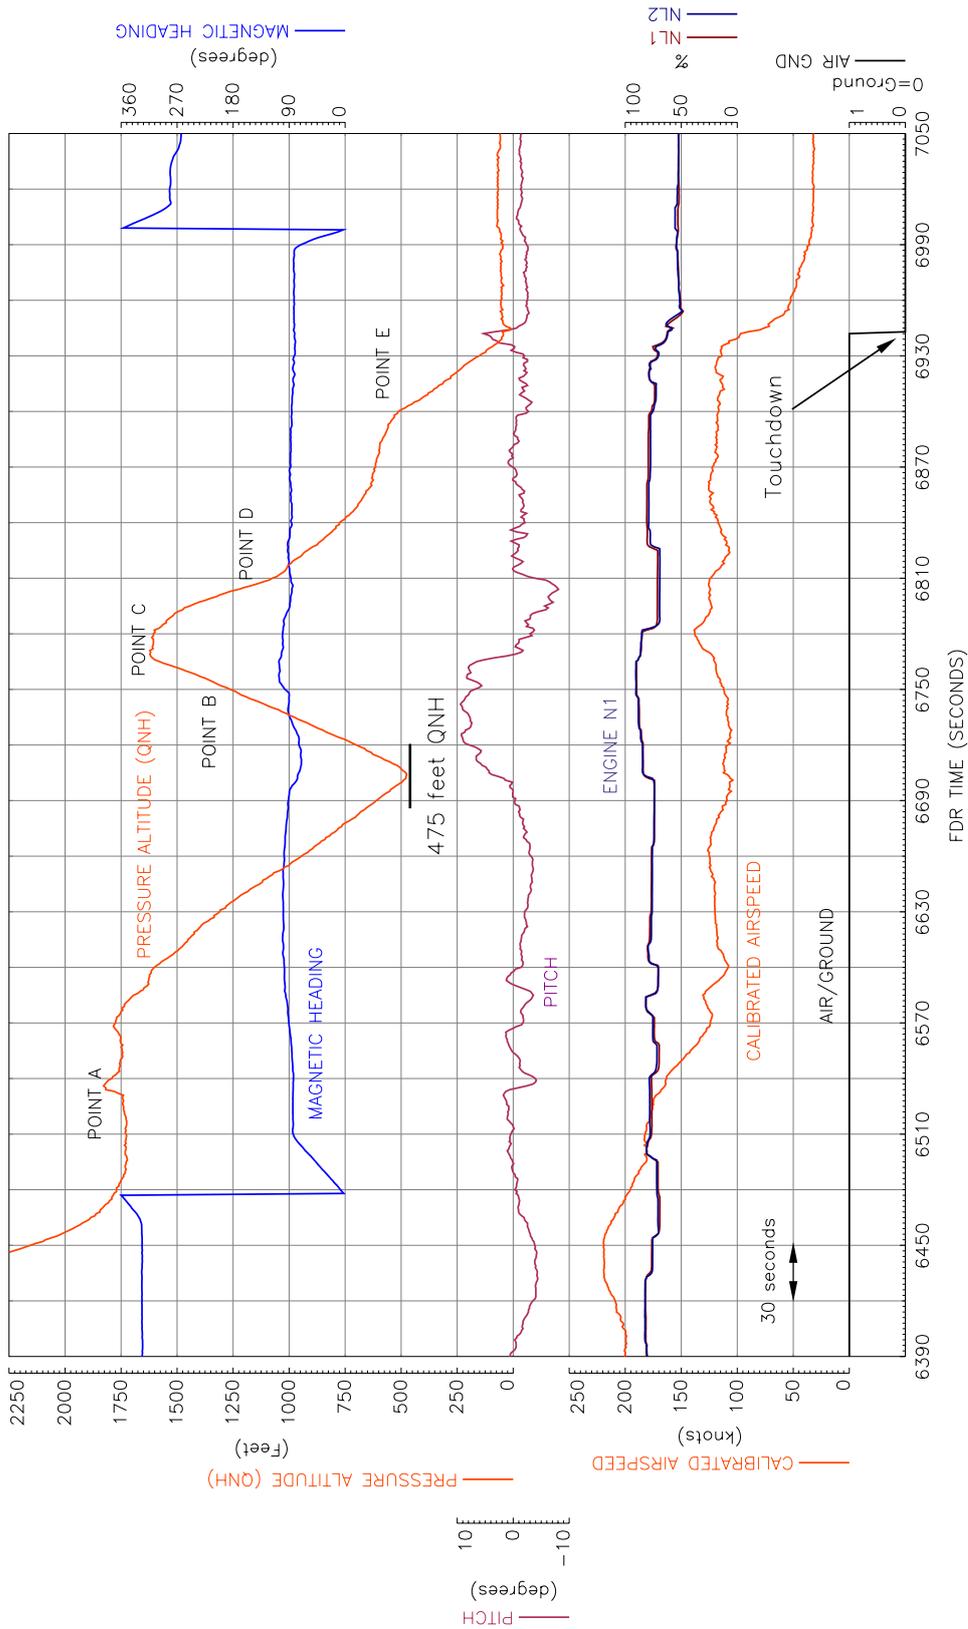
Figure 2
Salient FDR Parameters
(Incident to F-GFEO on 31 March 2005)

Figure 2 represents data covering the approach and landing phase of the flight. At 0846 hrs, the aircraft had descended to about 1,700 ft QNH (Point A) and had turned onto a magnetic heading of about 080°, with Flap 25 set. At 0847 hrs, the aircraft was approximately 12 nm from the airfield, at which time it started to descend at approximately 600 fpm on a

glide path of about 3°. The descent continued until, at approximately 475 ft QNH, engine power increased, the aircraft pitched up and started to climb. The climb rate was stabilised at about 1,000 fpm (Point B) until it levelled off at 1,600 ft QNH. The aircraft remained at this level until, at approximately 5 nm from the airfield (Point C), it began its final descent. Initially, the average descent rate was about 800 fpm, (Point D), but this was then reduced as an altitude of 650 ft was approached (Point E). Subsequently, it increased again to about 600 fpm following which the aircraft flew down a glide path of approximately 3° to touchdown, which occurred at 0853:21 hrs. The aircraft taxied clear of the runway and the FDR stopped recording at 0858:32 hrs, when the anti-collision beacon was turned off.
