INCIDENT

Aircraft Type and Registration:	Embraer E120 Brazilia, F-GFEO	
No & Type of Engines:	2 Pratt and Whitney PW-118 turboprop engines	
Year of Manufacture:	1987	
Date & Time (UTC):	31 March 2005 at 0848 hrs	
Location:	Seven miles to the west of Isle of Man Airport, on approach to Runway 08	
Type of Flight:	Public Transport (Passenger)	
Persons on Board:	Crew - 3	Passengers - 7
Injuries:	Crew - None	Passengers - None
Nature of Damage:	None	
Commander's Licence:	Airline Transport Pilot's Licence	
Commander's Age:	50 years	
Commander's Flying Experience:	11,750 hours (of which 2,210 hours were on type) Last 90 days - 117 hours Last 28 days - 37 hours	
Information Source:	AAIB Field Investigation

Synopsis

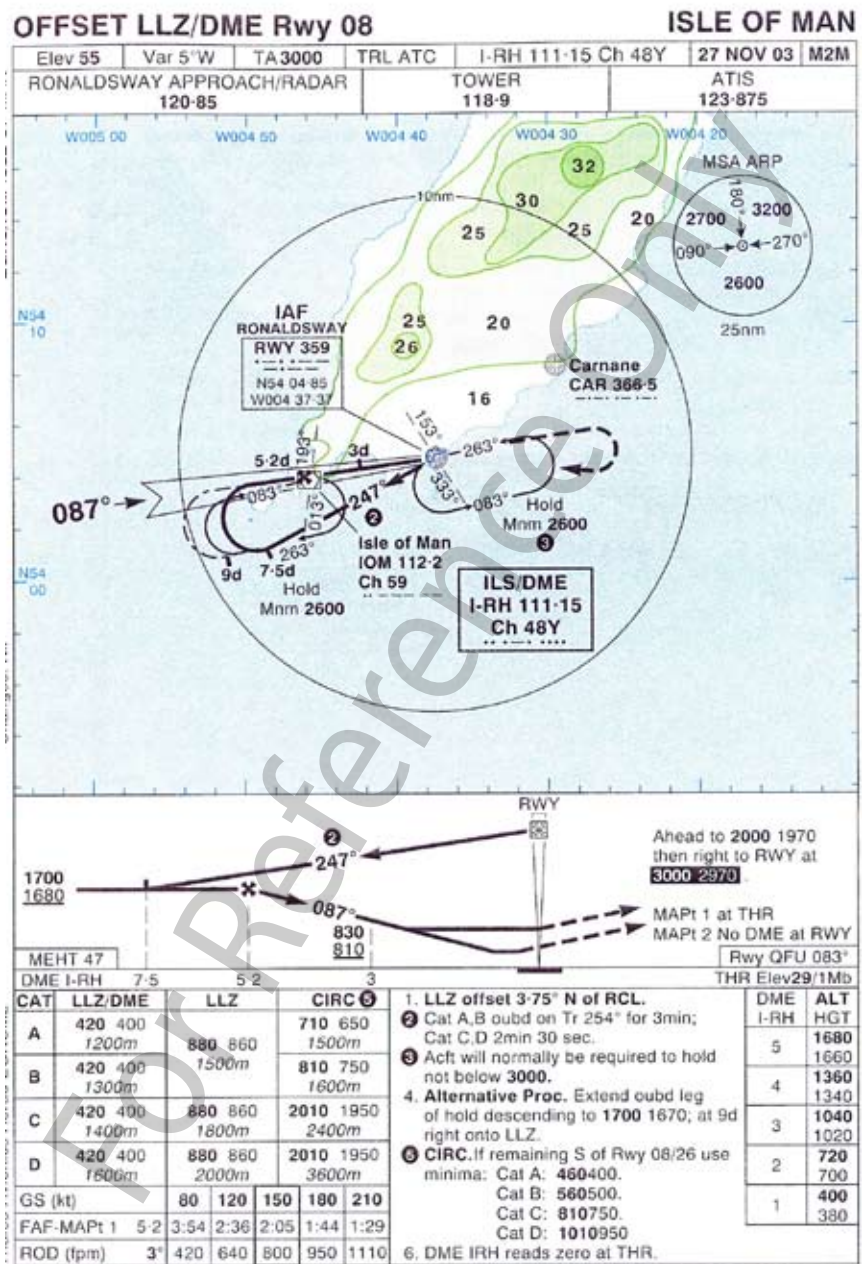
Figure 1

The aircraft took off from Manchester Airport at 0817 hrs with the commander acting as the handling pilot. During the cruise the commander briefed for a localiser/DME approach to Runway 08 at the Isle of Man, Figure 1. He recalled selecting the ILS frequency on his instruments for the approach whilst the first officer retained the Isle of Man (IOM) VOR. The crew were given radar vectors by ATC, to position the aircraft onto an intercept heading for the final approach and were cleared for the localiser/DME approach. The commander stated that, at about this time, and for reasons he cannot recall, either he or the first officer changed the ILS frequency previously selected on the commander's instruments to the IOM VOR frequency. The aircraft was fully configured for landing and the first officer reported to ATC that they were established on the localiser. The Approach controller then instructed the crew to transfer to the Tower frequency. The commander later stated that when he established the aircraft on the final approach track, by reference to the IOM VOR, he believed he was in fact establishing on the localiser. The IOM VOR antenna is positioned 5.2 nm to the west of the I-RH Localiser/DME antenna on the final approach track to the airfield, Figure 1¹.

The commander was familiar with this particular approach and noticed that the DME reading was less than he was expecting when initially establishing on the final inbound track. On checking, he realised that he had the IOM VOR frequency selected instead of that for the ILS. The commander considered that this would make a good training point for the first officer
