ACCIDENT

Aircraft Type and Registration:	Lockheed T-33 Silver Star Mk 3, G-TBRD	
No & Type of Engines:	1 Rolls Royce Nene 10 turbojet engine	
Year of Manufacture:	1953	
Date & Time (UTC):	6 September 2006 at 1320 hrs	
Location:	Duxford Aerodrome, Cambridgeshire	
Type of Flight:	Private	
Persons on Board:	Crew - 1	Passengers - 1
Injuries:	Crew - 1 (Minor)	Passenger - 1 (Serious)
Nature of Damage:	Aircraft destroyed	
Commander's Licence:	Airline Transport Pilot's Licence	
Commander's Age:	59 years	
Commander's Flying Experience:	22,000 hours (of which 14 were on type) Last 90 days - 158 hours Last 28 days - 78 hours	
Information Source:	AAIB Field Investigation

Synopsis

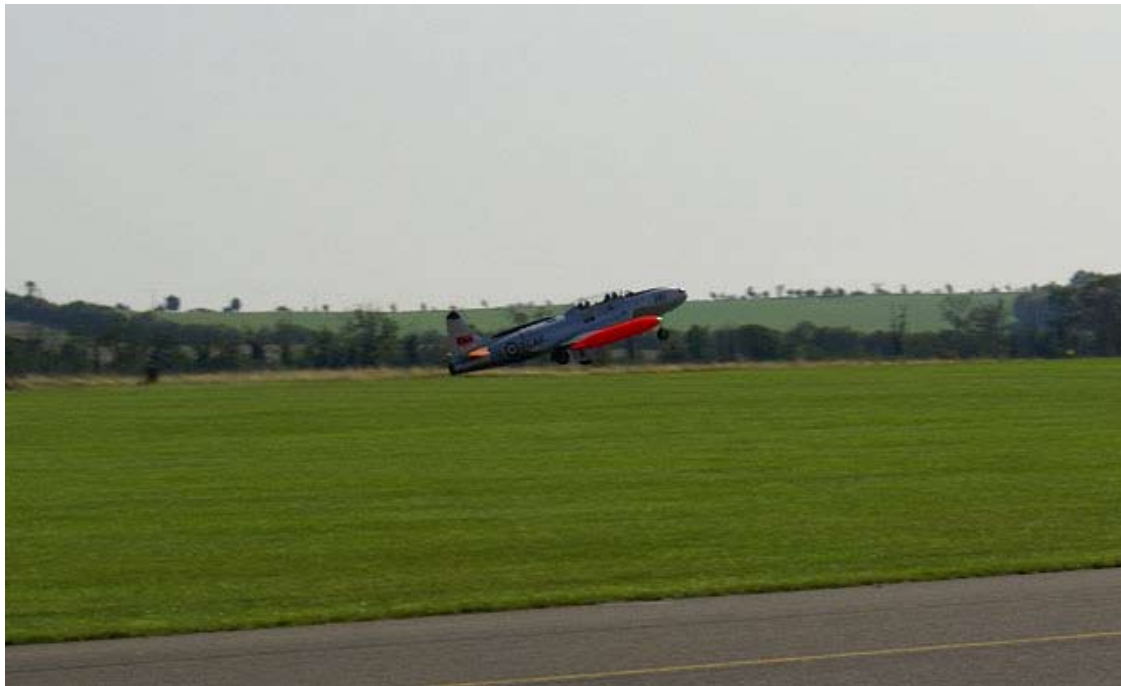
Figure 1

One witness, who was positioned to the north of the runway, recorded the takeoff on a series of photographs. He had set his camera to take a rapid sequence of still images, automatically, at a rate of 34 photographs every 15 seconds. The series of photographs started when G-TBRD was still in the early stages of its takeoff roll and provided good evidence of the subsequent chain of events and the pitch attitude that was achieved during the takeoff, which was approximately 15° nose-up (see Figure 1).

The technique used by the pilot during the takeoff produced an excessive nose-up pitch attitude of about 15° shortly after rotation. This differed from the advice given in the T-33 Operating Instructions and Training manuals held by the operator, in which the nosewheel should be lifted just off the ground during the latter stages of the takeoff roll, and that attitude maintained as the aircraft becomes airborne. Following lift off, a typical pitch attitude during the initial climb is 5-6° nose up.

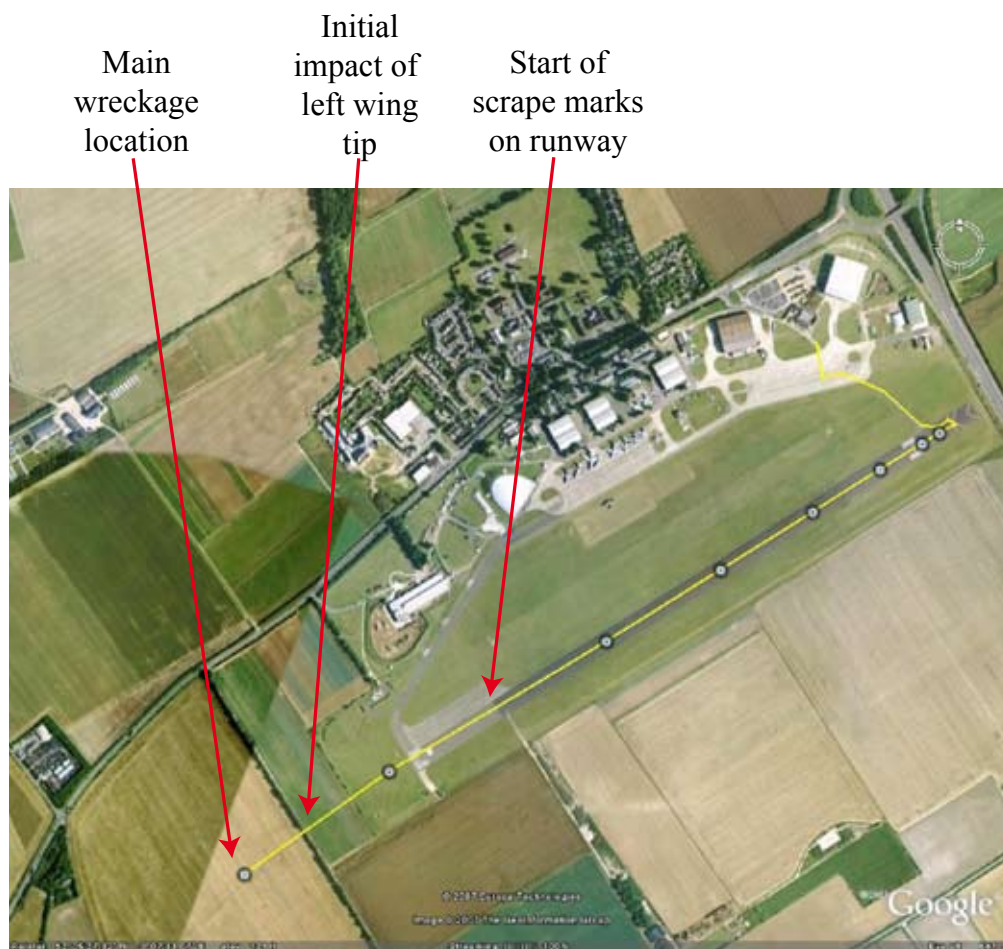
Figure 2

The initial ground contact was from the tailpipe, at the rear of the aircraft, scraping on the runway surface, approximately 230 m from the end of the runway. Beyond the end of the paved surface there was a trail on the grass where it had been scorched by the jet blast. There were also marks from the left main landing gear running along the ground. The initial impact was from the left wing tip tank, which contacted the ground just in front of a high hedge, 250 m beyond the end of the paved surface. Photographic evidence showed the aircraft was in a left bank of over 45° at the time. Pieces from the left wing tip tank were found in the flattened hedge. The aircraft continued ahead for approximately 100 m before the nose impacted the ground. The aircraft then broke up into three main pieces; the front fuselage containing both occupants and the remaining section of the left wing, the rear fuselage including the engine and empennage, and the outer section of the right wing. Fuel, contained in tanks located in the fuselage, both wings and tip tanks, was released on impact, ignited and was consumed in a large fireball.

It was possible to estimate from this information the aircraft position at points during the takeoff run. At around 510 m before the end of the runway the nose of the aircraft began to lift off, and at around 440 m from the end of the runway the main wheels began to leave the runway. The aircraft became airborne briefly, but then descended and contacted the ground at around 230 m from the end of the runway; this was consistent with the scrape marks on the runway surface. When the aircraft crossed the end of the runway it was still in a nose-up attitude but was not climbing.

The photographs showed the aircraft maintaining the same level beyond the end of the runway as the ground dropped away, enabling it to become airborne for the second time, until the left wing dropped by about 50° and the aircraft disappeared from view. The photographs continued until after the aircraft had struck the ground.

The accident sequence and wreckage location is shown at Figure 2:
