SERIOUS INCIDENT

Aircraft Type and Registration:	Beech B200 Super King Air, G-SYGA	
No & Type of Engines:	2 Pratt & Whitney Canada PT6A-42 turboprop engines	
Year of Manufacture:	1982 (Serial no: BB-1044)	
Date & Time (UTC):	15 September 2012 at 0500 hrs	
Location:	Glasgow Airport	
Type of Flight:	Commercial Air Transport (Non-Revenue)	
Persons on Board:	Crew - 2	Passengers - 3
Injuries:	Crew - None	Passengers - None
Nature of Damage:	No damage	
Commander's Licence:	Commercial Pilot's Licence	
Commander's Age:	45 years	
Commander's Flying Experience:	2,700 hours (of which 2,000 were on type) Last 90 days - 45 hours Last 28 days - 21 hours	
Information Source:	AAIB Field Investigation

Synopsis

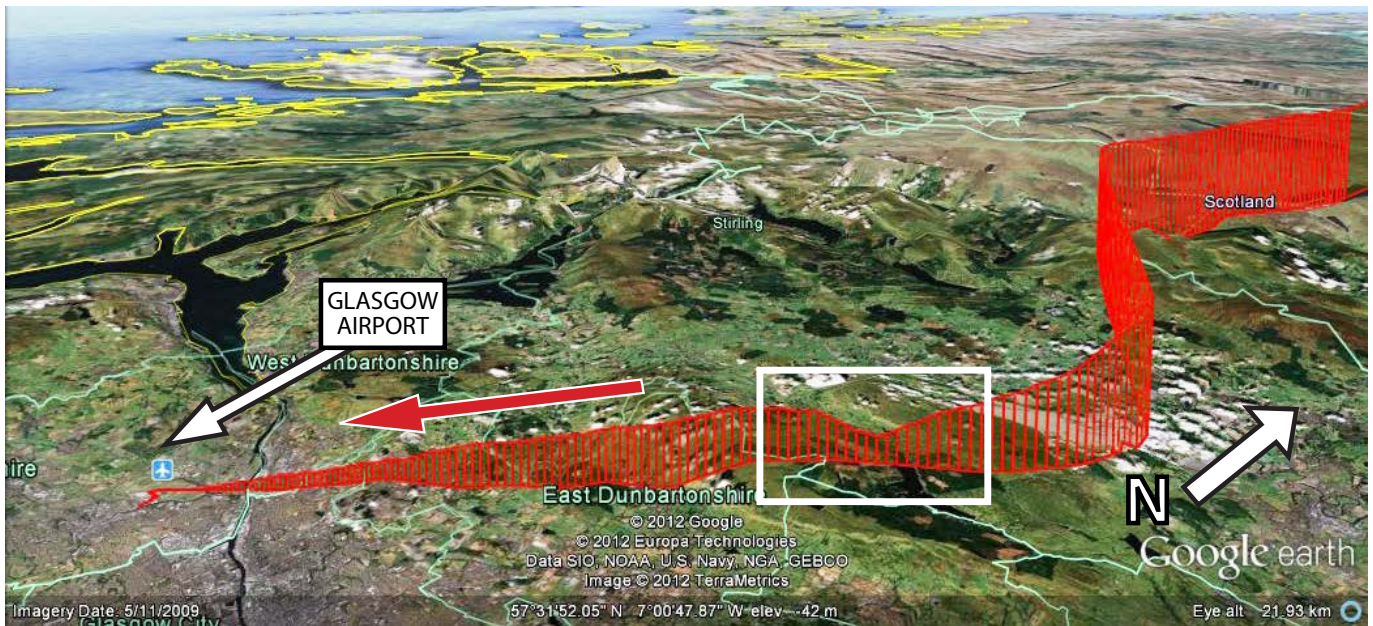
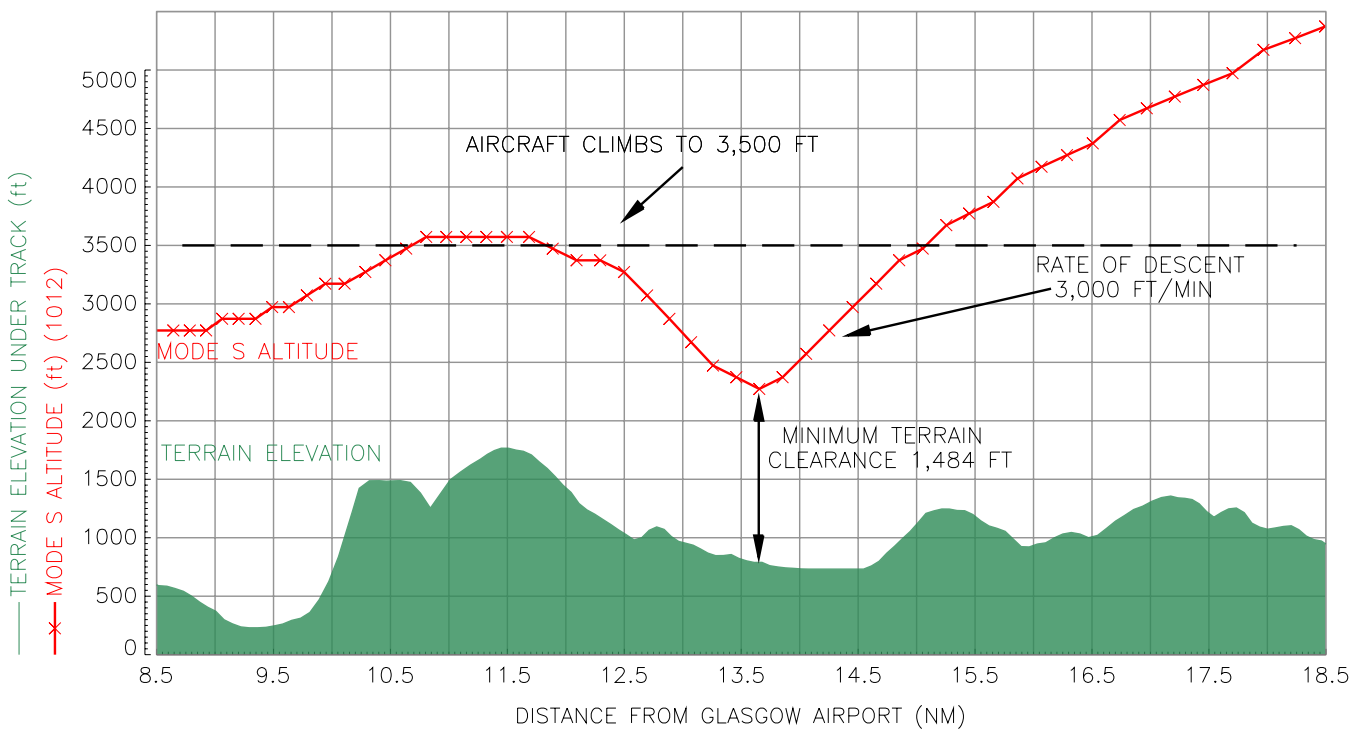
Figure 1
G-SYGA radar track and terrain under track

The aircraft's position was recorded by the Glasgow radar head which also recorded the aircraft's Mode S altitude to within ± 50 ft. This altitude was corrected to the Glasgow QNH of 1012 hPa. The recorded track shows the approach to Glasgow Airport which crossed over the high ground to the north-east of the airport (see Figure 1).

As the aircraft descended through 3,500 ft, the rate of descent increased to approximately 3,000 ft per minute which was maintained for around 16 seconds. The aircraft descended to 2,273 ft before climbing back to 3,500 ft over 40 seconds and then continuing its approach to Glasgow Airport. The minimum terrain clearance during this manoeuvre was 1,484 ft.

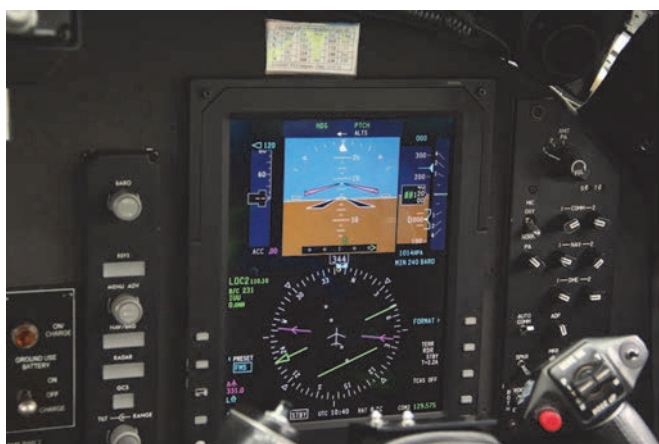
Figure 2

The B200 cockpit with which the pilots were more familiar featured a Pro Line 21 electronic flight information system (EFIS). The autopilot and flight director mode selector panel is positioned above the centre instrument panel, just below the coaming, and is placed centrally between the two pilots. Autopilot modes are annunciated in the top section of each pilot's primary flight display.

Pro Line 21 - Right primary flight instrument display

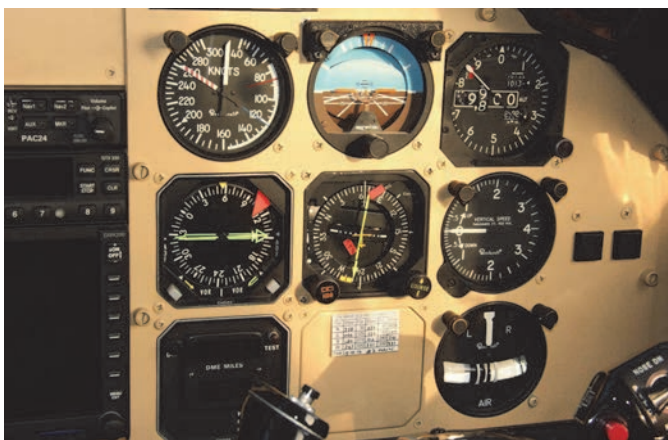
Figure 3

The cockpit of G-SYGA consists of conventional electromechanical flight instruments for both pilots. The left attitude indicator incorporates a flight director whereas the right attitude indicator has no flight director. The autopilot and flight director mode selector panel is located on the centre console to the right of the commander's right knee. The autopilot and flight director mode annunciators comprise a panel of rectangular lights positioned above the left attitude indicator. There are no mode annunciators on the co-pilot's side of the cockpit.

G-SYGA - Right primary flight instrument display

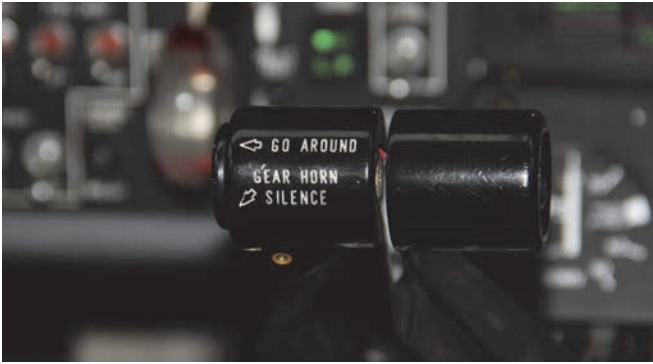
Figure 4

The GEAR HORN SILENCE button is positioned on the left side of the left power lever just underneath the GO-AROUND button, which is located in a recess on the left side of the left power lever knob.

Pro Line 21 – Power levers

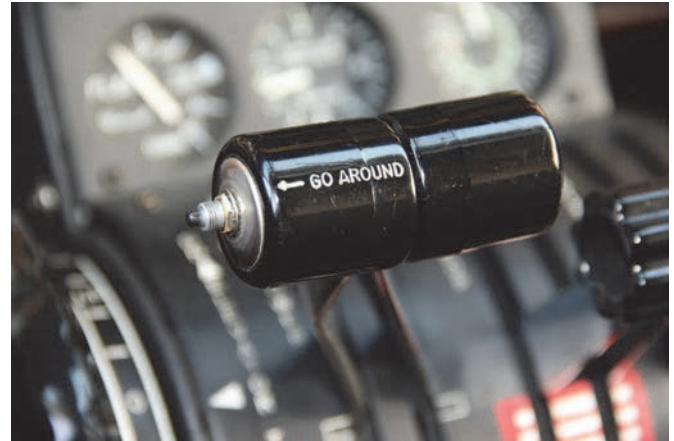
Figure 5

The WARN HORN SILENCE button is located on the lower main instrument panel just in front of the commander's left knee. The GO-AROUND button is located in a position similar to that of Pro Line 21-equipped aircraft but the button protrudes from the power lever knob rather than being recessed in it.

G-SYGA – Power levers.
